**2015 Annual Land-Use Covenant
Inspection Report
for DOE Areas at the Laboratory
for Energy-Related Health
Research/Old Campus Landfill
Superfund Site
University of California, Davis**

January 2016

U.S. DEPARTMENT OF
ENERGY

Legacy
Management

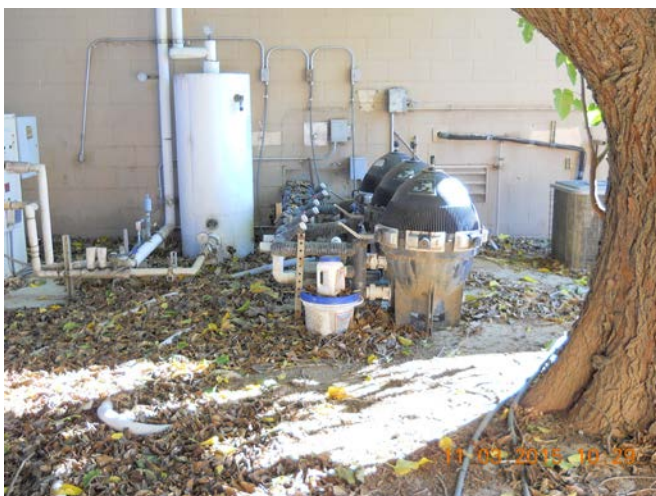
View east: Building H-216 in background, standing north/left of tree (photo No. 2884).

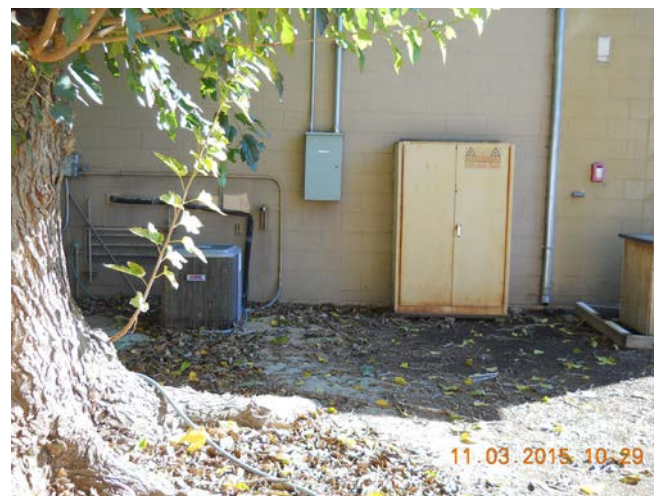
View east: Building H-216 in background, standing south/right of tree (photo No. 2885).

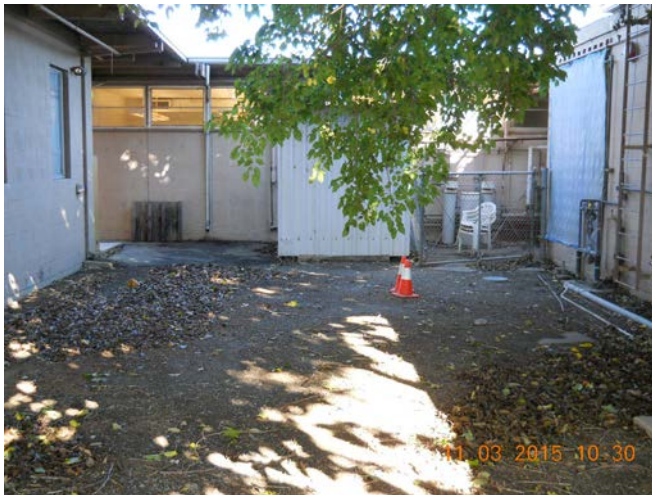
View north over Domestic Septic System 4 septic tank location and east end of leach field: Building H-215 to left, Building H-216 to right; Building H-217 in background (photo No. 2886).

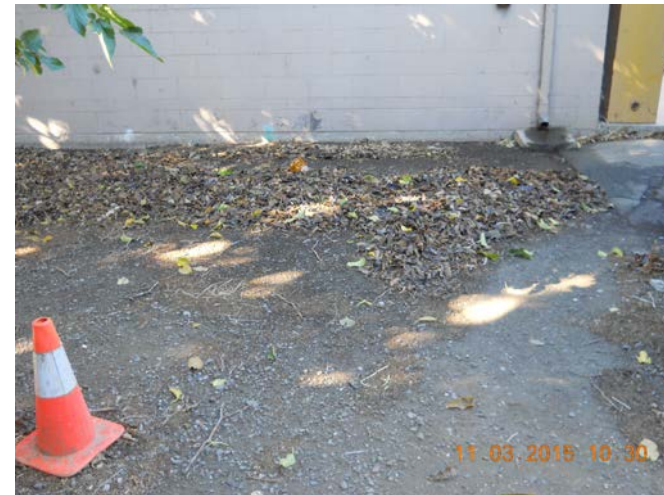
View west over east end of Domestic Septic System 4 leach field: Building H-215 in background (photo No. 2887).

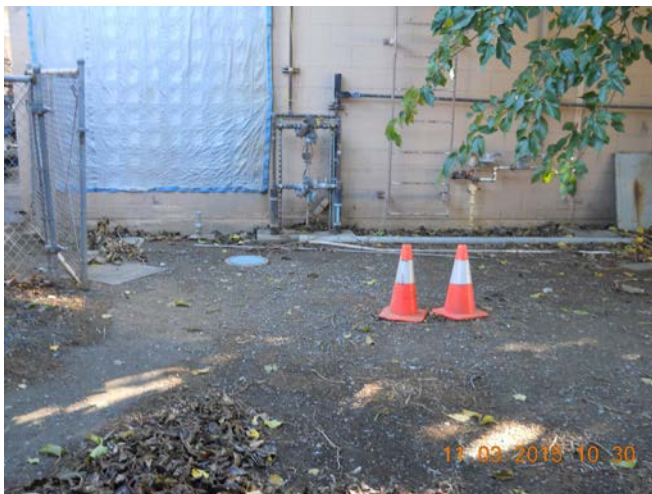
View east over Domestic Septic System 4 septic tank location: Building H-216 in background (photo No. 2888).

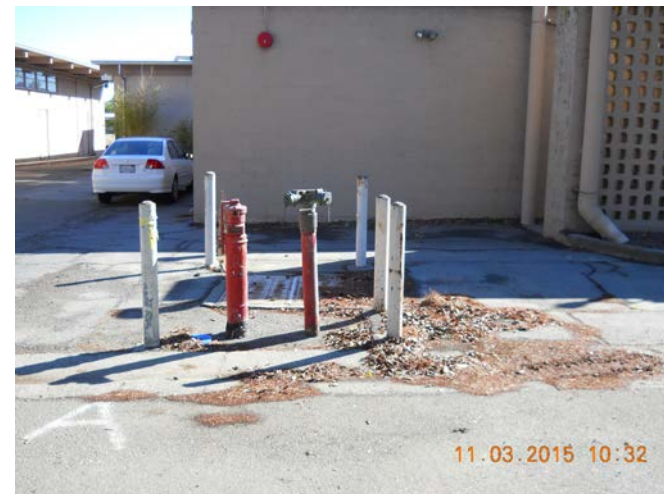
View east over western portion of Domestic Septic System 4 Area: Building H-215 in background (photo No. 2890).

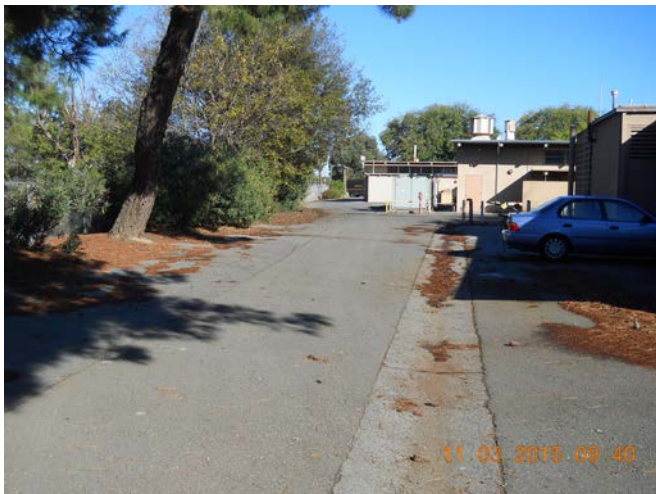
View north over southern portion of Radium/Strontium Treatment Systems Area: Building H-215 to right; Buildings H-218 and H-219 in background (photo No. 2852).

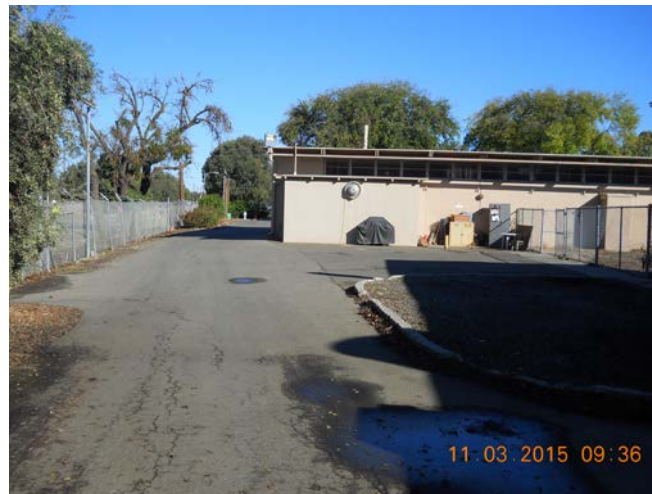
View north over middle portion of Radium/Strontium Treatment Systems Area: Building H-219 in background (photo No. 2850).

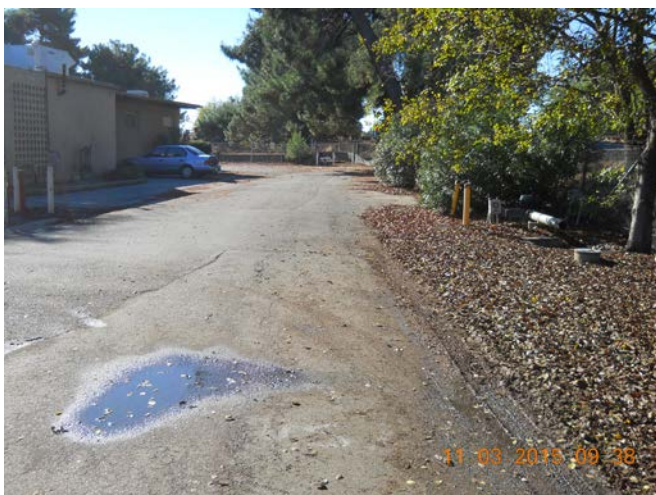
View south over southern portion of Radium/Strontium Treatment Systems Area: Building H-215 to left (photo No. 2851).

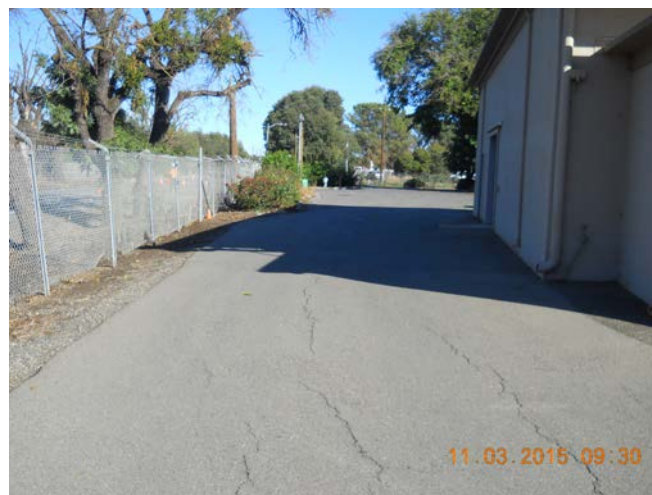
View north over northern portion of Radium/Strontium Treatment Systems Area: Building H-219 to right (photo No. 2845).

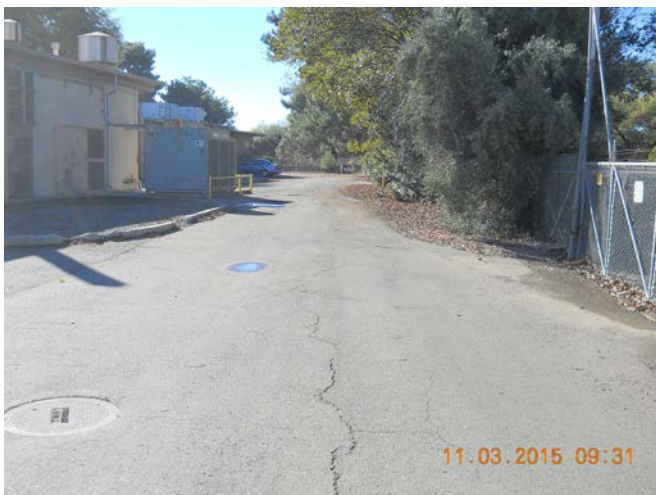
View south over the middle-south portion of Radium/Strontium Treatment Systems Area: Building H-218 to left (photo No. 2846).

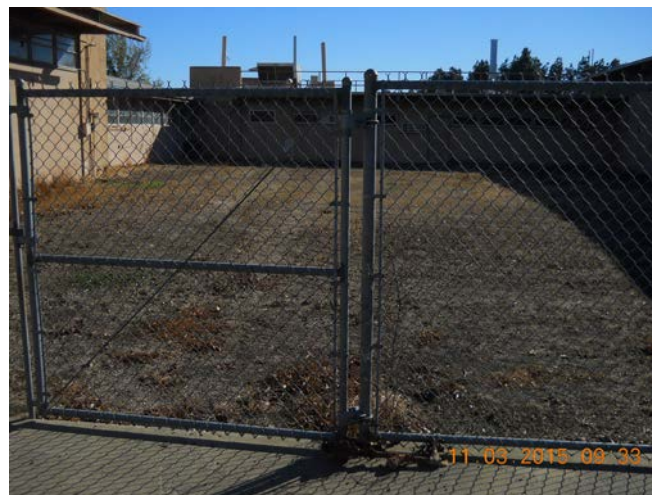
View east over middle portion of Radium/Strontium Treatment Systems Area: Building H-218 to right; Building H-219 to left (photo No. 2847).

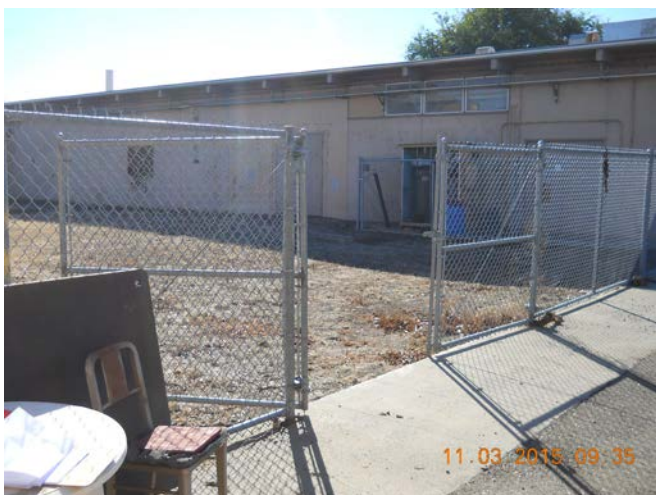
View southeast over Domestic Septic System 2 area within Radium/Strontium Treatment Systems Area: Building H-218 in background (photo No. 2849).

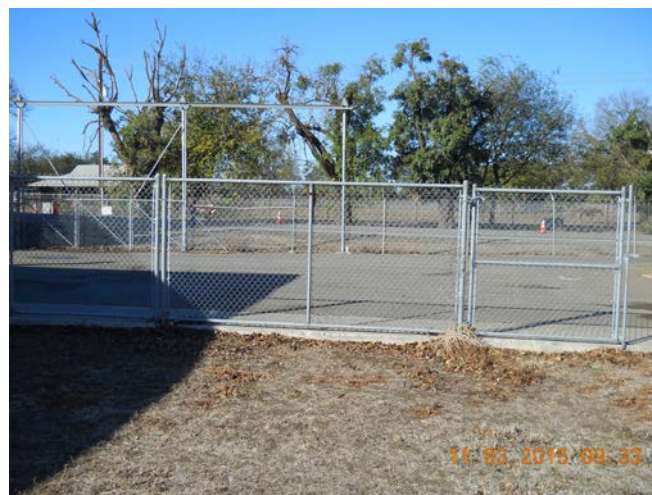
View west over Domestic Septic System 2 area within middle-west portion of Radium/Strontium Treatment Systems Area (photo No. 2848).

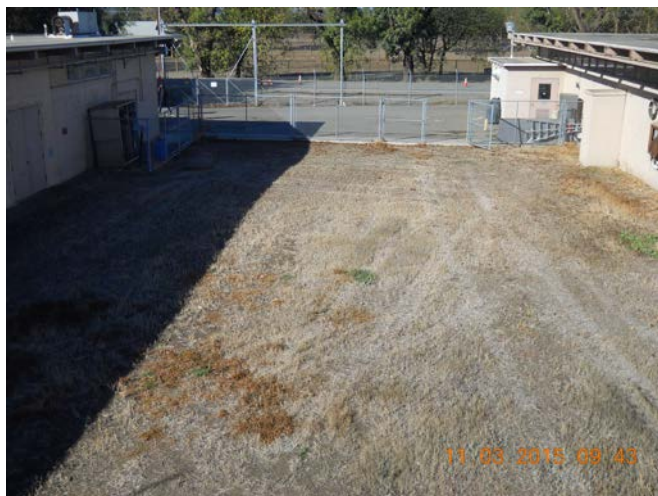
Roof-level view west over middle portion of Radium/Strontium Treatment Systems Area: Building H-219 to right, Building H-218 to left (photo No. 2853).

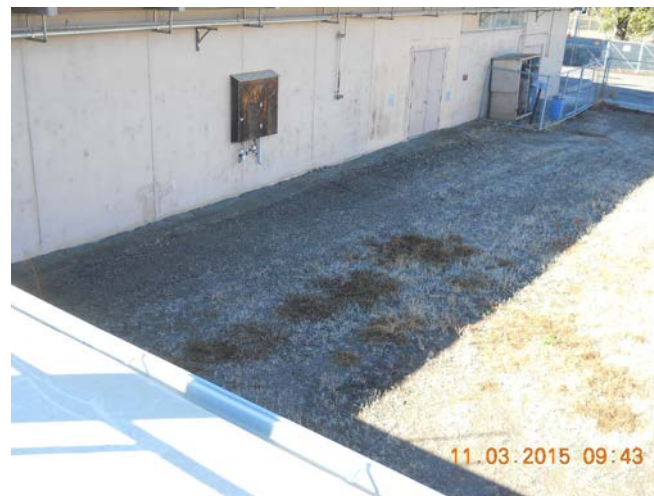
Roof-level view southwest over middle portion of Radium/Strontium Treatment Systems Area: Building H-218 in background (photo No. 2854).

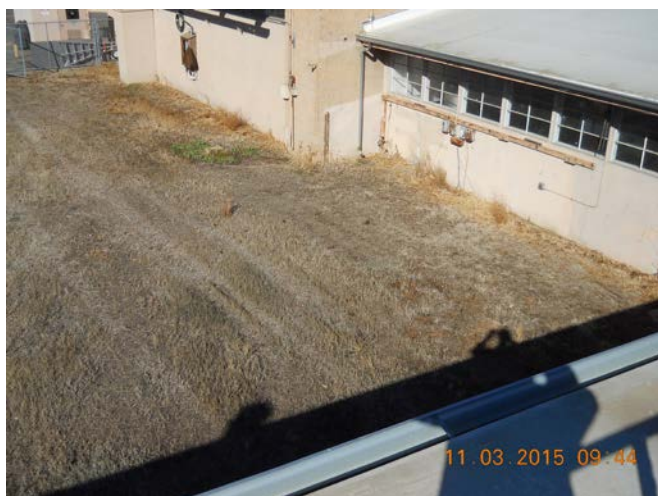
Roof-level view northwest over middle portion of Radium/Strontium Treatment Systems Area: Building H-219 in background (photo No. 2855).

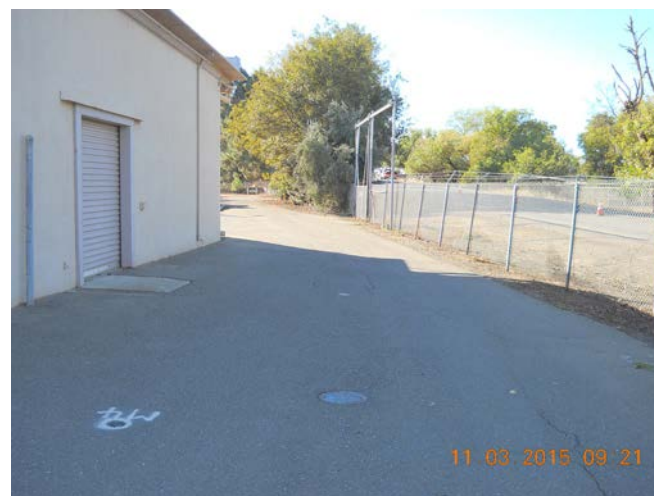
View south over northern portion of Radium/Strontium Treatment Systems Area: Building H-219 to left, west perimeter fence and Old Davis Road to right (photo No. 2844).

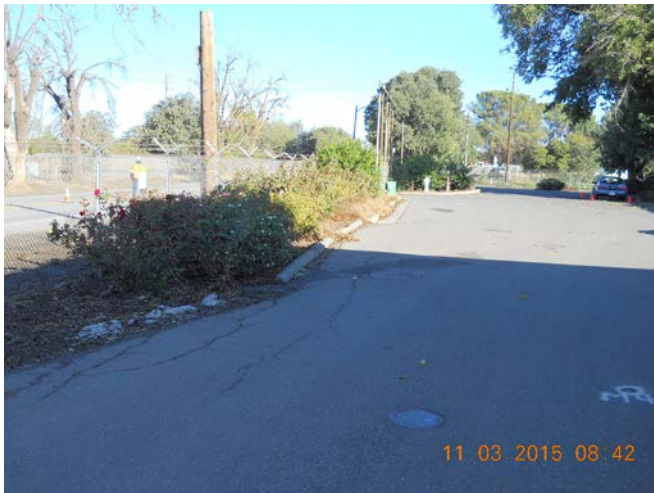
View north over Dry Wells A–E Area: Old Davis Road to left (photo No. 2826).

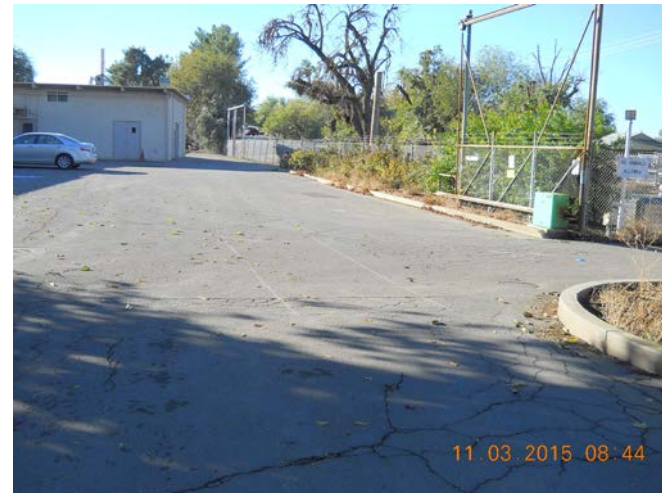
View south over Dry Wells A–E Area: Building H-219 in background/left; facility entrance to right (photo No. 2827).

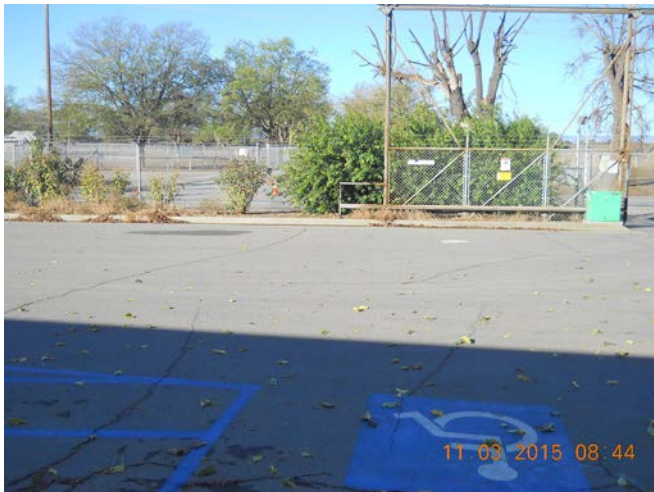
View west over Dry Wells A–E Area: retracted site entrance gate and Old Davis Road in background (photo No. 2828).

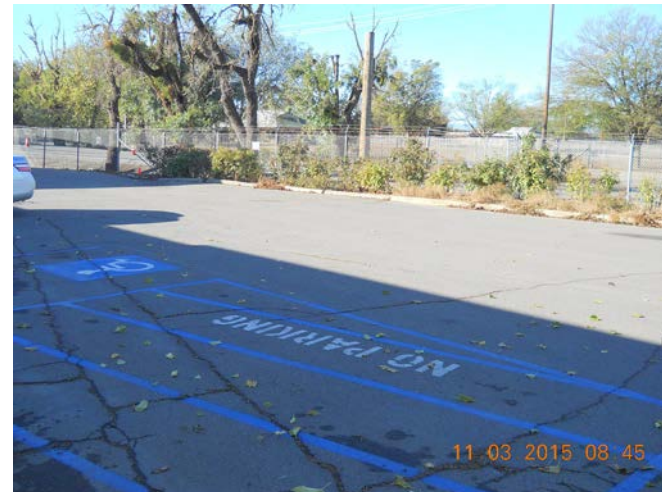
View southwest over Dry Wells A–E Area: Old Davis Road in background (photo No. 2829).

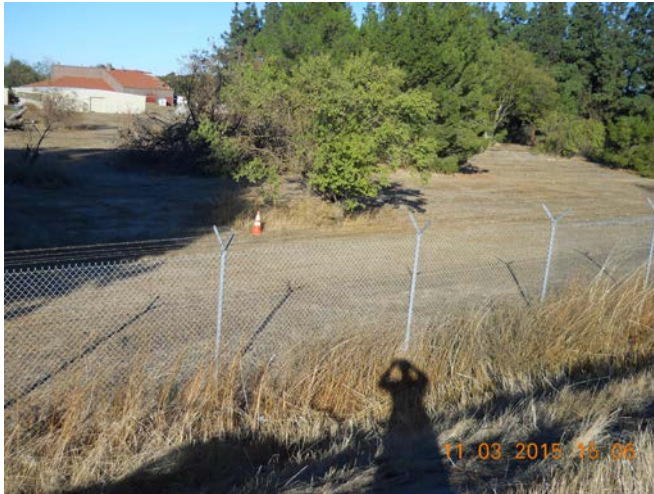
View northeast over Eastern Dog Pens Area from North Levee (photo No. 2981).

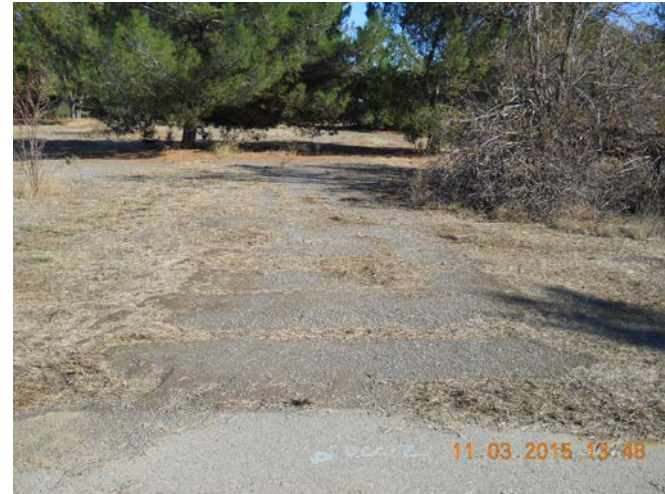
View east over Eastern Dog Pens Area (photo No. 2956).

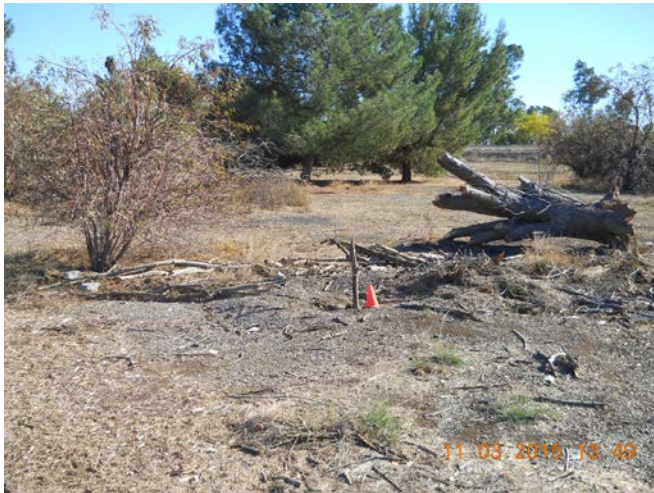
View southeast over Eastern Dog Pens Area from northwest corner (photo No. 2957).

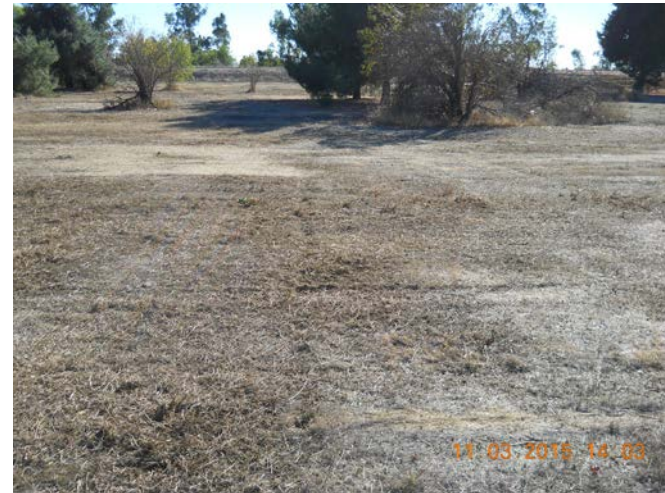
View south over Eastern Dog Pens Area (photo No. 2961).

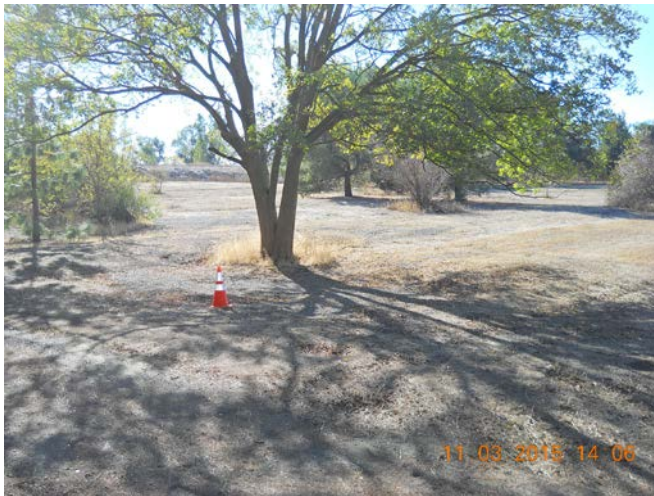
View southwest over Eastern Dog Pens Area from northeast corner (photo No. 2962).

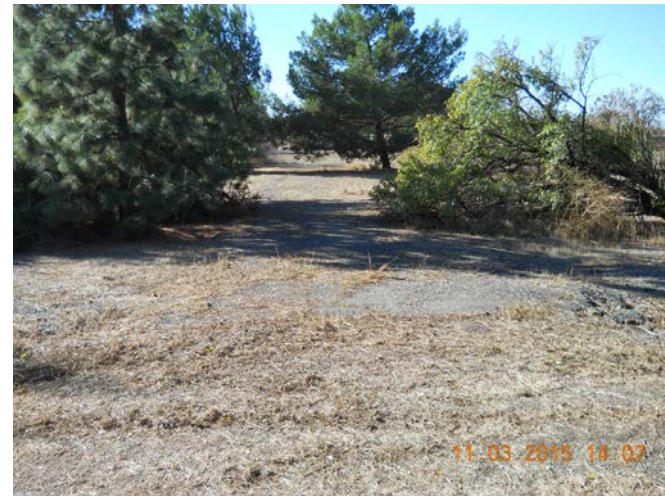
View west over Eastern Dog Pens Area (photo No. 2963).

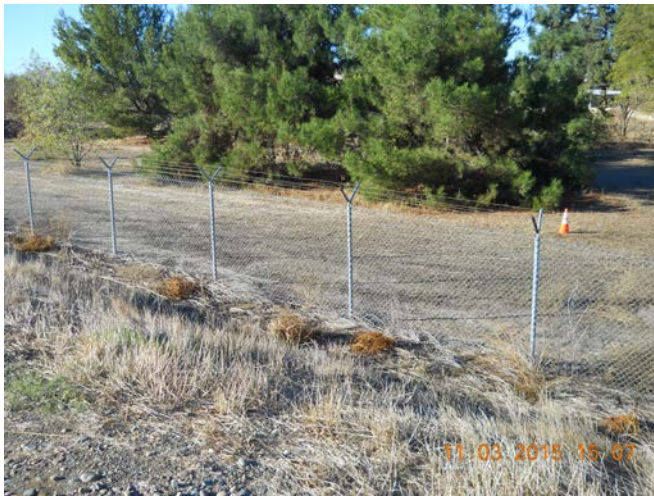
View northwest into Eastern Dog Pens Area from North Levee (photo No. 2983).

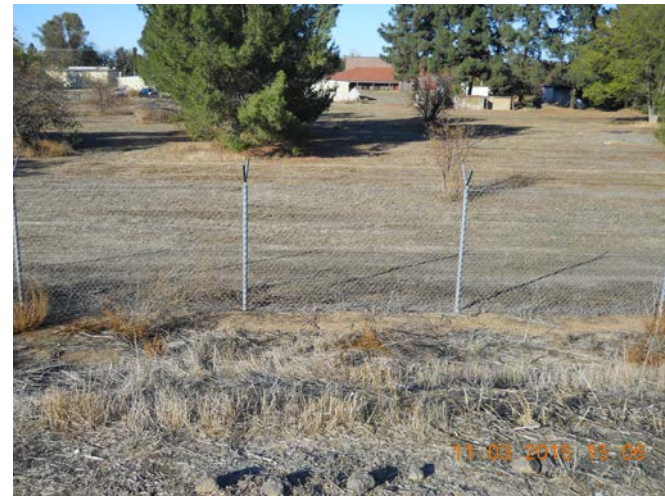
View north over Eastern Dog Pens Area from North Levee (photo No. 2982).

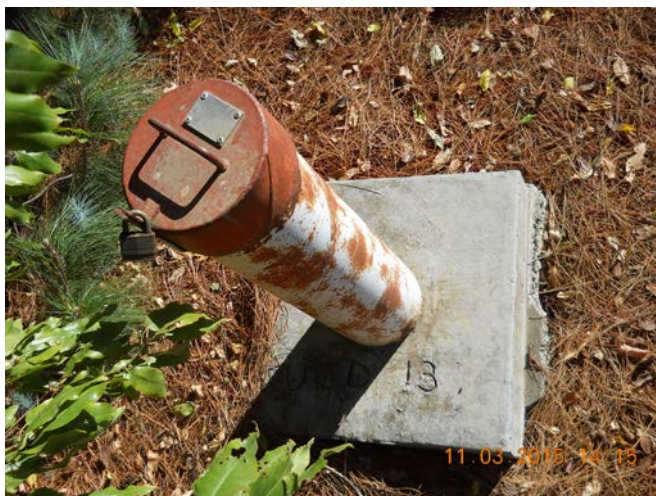
UCD1-013 Wellhead (photo No. 2968).

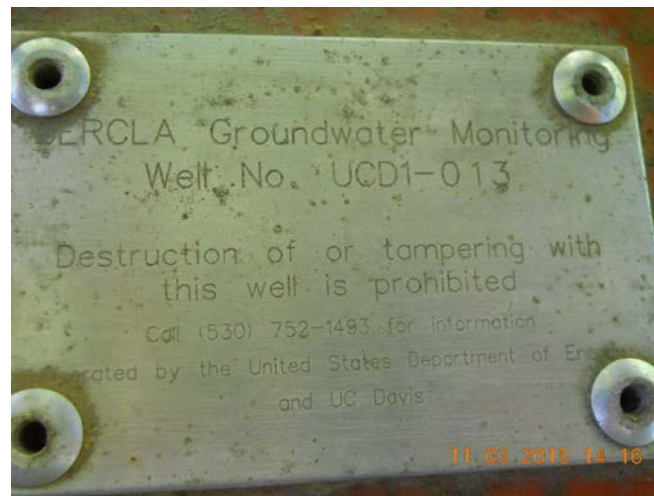
UCD1-013 Wellhead Plaque (photo No. 2969).

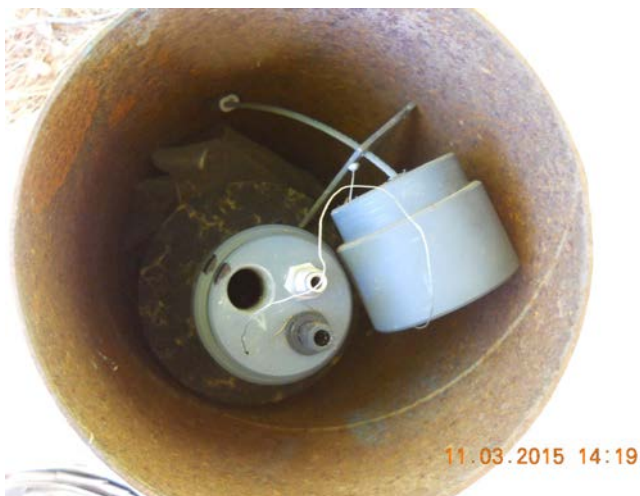
UCD1-013 Interior (photo No. 2971).

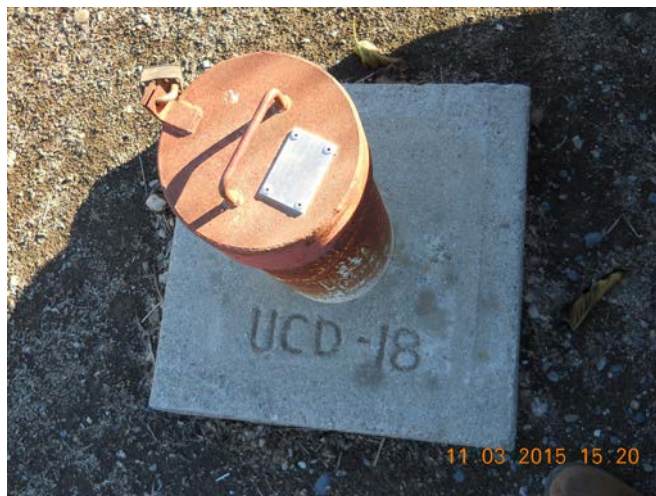
UCD1-018 Wellhead (photo No. 2984).

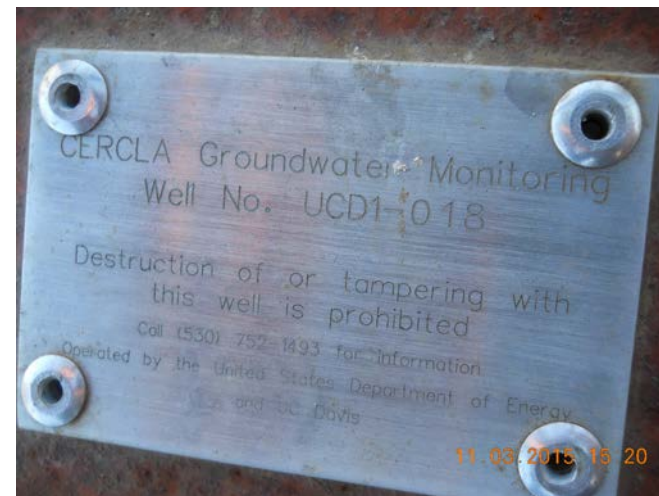
UCD1-018 Wellhead Plaque (photo No. 2986).

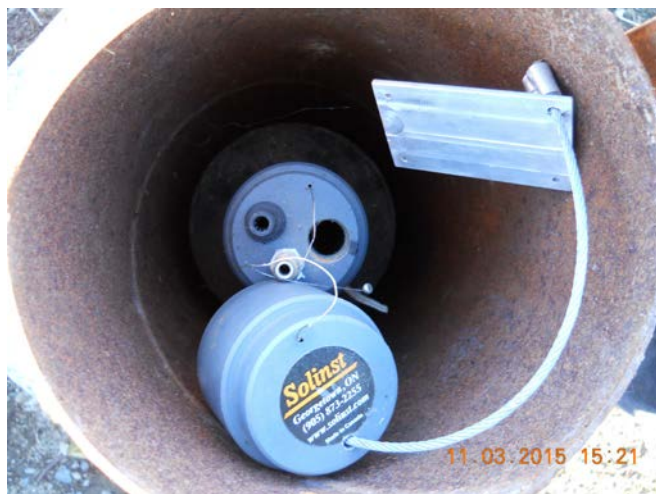
UCD1-018 Interior (photo No. 2987).

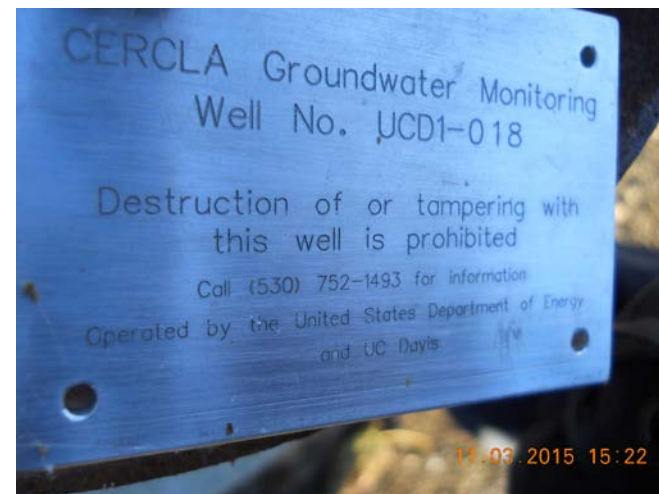
UCD1-018 Interior Plaque (photo No. 2989).

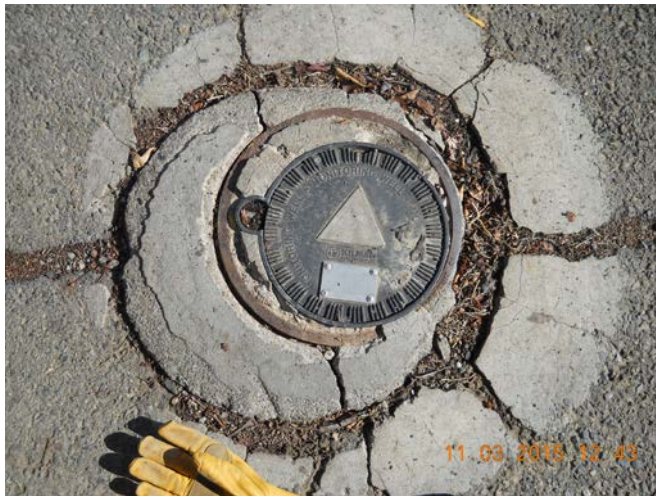
UCD1-021 Wellhead (photo No. 2917).

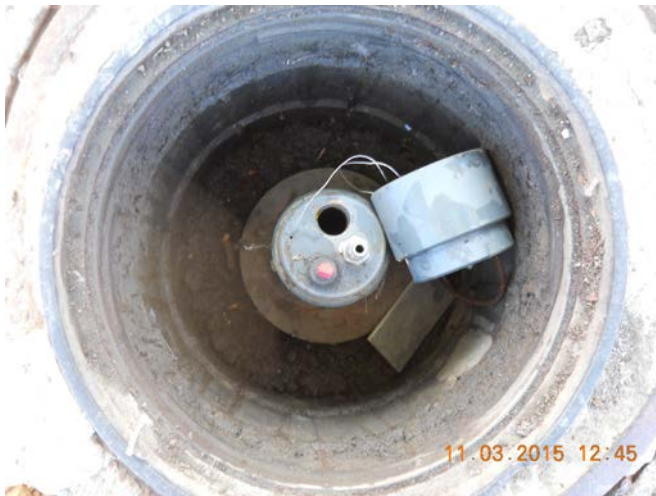
UCD1-021 Interior (photo No. 2921).

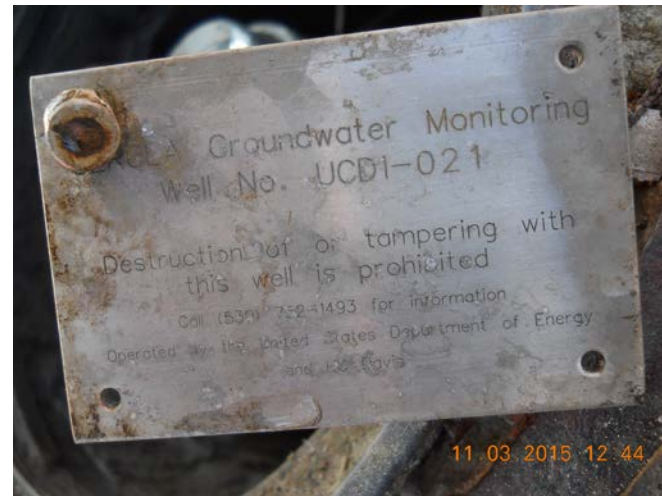
UCD1-021 Interior Plaque (photo No. 2920).

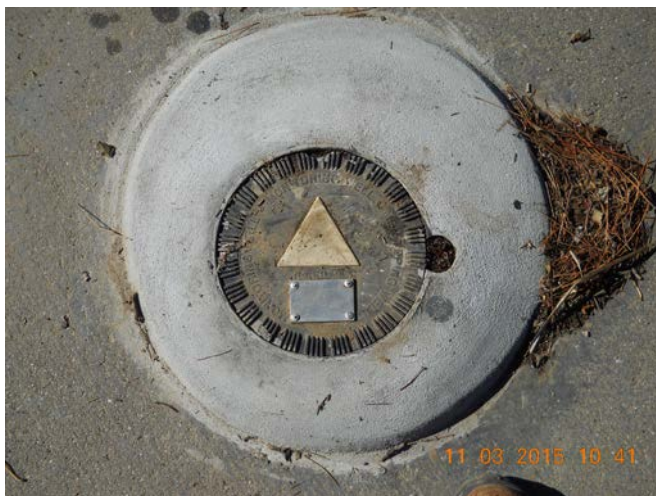
UCD1-023 Wellhead (photo No. 2891).

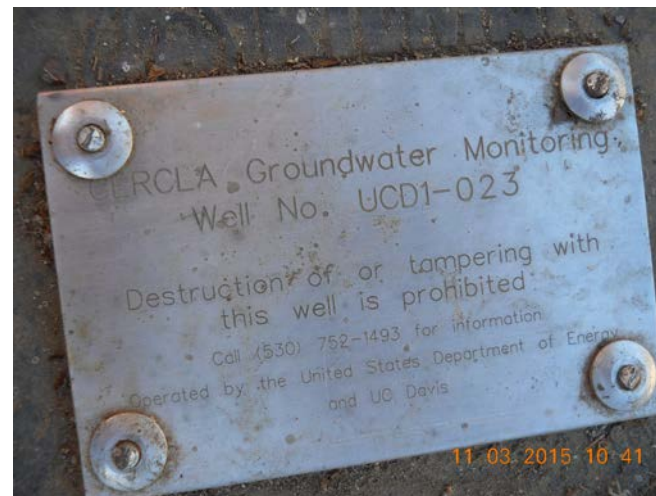
UCD1-023 Wellhead Plaque (photo No. 2893).

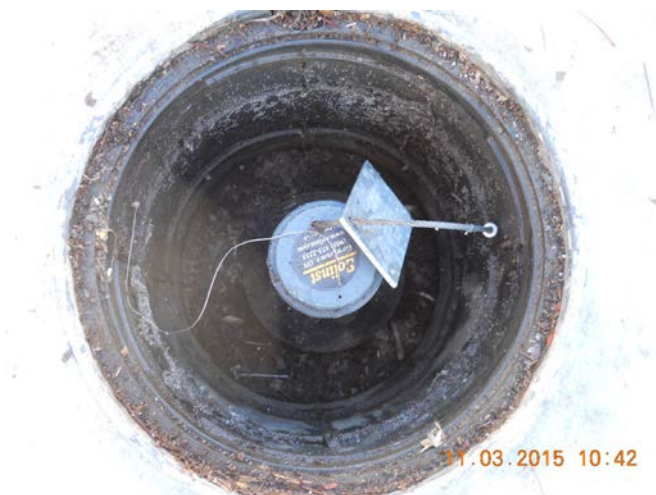
UCD1-023 Interior (photo No. 2895).

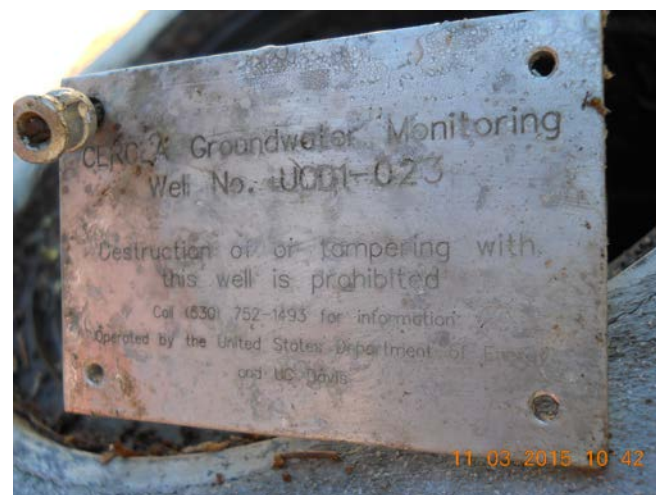
UCD1-023 Interior Plaque (photo No. 2896).

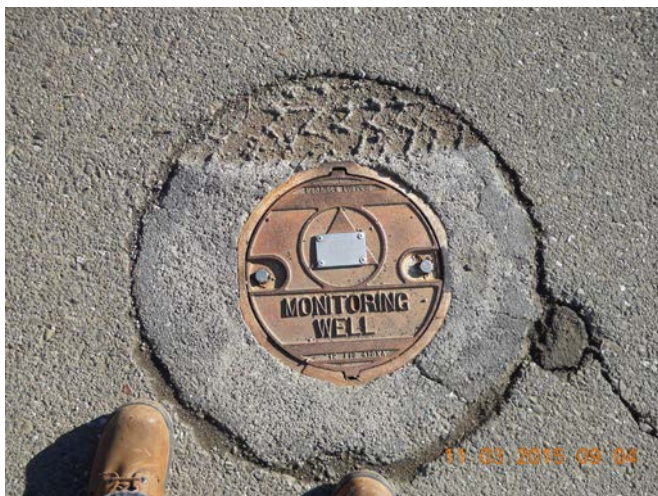
UCD1-054 Wellhead (photo No. 2840).

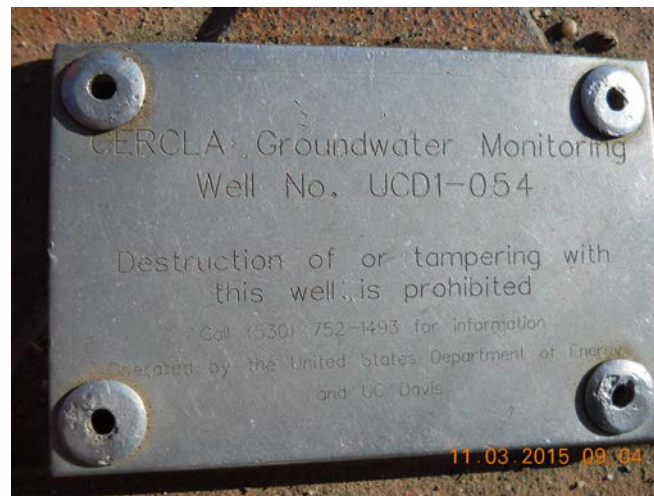
UCD1-054 Wellhead Plaque (photo No. 2841).

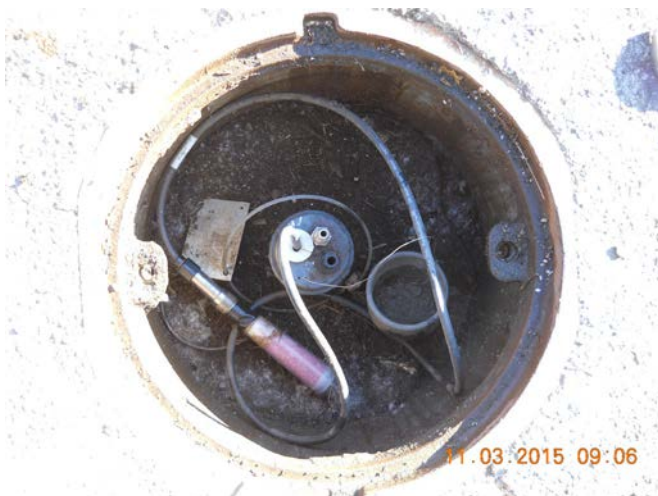
UCD1-054 Interior (photo No. 2842).

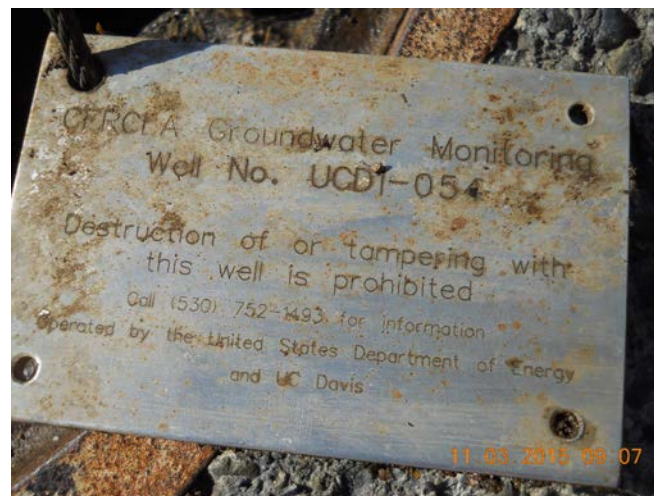
UCD1-054 Interior Plaque (photo No. 2843).

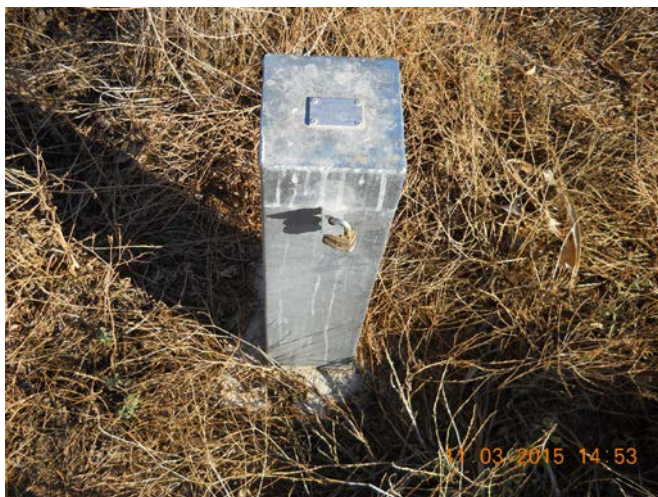
UCD1-063 Wellhead (photo No. 2976).

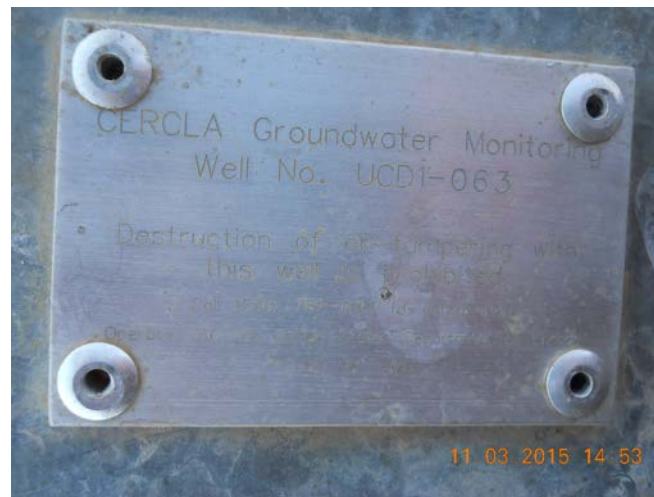
UCD1-063 Wellhead Plaque (photo No. 2978).

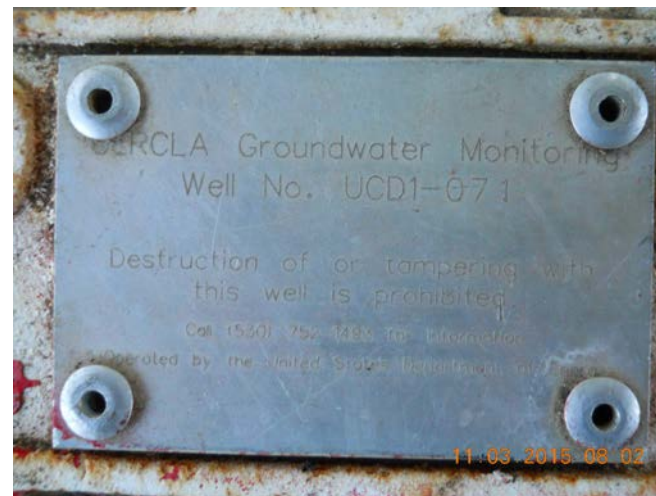
UCD1-071 Wellhead (photo of gasket replacement in Appendix E) (photo No. 2821).

^a replaced vault seal. Existing bolts fastened easily and securely with new seal.

UCD1-071: vault lid gasket replacement.
