**2016 Annual Land-Use Covenant
Inspection Report
for DOE Areas at the Laboratory
for Energy-Related Health
Research/Old Campus Landfill
Superfund Site
University of California, Davis**

January 2017

U.S. DEPARTMENT OF
ENERGY

Legacy
Management

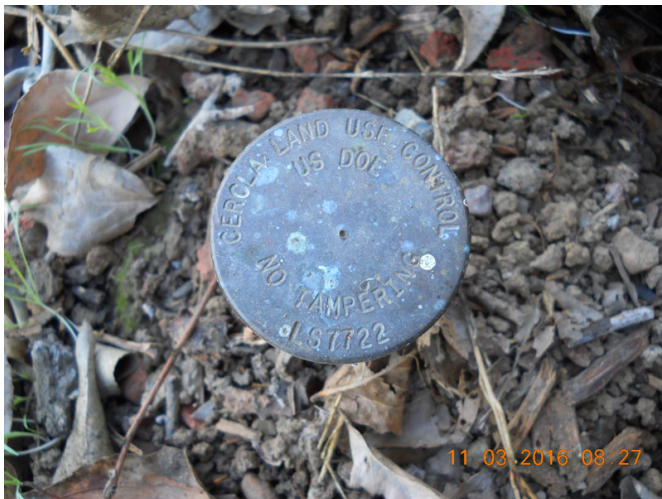
Monument 1: northwest corner of Dry Wells A-E Area (photo No. 3089).

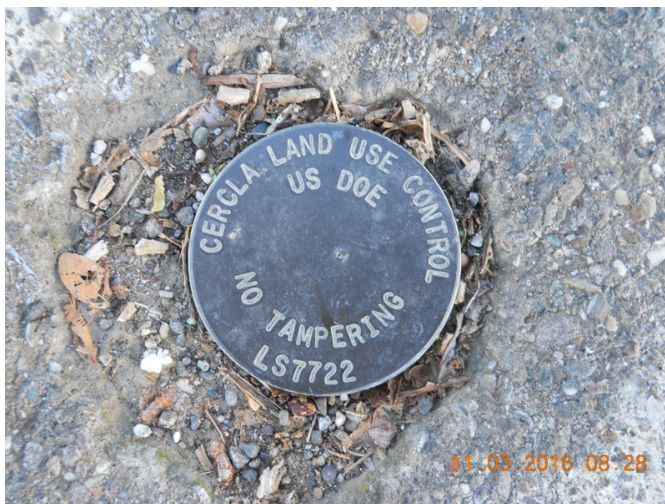
Monument 2: northeast corner of Dry Wells A-E Area (photo No. 3091).

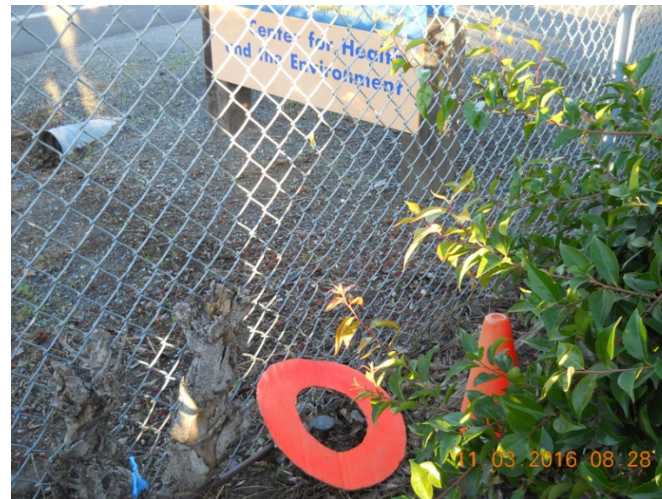
View northwest: Monument 1, within orange ring in foreground; entrance sign in background (photo No. 3090).

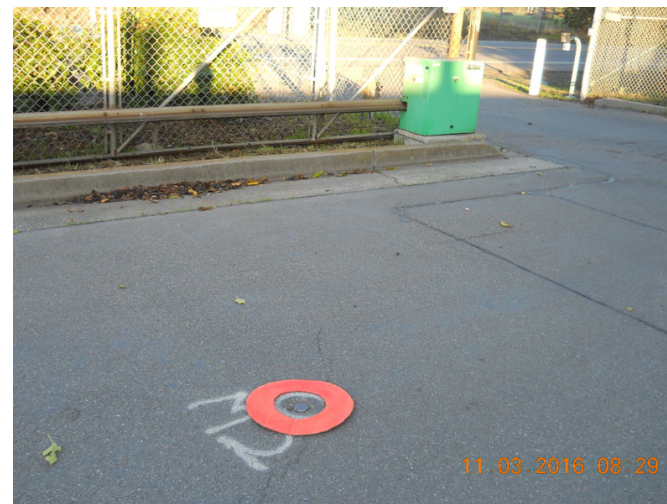
View northwest: Monument 2, within orange ring; entrance and retracted entrance gate in background (photo No. 3092).

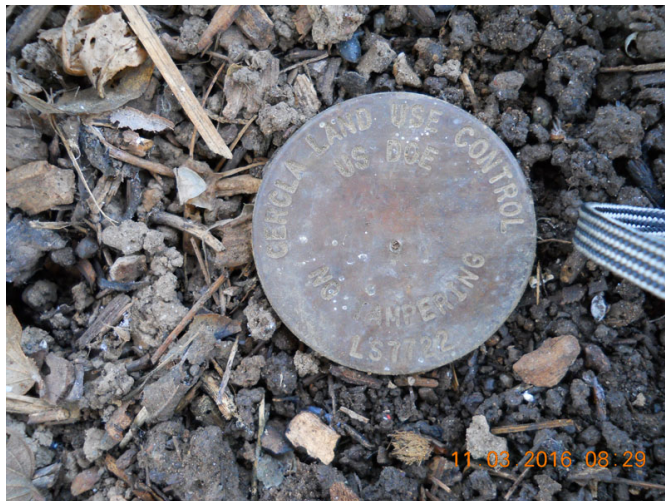
*Monument 3: southwest corner of Dry Wells A–E Area
(photo No. 3093).*

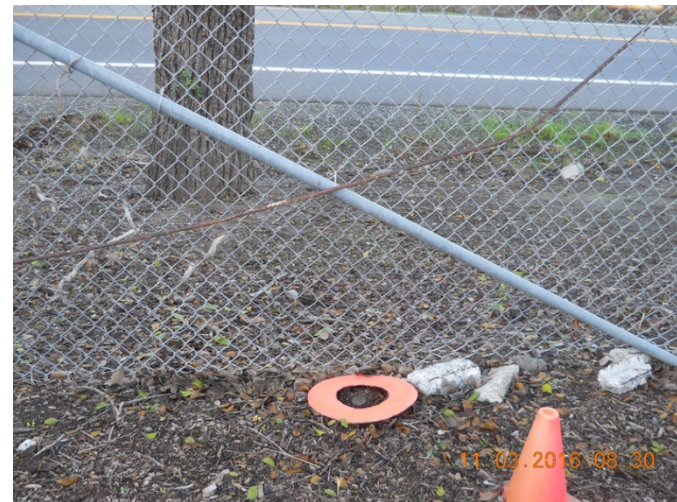
*View west: Monument 3, within orange ring;
west perimeter fence and Old Davis Road in background
(photo No. 3094).*

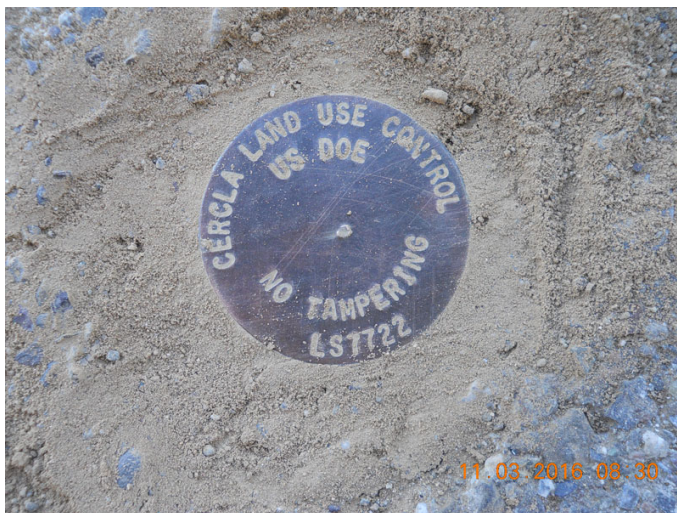
*Monument 4: southeast corner of Dry Wells A–E Area
(photo No. 3095).*

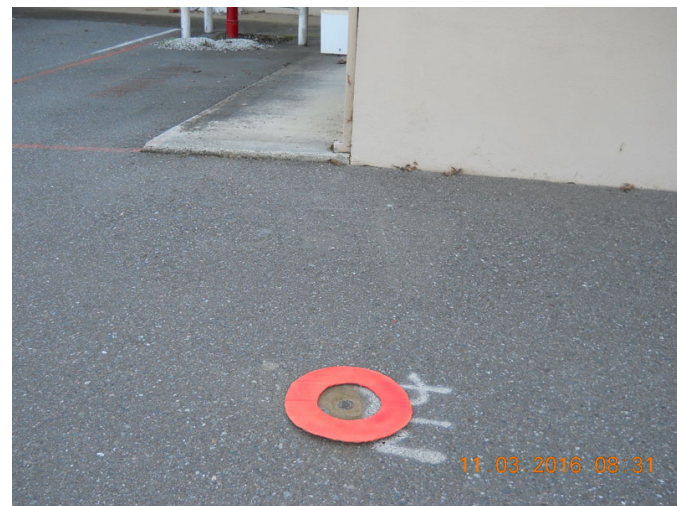
*View east: Monument 4 with Building H-219 in background
(photo No. 3096).*

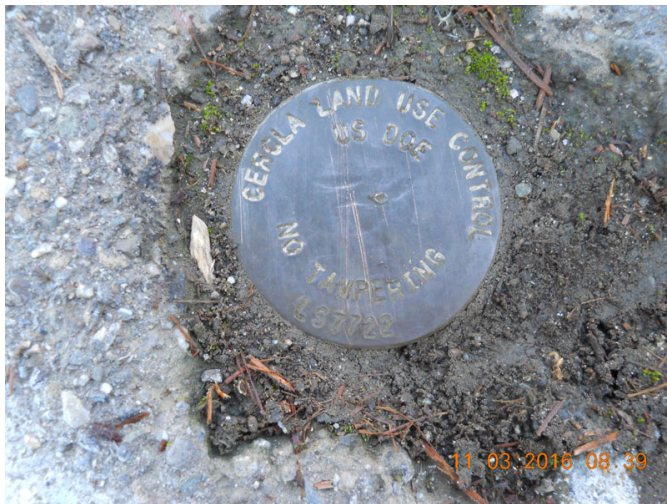
Monument 5: northwest corner of Domestic Septic System 4 (photo No. 3097).

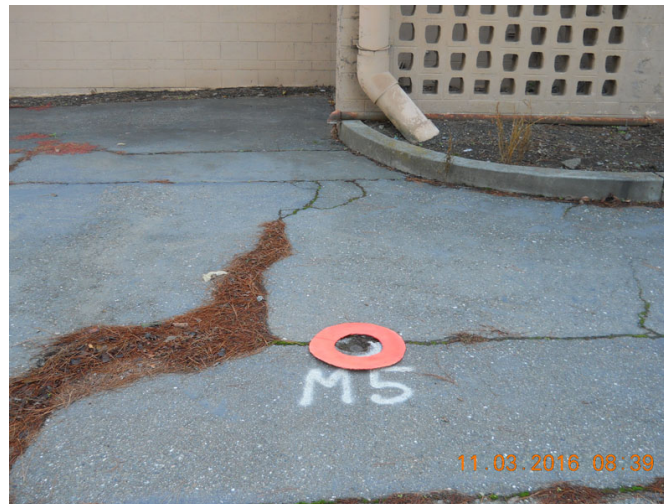
View east: Monument 5, within orange ring; Building H-215 in background (photo No. 3098).

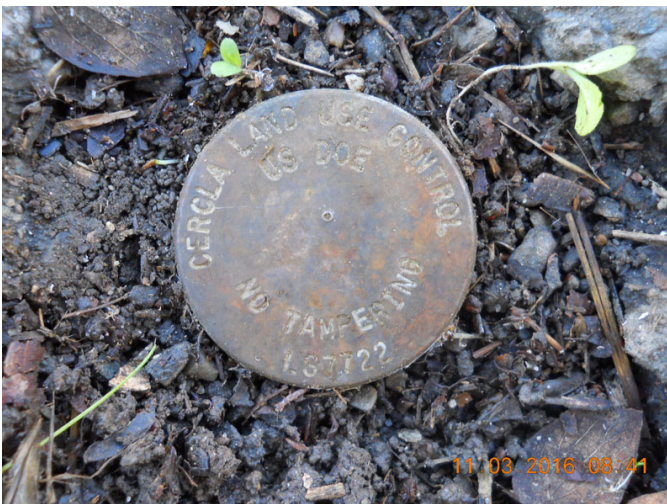
Monument 6: adjacent to northwest corner of Building H-218; Radium/Strontium Treatment Systems Area (photo No. 3099).

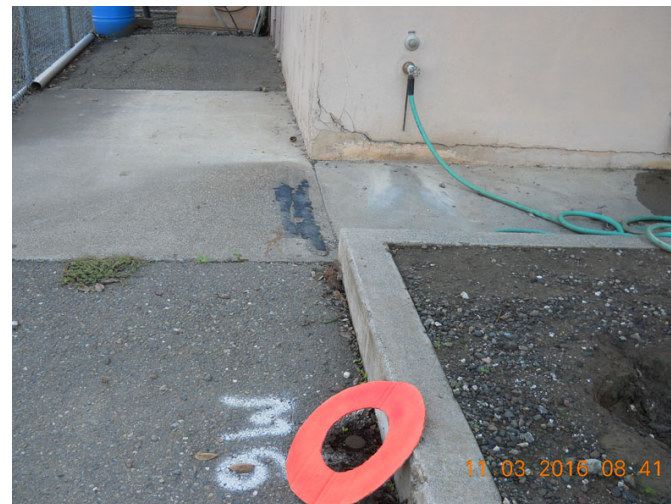
View east: Monument 6 within orange ring; corner of Building H-218 in background (photo No. 3100).

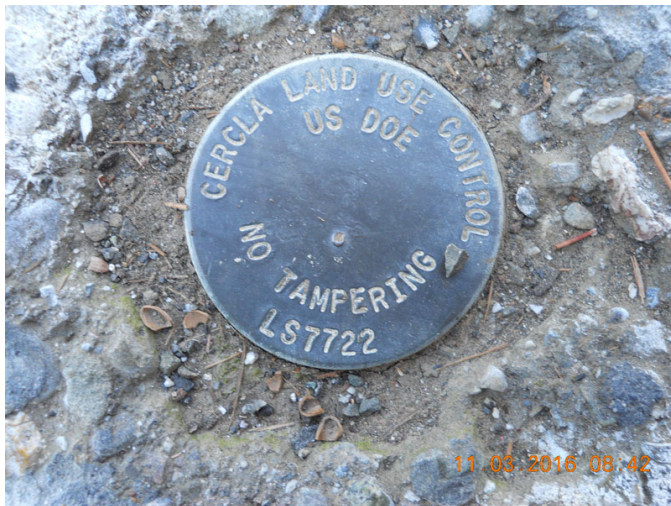
Monument 7: southwest corner of Domestic Septic System 4 (photo No. 3101).

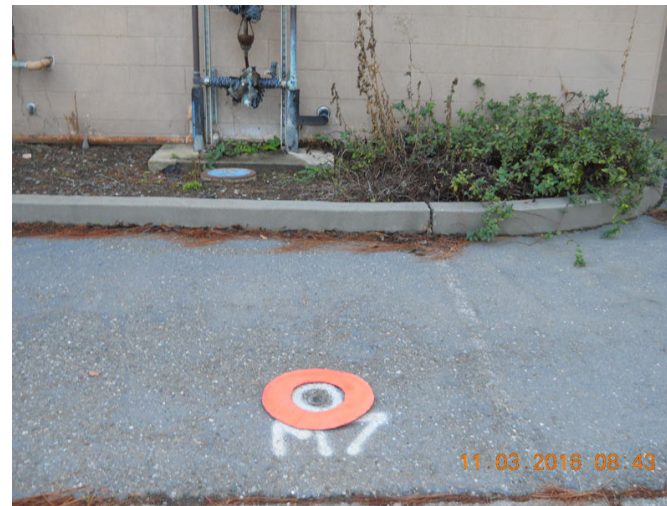
View east: Monument 7, within orange ring; Building H-215 in background (photo No. 3102).

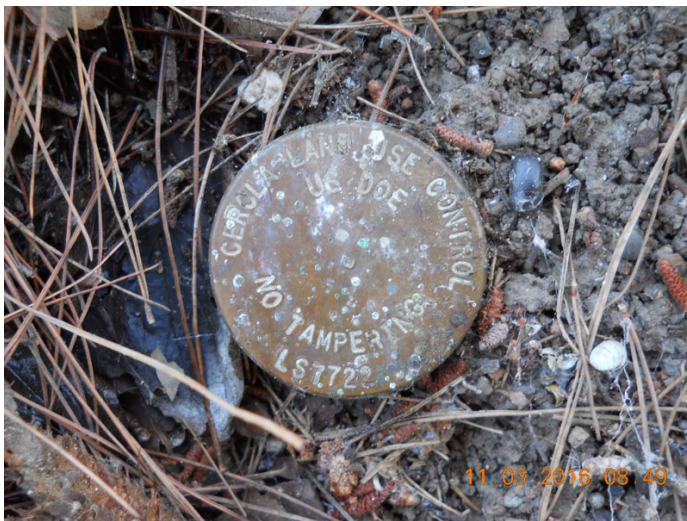
Monument 8: southwest corner of radium-226 leach trench; Radium/Strontium Treatment Systems Area (photo No. 3104).

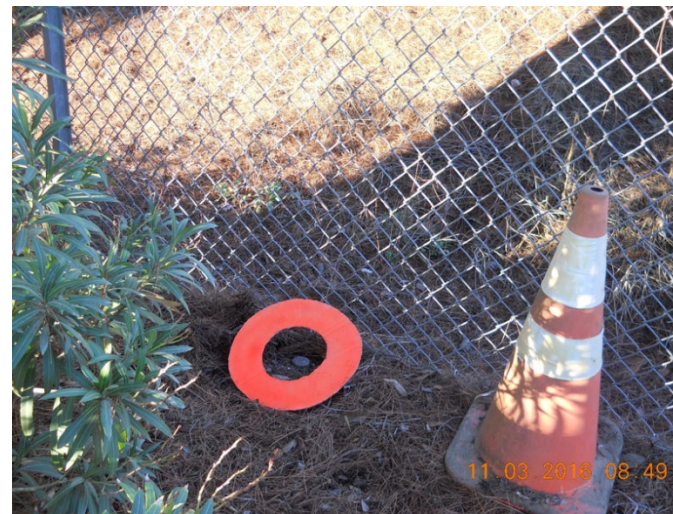
View southwest: Monument 8, within orange ring; west perimeter fence upper right (photo No. 3105).

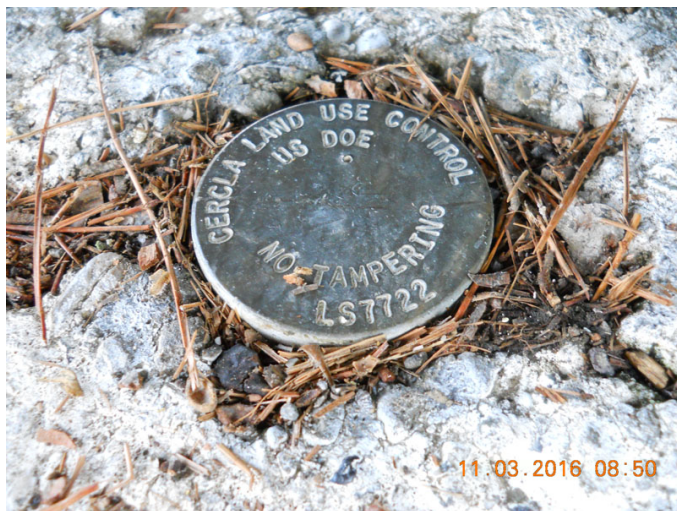
*Monument 9: southeast corner of radium-226 leach trench;
Radium/Strontium Treatment Systems Area (photo No. 3106).*

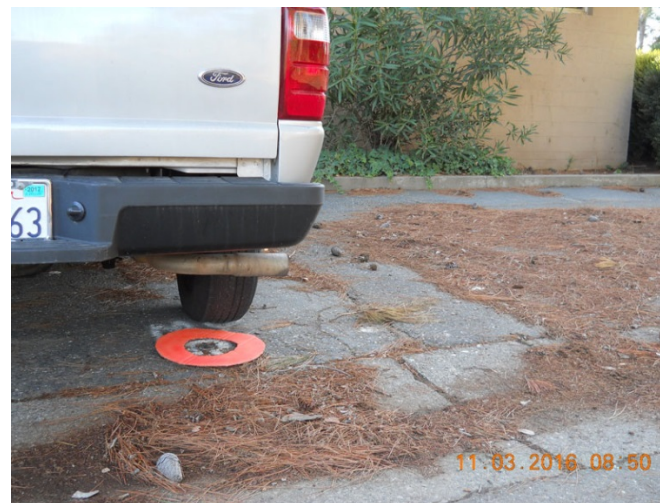
*View east: Monument 9, within orange ring;
Building H-215 in background right (photo No. 3107).*

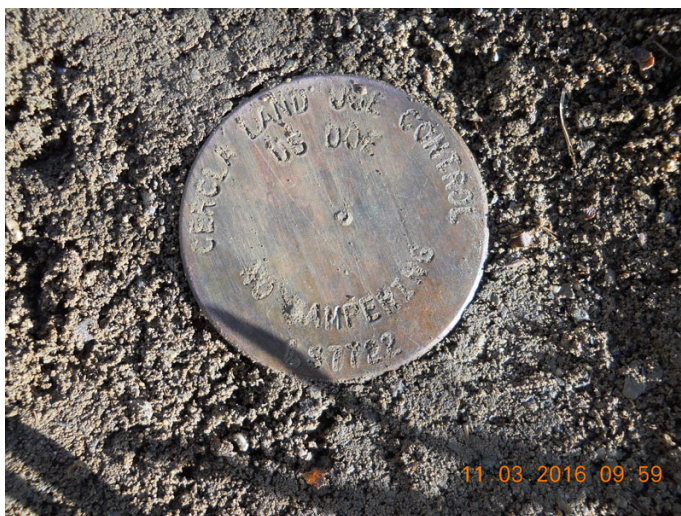
*Monument 10: northeast corner of former leach field in
Domestic Septic System 3 Area (photo No. 3139).*

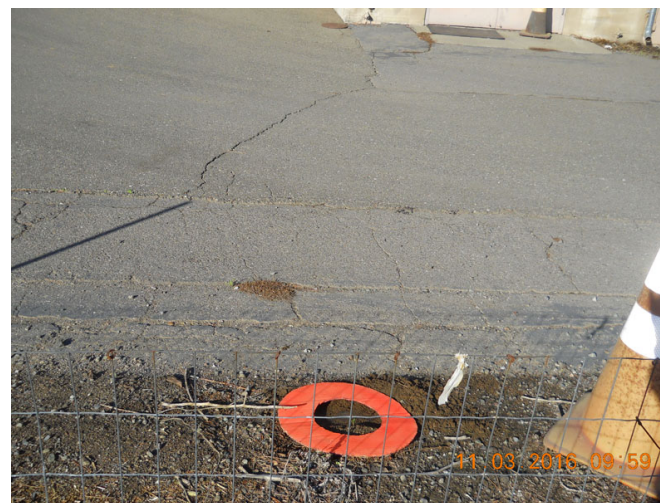
*View northwest: Monument 10, within orange ring in foreground;
Building H-216 in background right (photo No. 3140).*

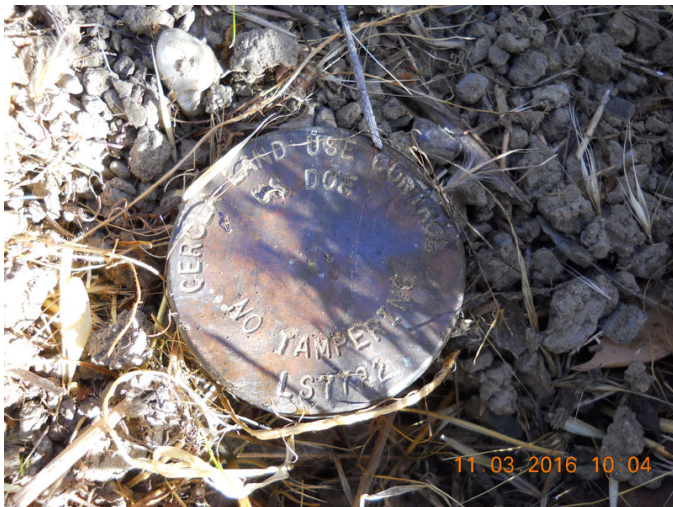
Monument 11: northeast corner of Eastern Remediation Support Area (photo No. 3143).

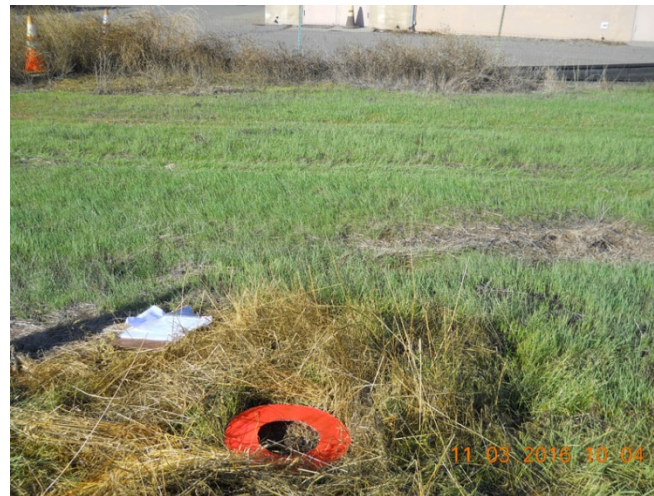
View west: Monument 11, within orange ring in foreground; Building H-216 in background (photo No. 3144).

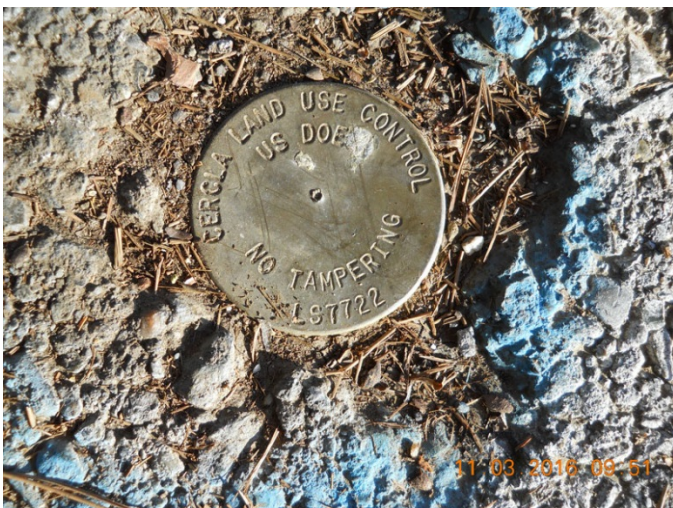
Monument 12: northwest corner of Southwest Trenches Area (photo No. 3132).

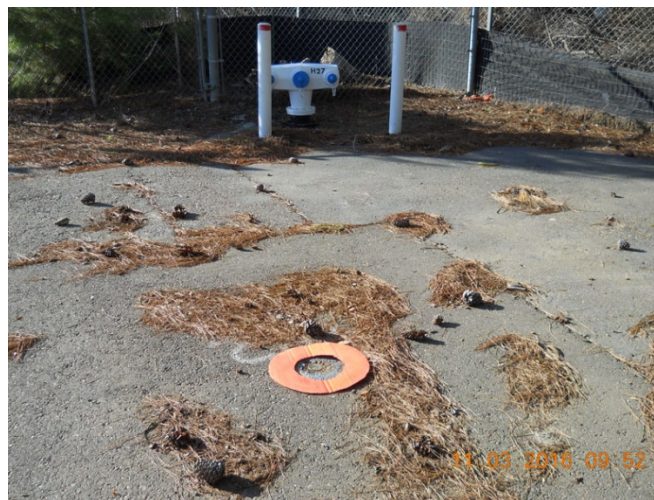
View south: Monument 12, within orange ring in foreground; water hydrant in background (photo No. 3133).

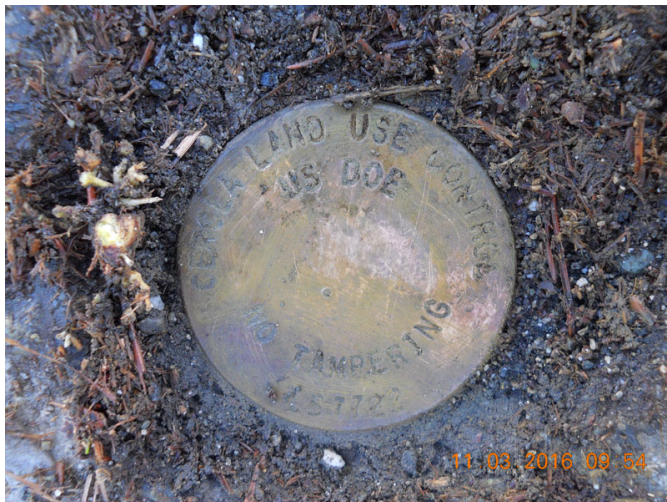
Monument 13: southwest corner of Domestic Septic System 3, at northern perimeter of Southwest Trenches Area (photo No. 3135).

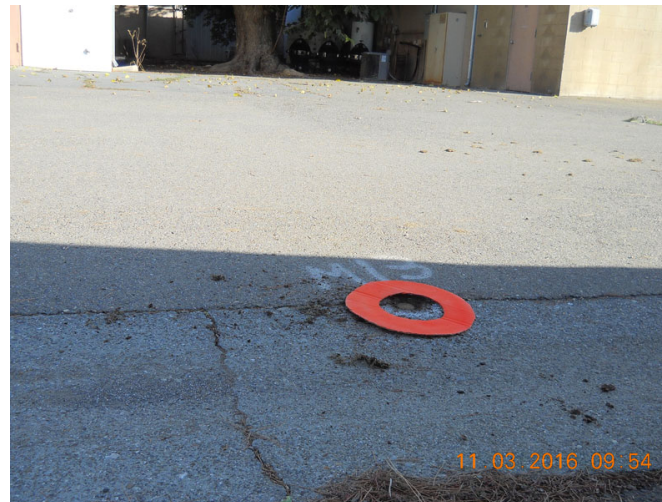
View north: Monument 13 within orange ring at edge of concrete swale; Buildings H-215 and H-216 in background (photo No. 3136).

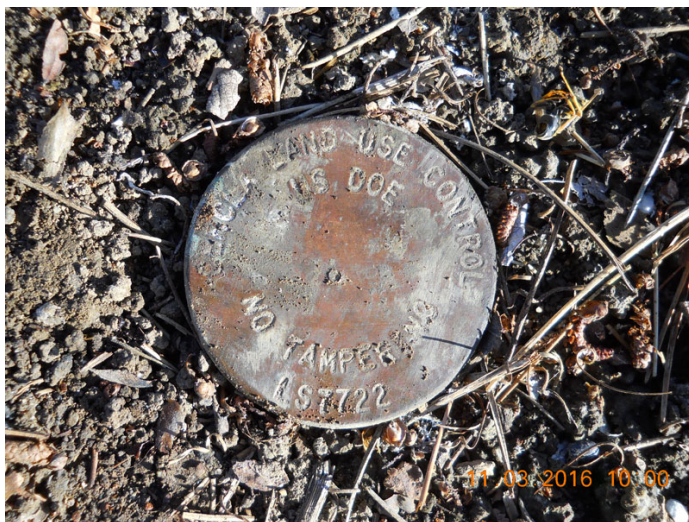
Monument 14: southeast corner of Domestic Septic System 3 (photo No. 3141).

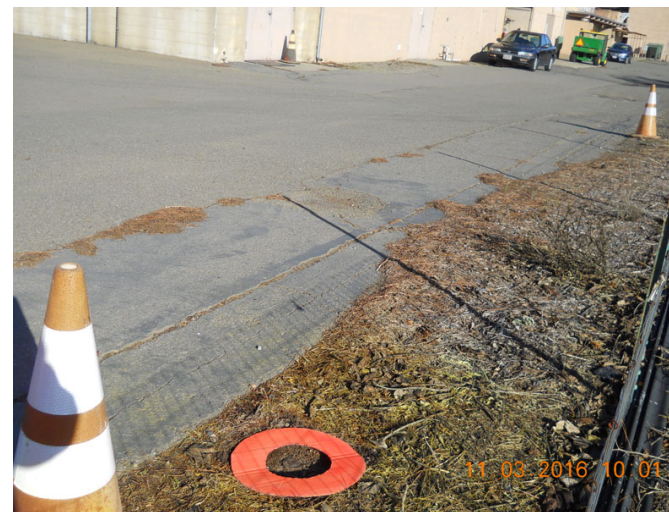
View northwest: Monument 14, within orange ring in foreground; Building H-216 in background (photo No. 3142).

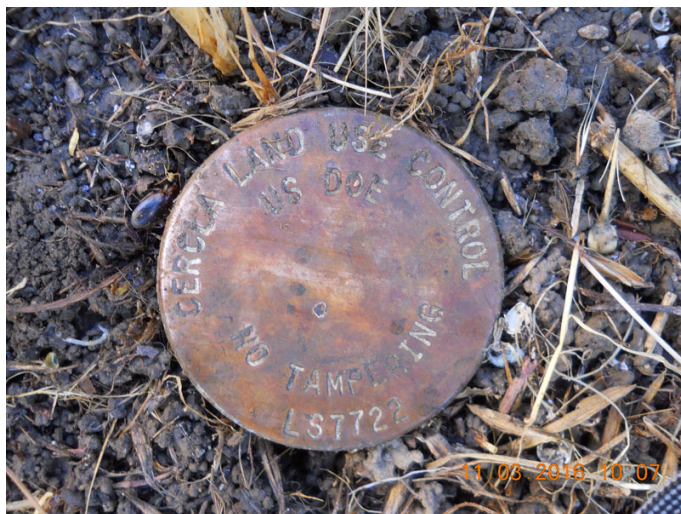
Monument 15: eastern corner of Southwest Trenches Area (photo No. 3145).

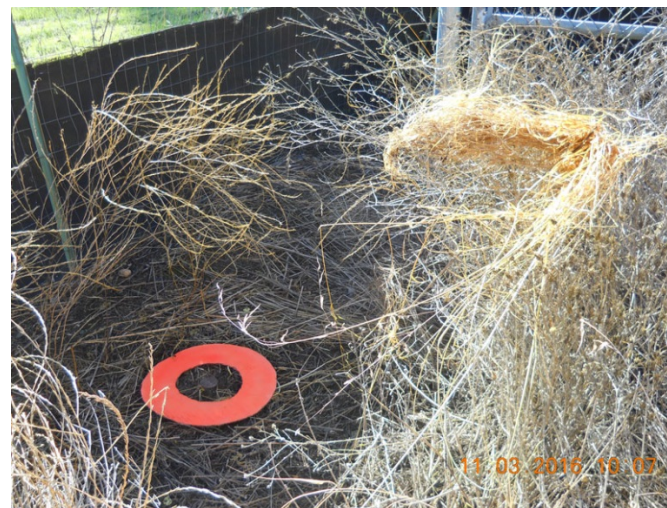
View southeast: Monument 15, within orange ring in foreground; former Western Dog Pens silt fence in left of background and trailer shed fence in right of background (photo No. 3146).

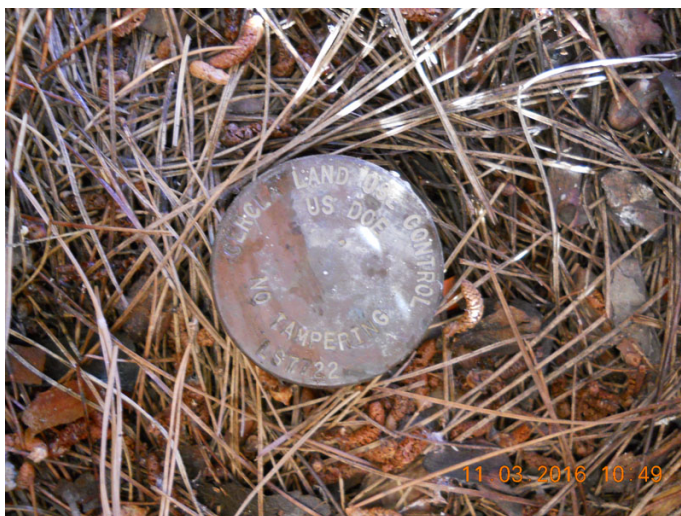
Monument 16: southwest corner of Southwest Trenches Area (photo No. 3168).

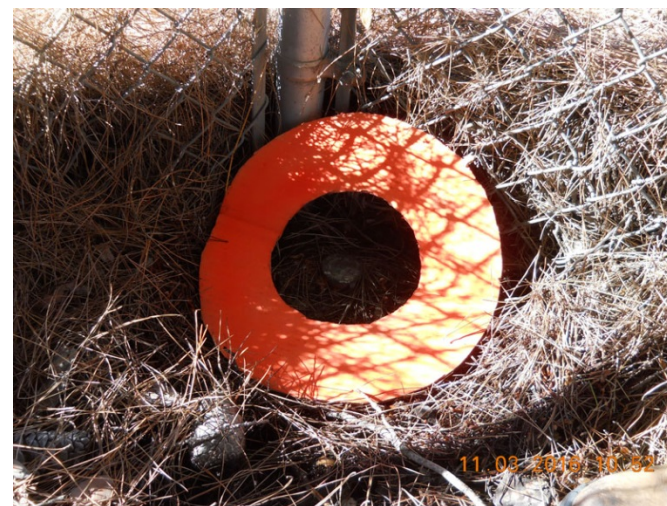
View southwest: Monument 16, within orange ring; southwest corner post of perimeter fence in background (photo No. 3171).

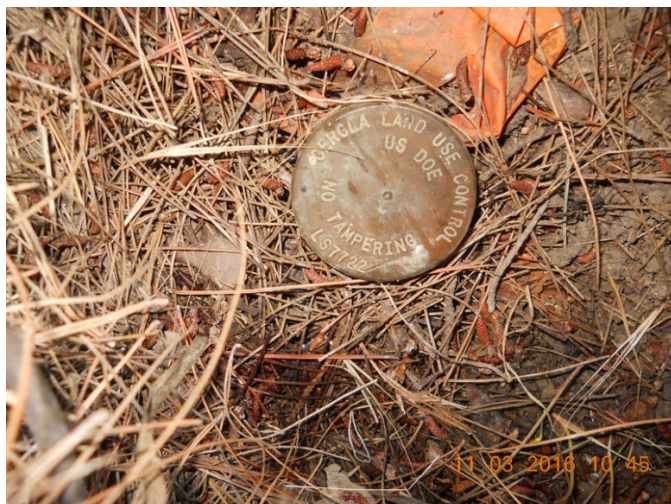
Monument 17: southeast corner of Southwest Trenches Area (photo No. 3163).

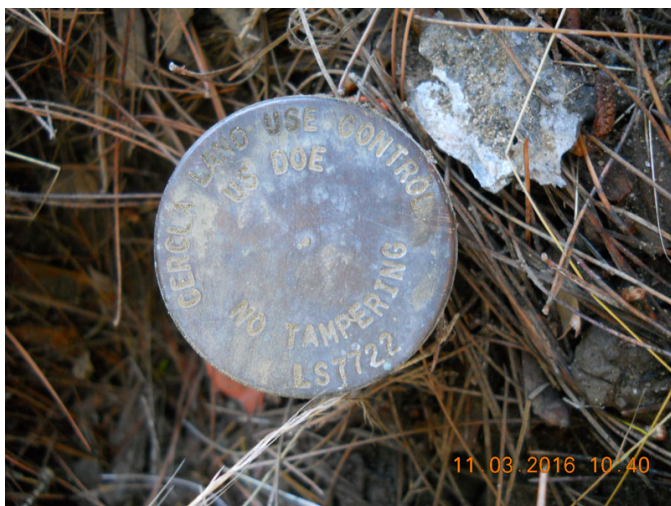
Monument 18: southeast corner of Eastern Remediation Support Area (photo No. 3160).

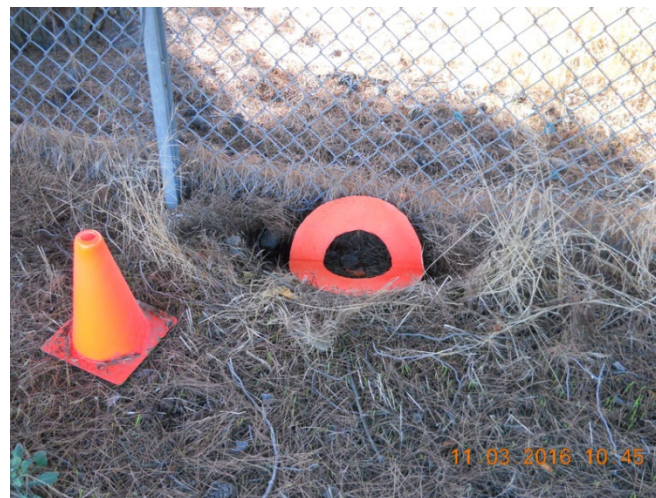
View south: Monument 17, within orange ring; south perimeter fence behind; foot of North Levee in background (photo No. 3164).

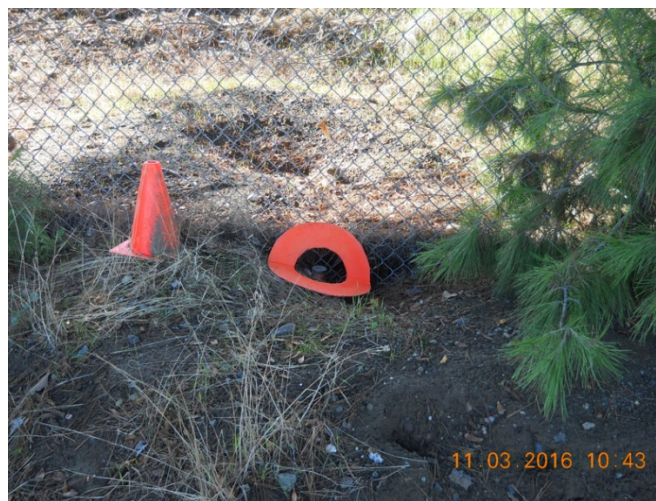
View south: Monument 18, within orange ring; foot of North Levee in background (photo No. 3161).

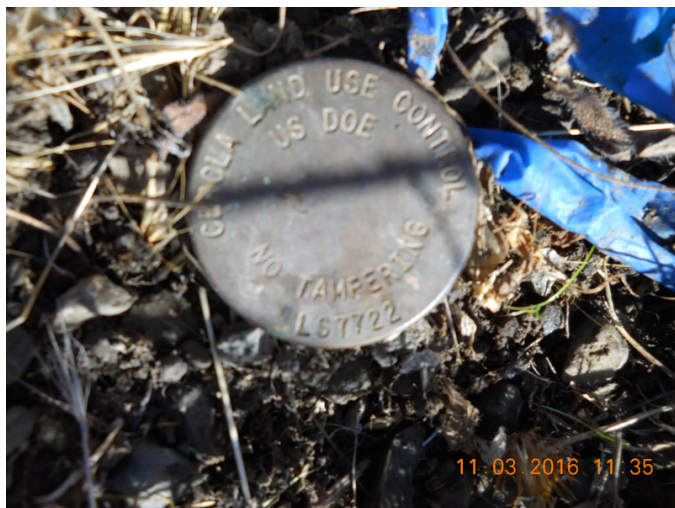
Monument 19: northwest corner of Eastern Dog Pens Area (photo No. 3183).

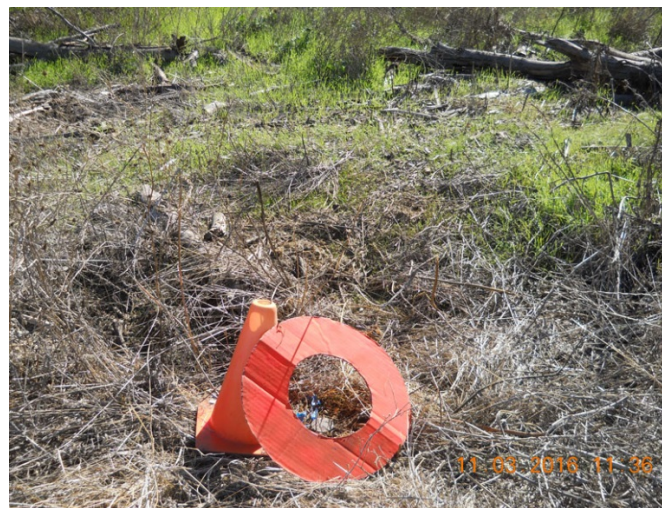
View southeast: Monument 19, within orange ring; Eastern Dog Pens Area in background (photo No. 3184).

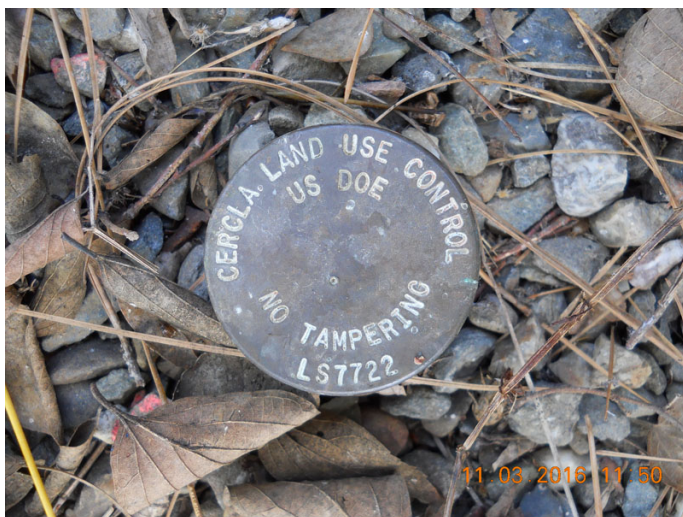
Monument 20: northeast corner of Eastern Dog Pens Area (photo No. 3191).

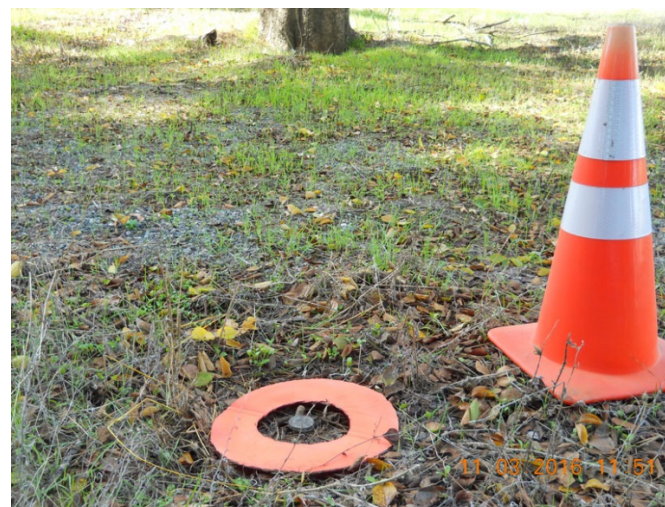
View southwest: Monument 20, within orange ring; Eastern Dog Pens Area in background (photo No. 3192).

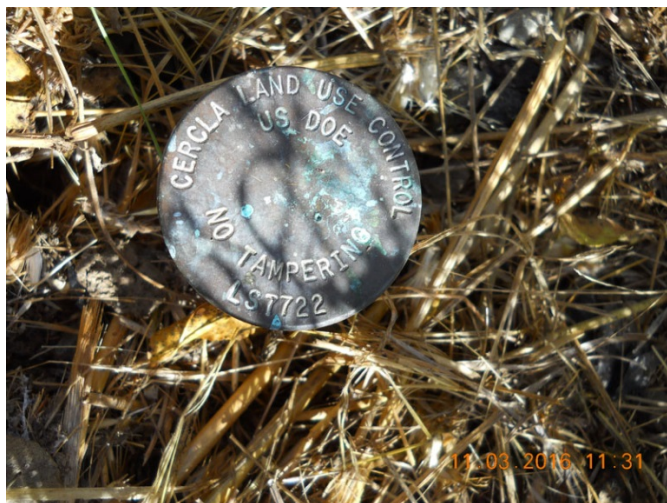
Monument 21: southwest corner of Eastern Dog Pens Area
(photo No. 3181).

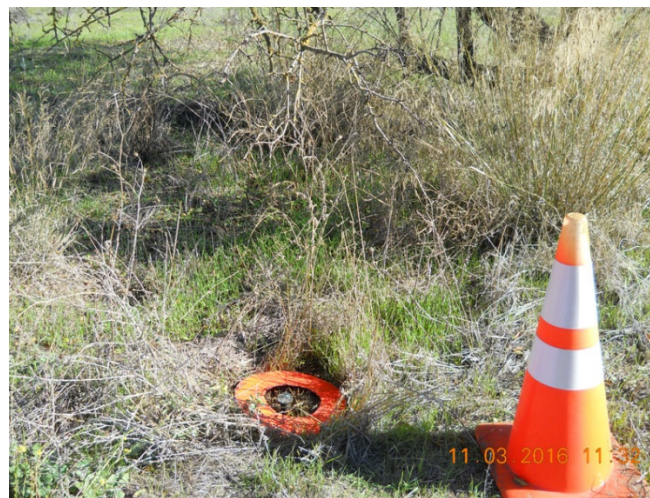
View northeast: Monument 21, within orange ring;
Eastern Dog Pens Area in background (photo No. 3182).

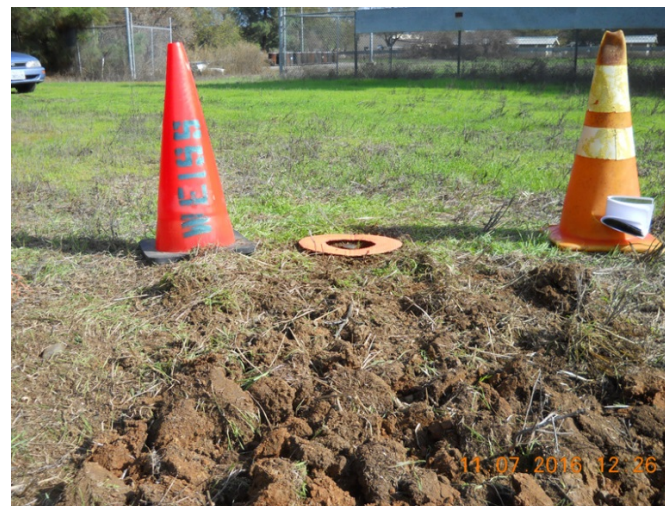
View east: Monument 22, within orange ring;
Cobalt-60 Area fence in background (photo No. 3263).

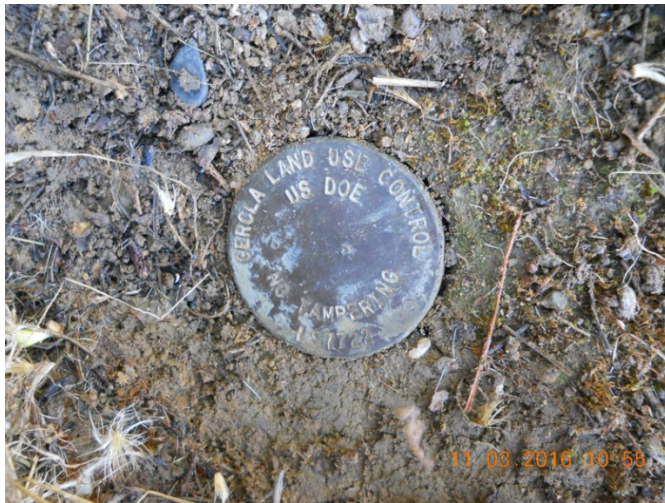
Monument 23: western perimeter point of Southwest Trenches Area (photo No. 3175).

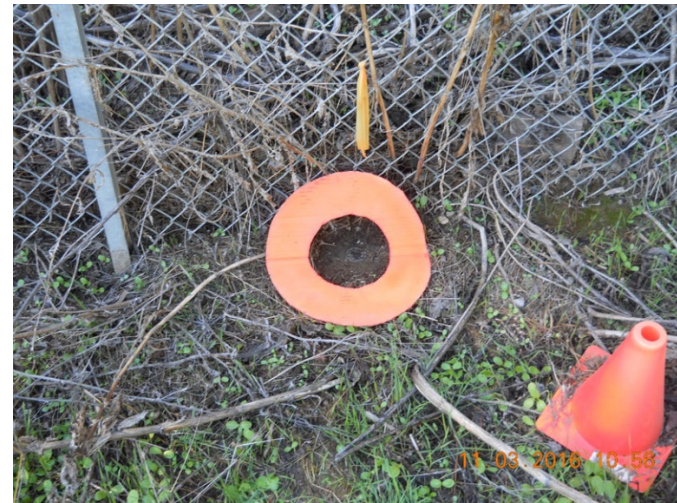
View west: Monument 23, within orange ring; west perimeter fence in background (photo No. 3176).

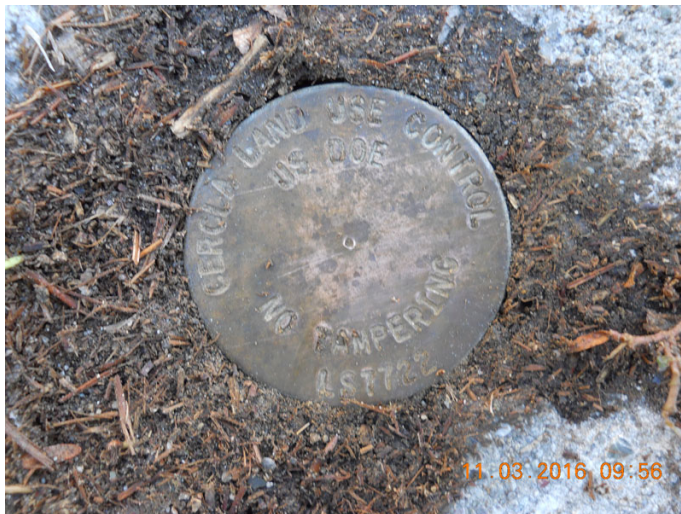
Monument 24: northeast corner of Southwest Trenches Area, at southern perimeter of Domestic Septic System 3 (photo No. 3137).

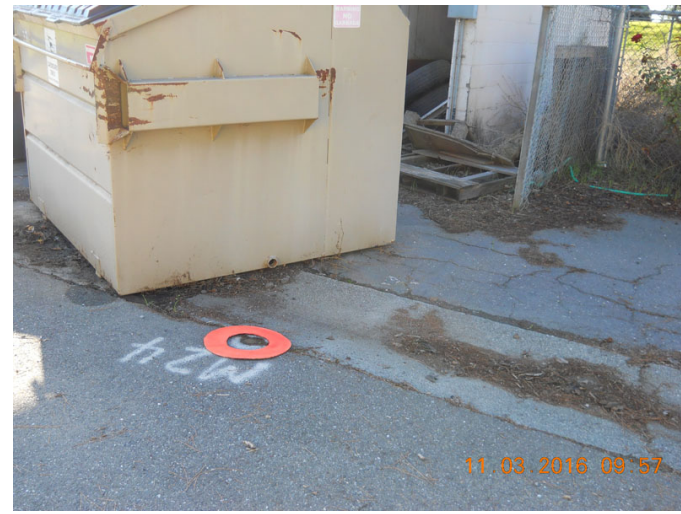
View southeast: Monument 24, within orange ring on edge of concrete swale—waste bin and trailer shed behind; rose planter in right of background (photo No. 3138).

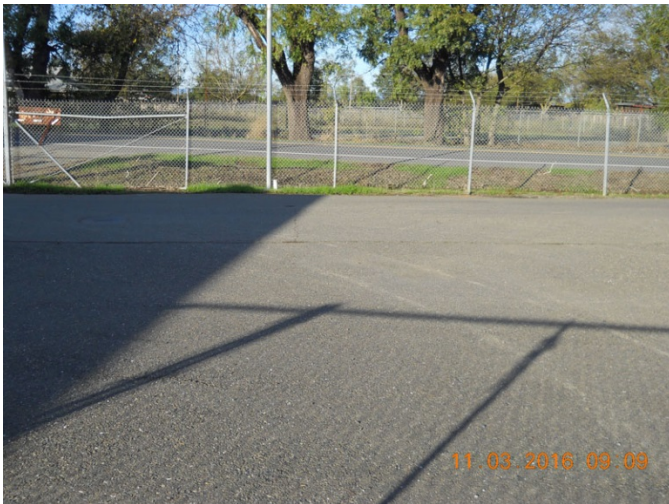
View west over Domestic Septic System 2 area within middle-west portion of Radium/Strontium Treatment Systems Area (photo No. 3115).

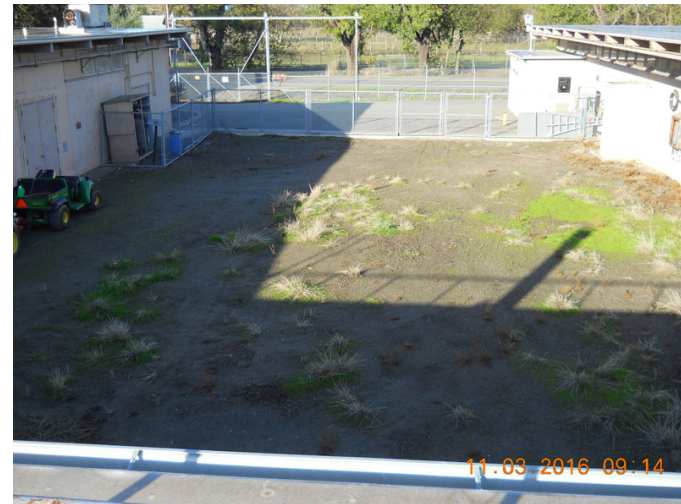
Roof-level view west over middle portion of Radium/Strontium Treatment Systems Area: Building H-219 to right, Building H-218 to left (photo No. 3117).

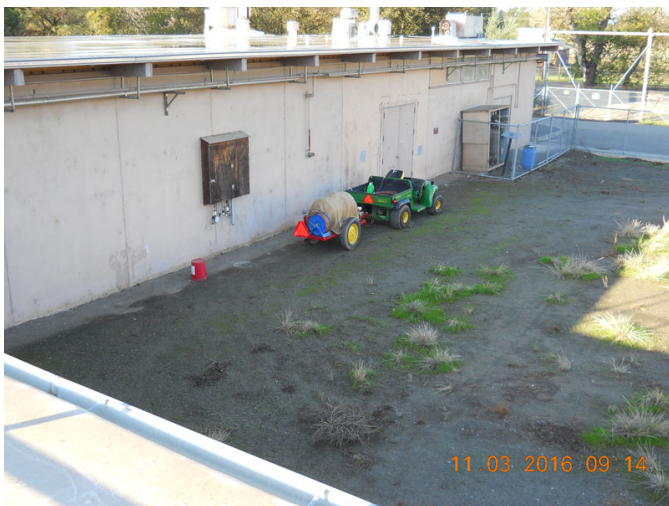
Roof-level view southwest over middle portion of Radium/Strontium Treatment Systems Area: Building H-218 in background (photo No. 3118).

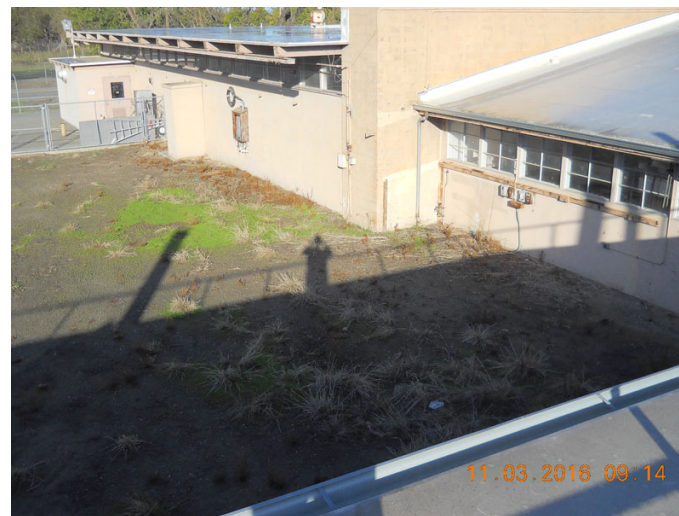
Roof-level view northwest over middle portion of Radium/Strontium Treatment Systems Area: Building H-219 in background (photo No. 3119).

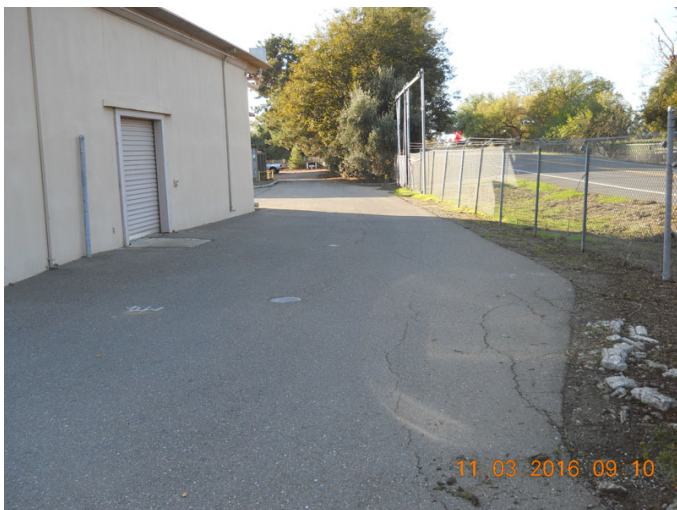
View south over northern portion of Radium/Strontium Treatment Systems Area: Building H-219 to left, west perimeter fence and Old Davis Road to right (photo No. 3116).

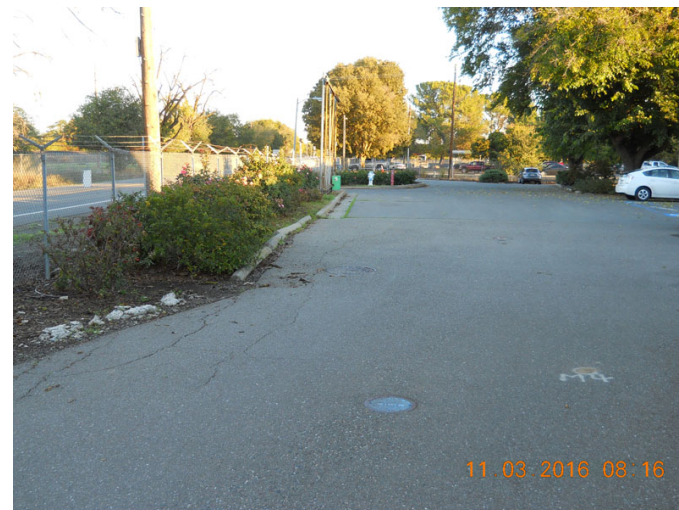
View north over Dry Wells A-E Area: Old Davis Road to left (photo No. 3084).

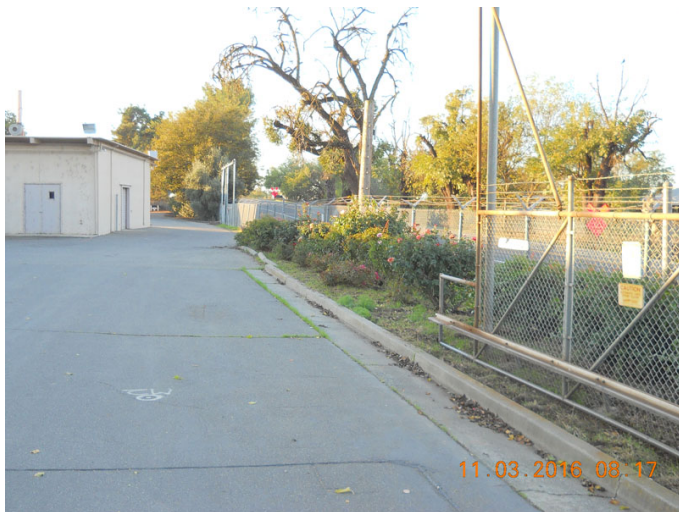
View south over Dry Wells A-E Area: Building H-219 in background/left; retracted site entrance gate to right (photo No. 3085).

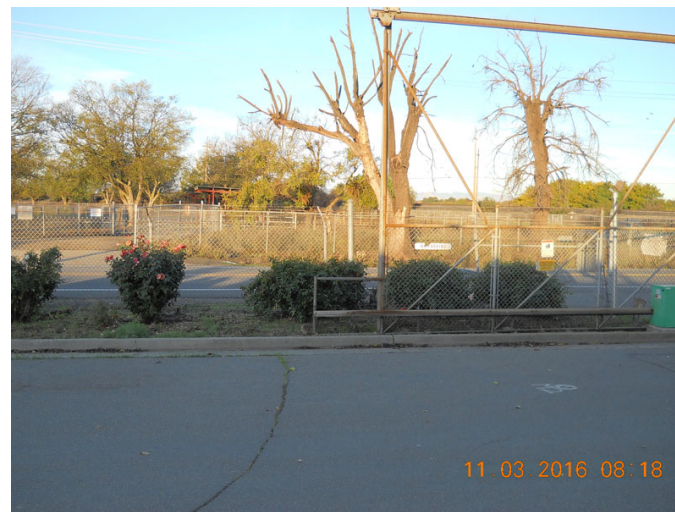
View west over Dry Wells A-E Area: retracted site entrance gate and Old Davis Road in background (photo No. 3086).

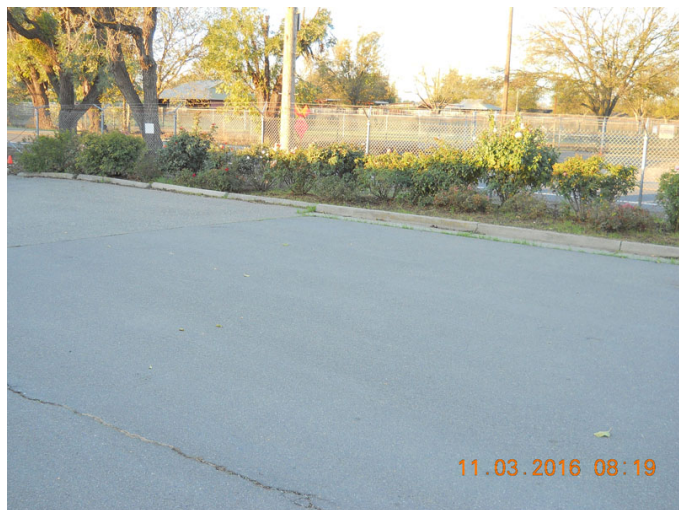
View southwest over Dry Wells A-E Area (photo No. 3087).

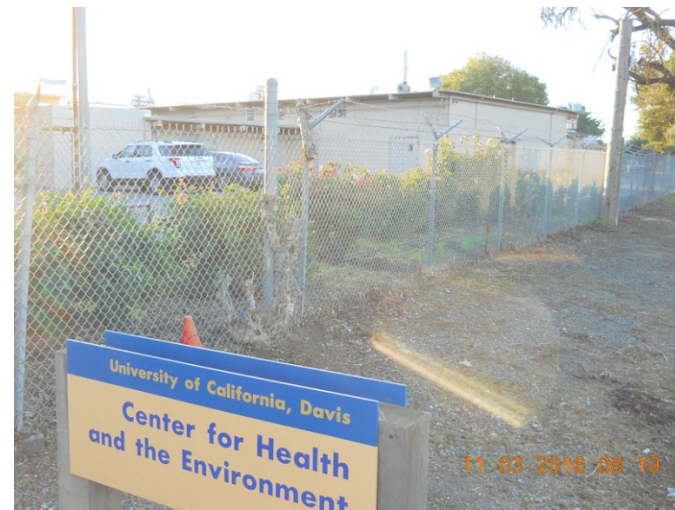
View southeast over Dry Wells A-E Area: entrance sign in foreground (photo No. 3088).

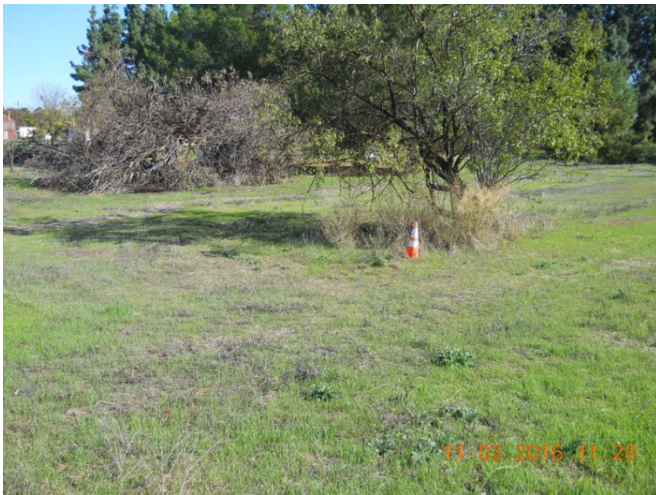
*View northeast over Eastern Dog Pens Area
(photo No. 3179).*

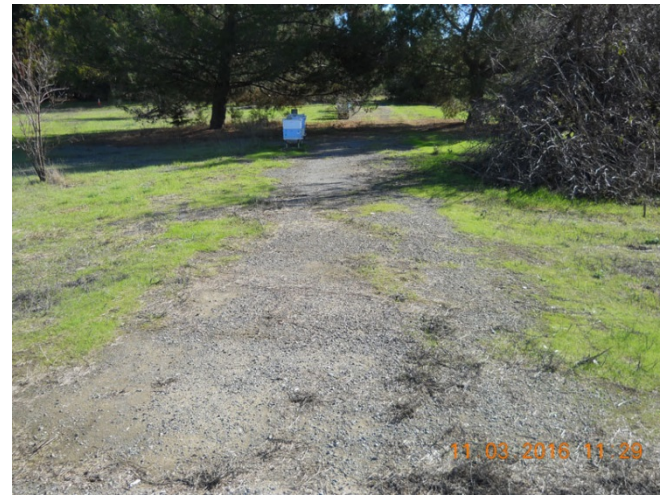
View east over Eastern Dog Pens Area (photo No. 3180).

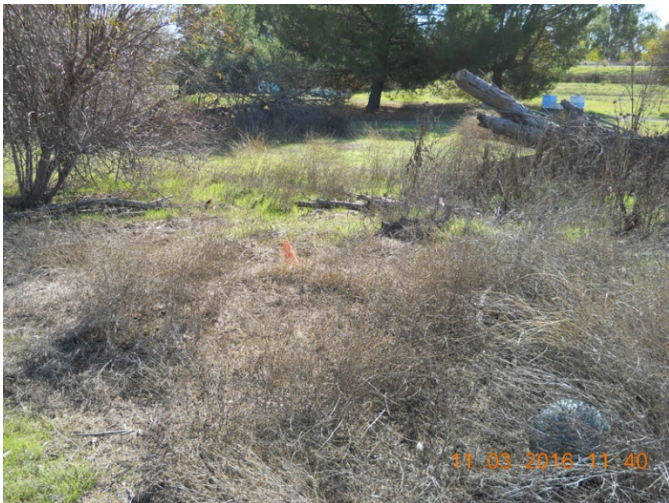
*View southeast over Eastern Dog Pens Area from
northwest corner (photo No. 3185).*

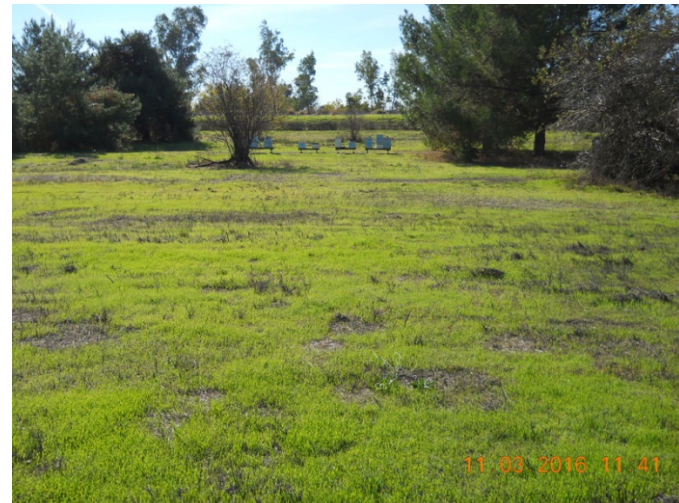
View south over Eastern Dog Pens Area (photo No. 3186).

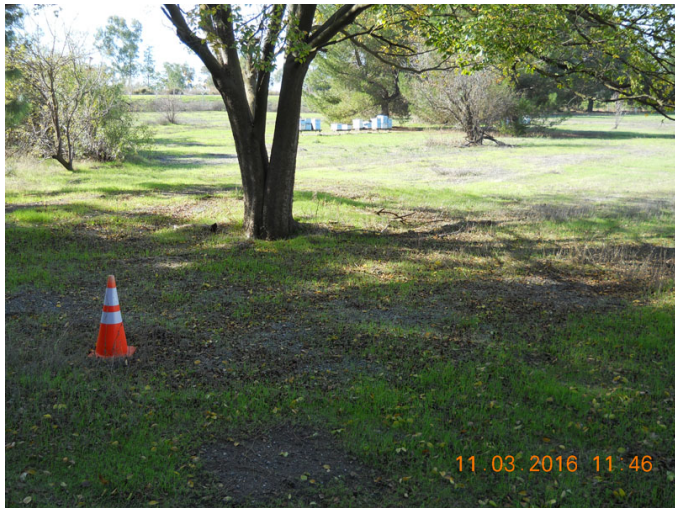
View southwest over Eastern Dog Pens Area from northeast corner (photo No. 3187).

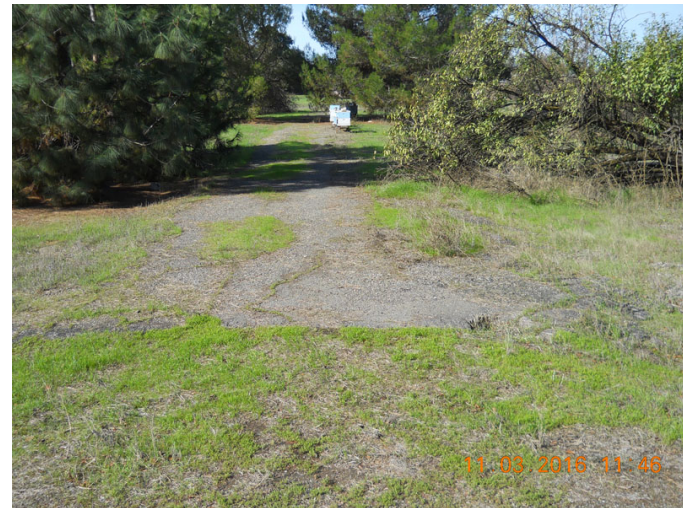
View west over Eastern Dog Pens Area (photo No. 3188).
