**2016 Annual Land-Use Covenant
Inspection Report
for DOE Areas at the Laboratory
for Energy-Related Health
Research/Old Campus Landfill
Superfund Site
University of California, Davis**

January 2017

U.S. DEPARTMENT OF
ENERGY

Legacy
Management

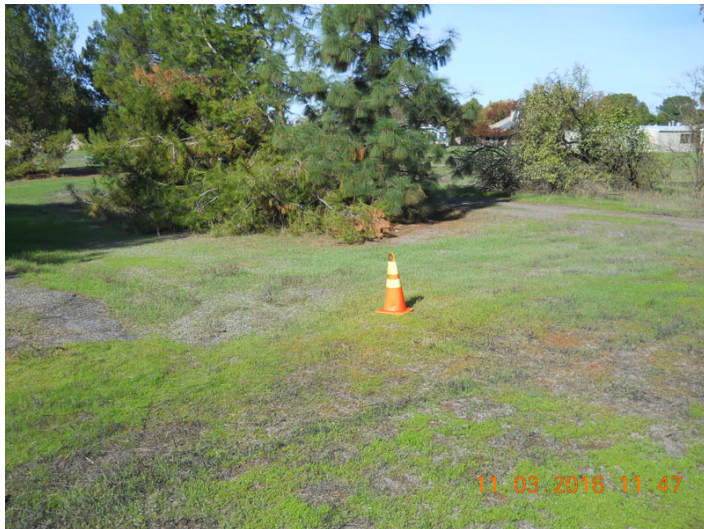
View northwest into Eastern Dog Pens Area (photo No. 3189).

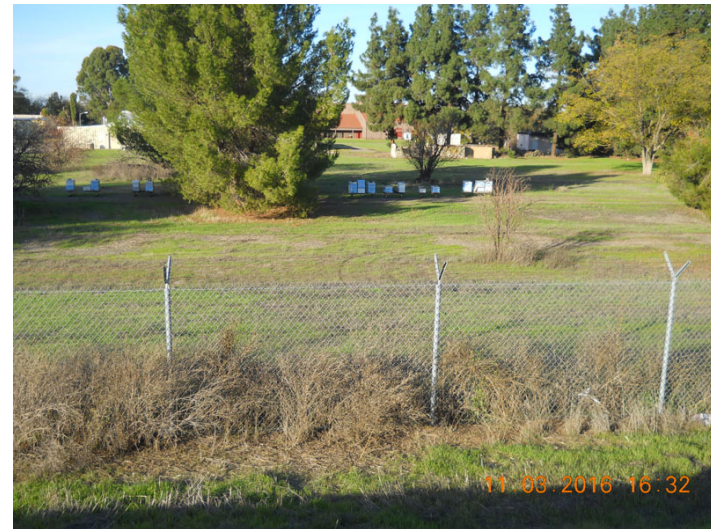
View north over Eastern Dog Pens Area from North Levee (photo No. 3255).

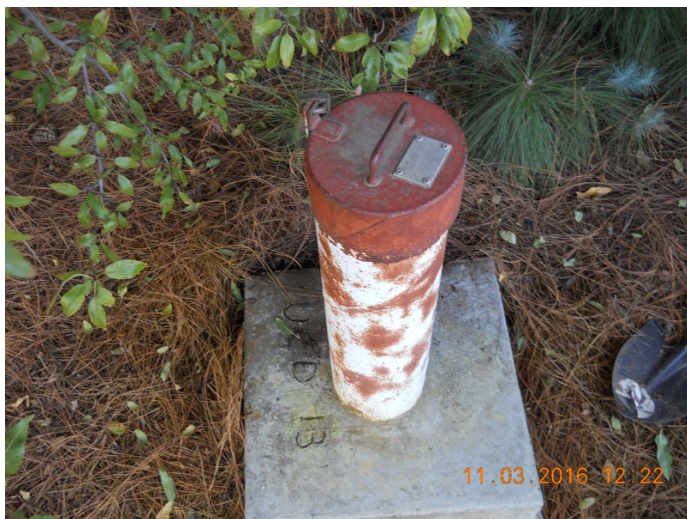
UCD1-013 Wellhead (photo No. 3195).

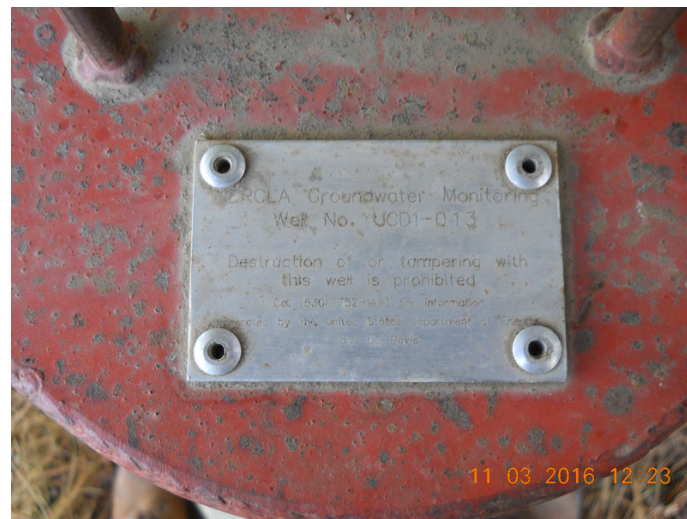
UCD1-013 Wellhead plaque (photo No. 3197).

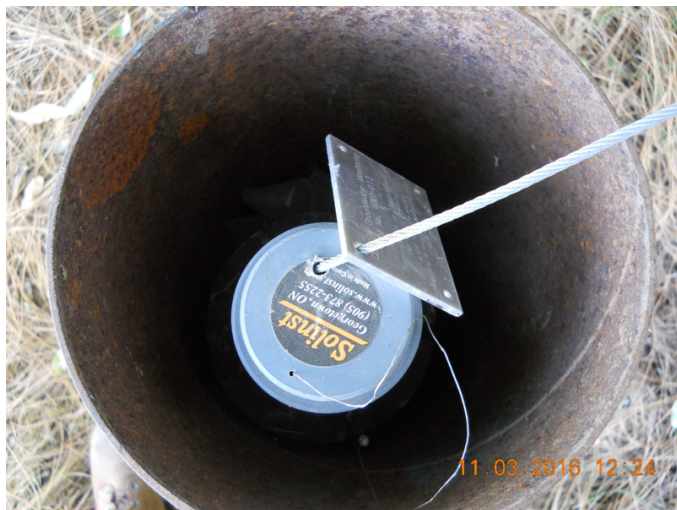
UCD1-013 Interior (photo No. 3198).

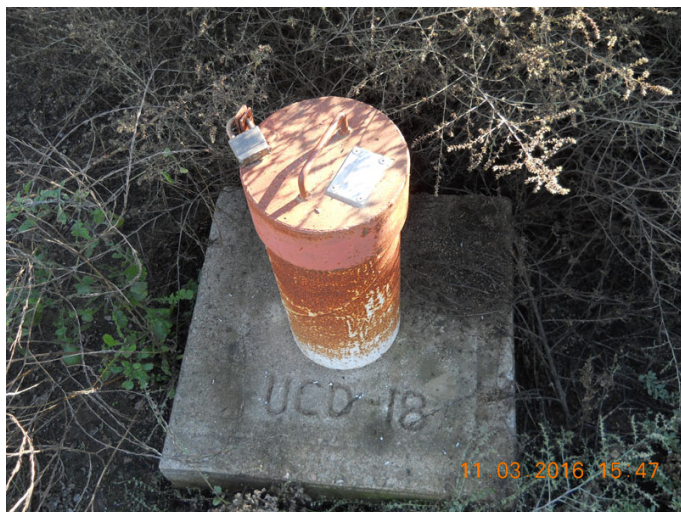
UCD1-018 Wellhead (photo No. 3240).

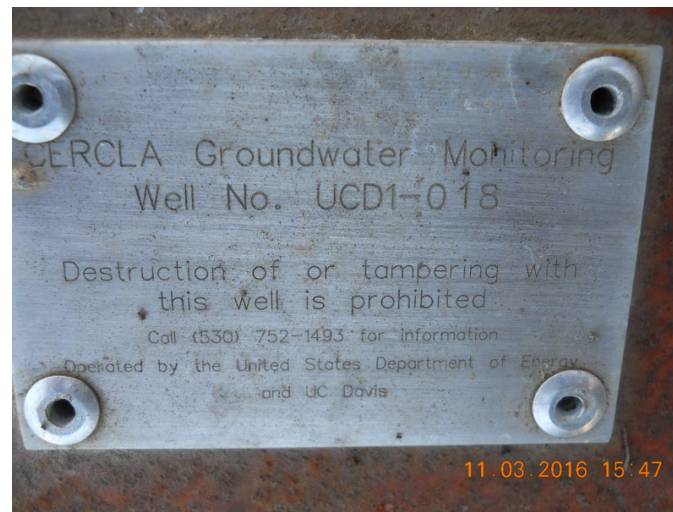
UCD1-018 Wellhead plaque (photo No. 3241).

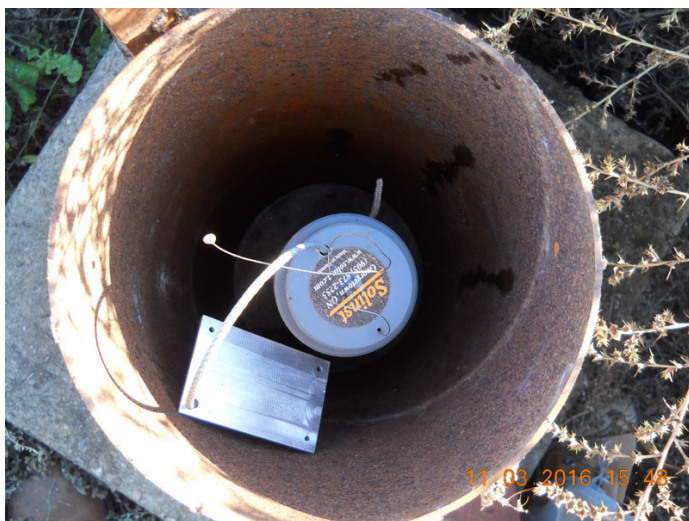
UCD1-018 Interior (photo No. 3242).

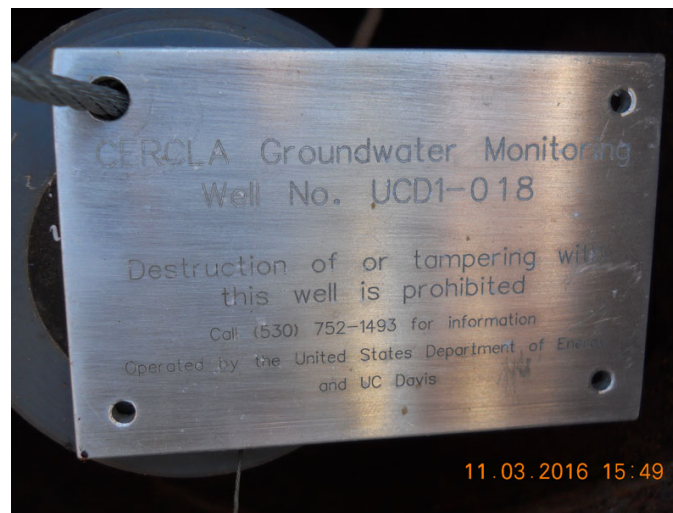
UCD1-018 Interior plaque (photo No. 3243).

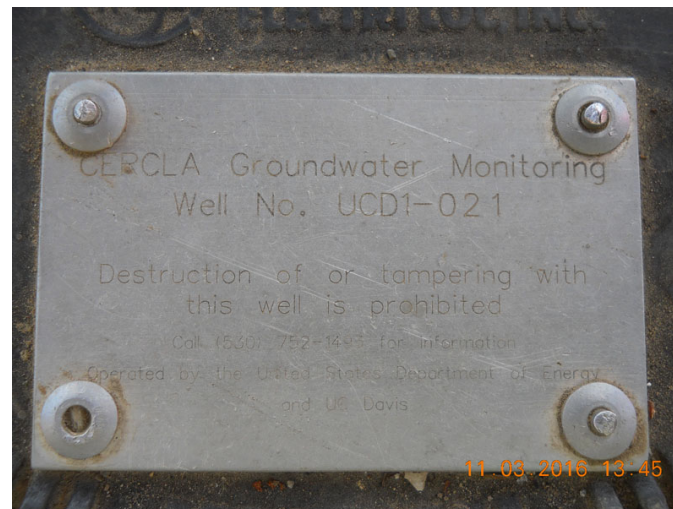
UCD1-021 Wellhead plaque (photo No. 3219).

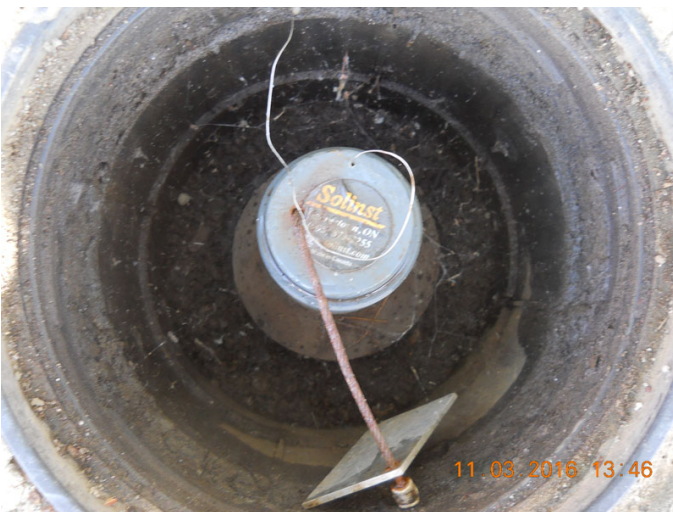
UCD1-021 Interior (photo No. 3220).

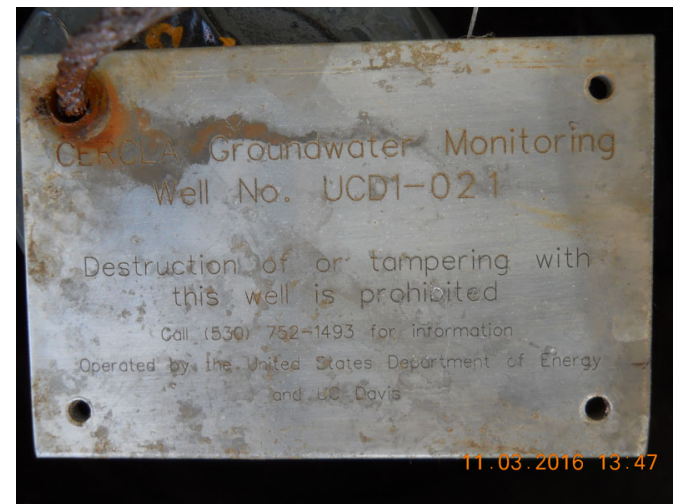
UCD1-021 Interior plaque (photo No. 3221).

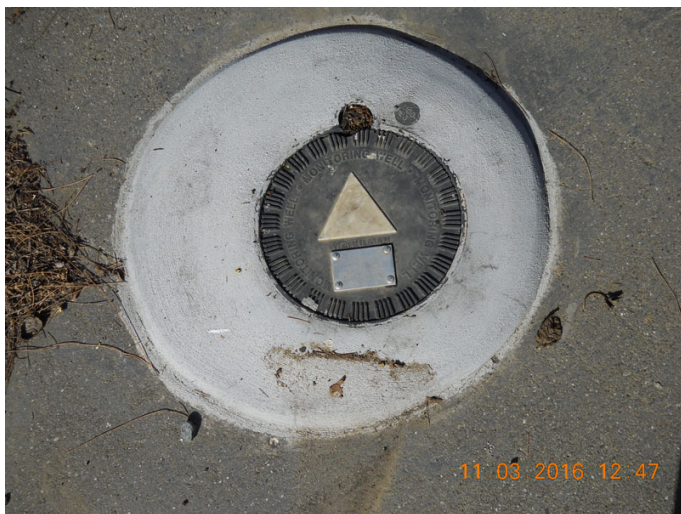
UCD1-023 Wellhead (photo No. 3200).

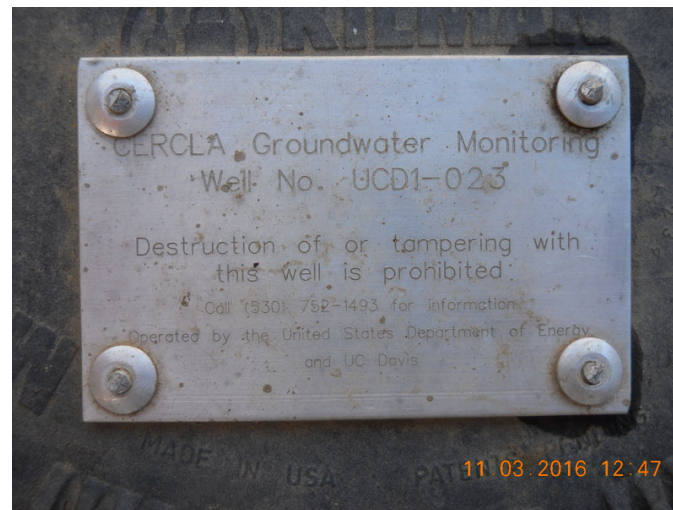
UCD1-023 Wellhead plaque (photo No. 3201).

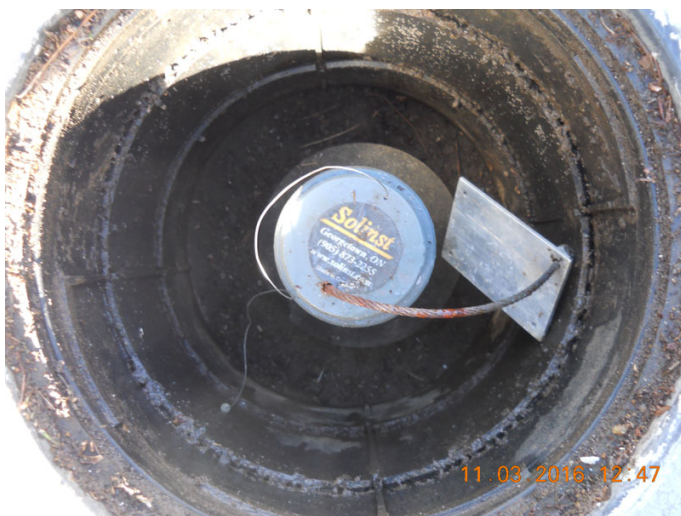
UCD1-023 Interior (photo No. 3202).

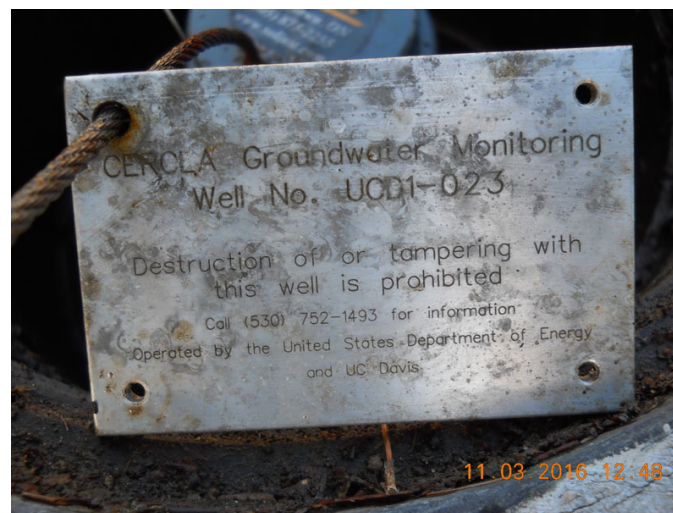
UCD1-023 Interior plaque (photo No. 3203).

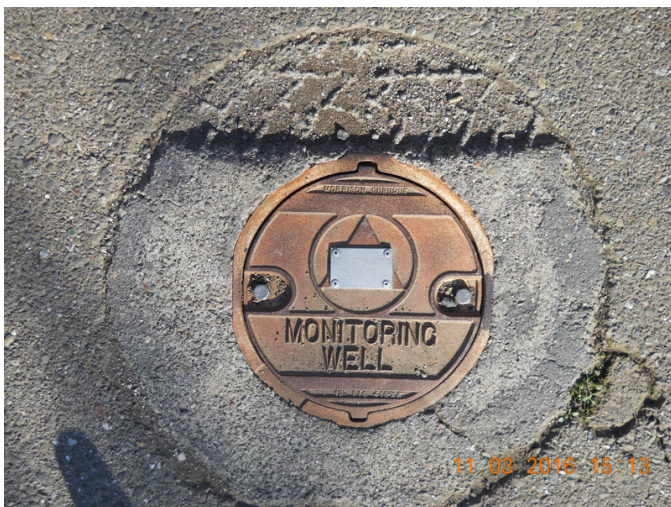
UCD1-054 Wellhead (photo No. 3231).

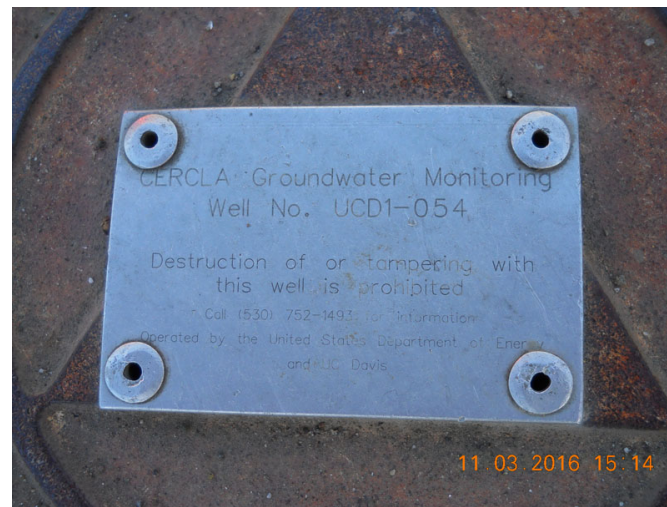
UCD1-054 Wellhead plaque (photo No. 3233).

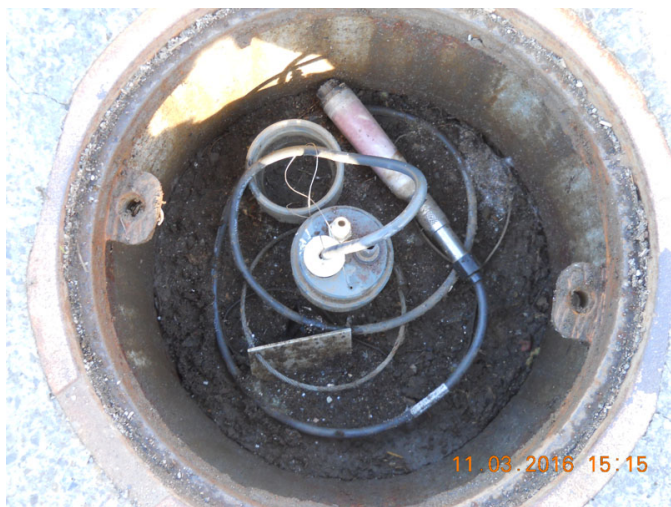
UCD1-054 Interior (photo No. 3234).

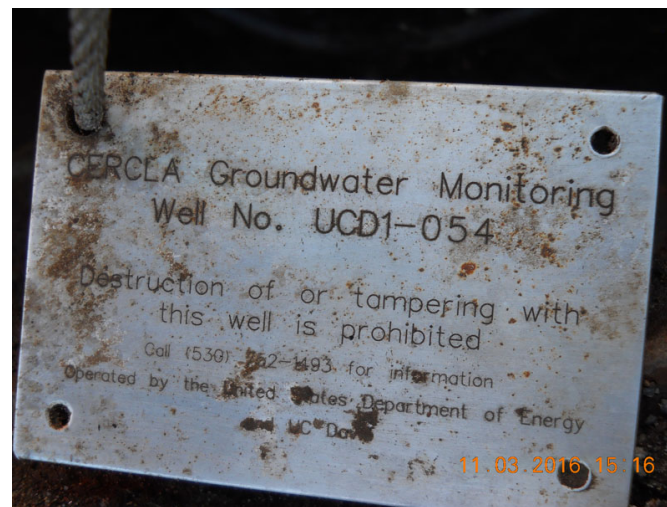
UCD1-054 Interior plaque (photo No. 3235).

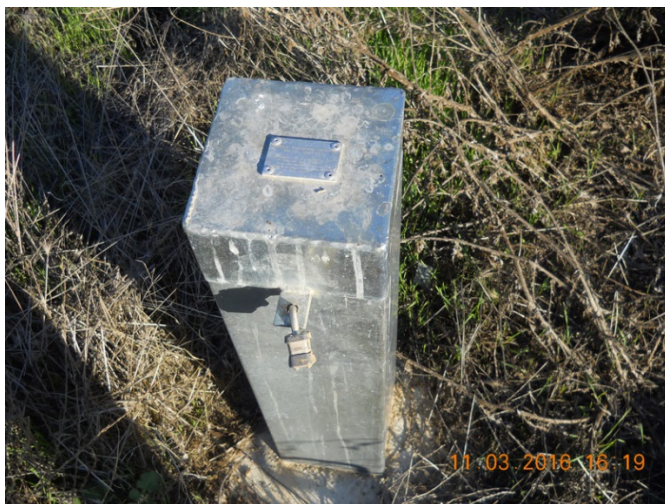
UCD1-063 Wellhead (photo No. 3250).

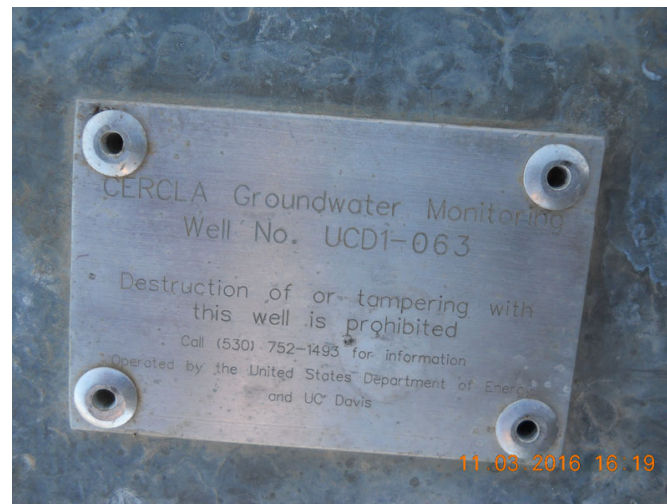
UCD1-063 Wellhead plaque (photo No. 3252).

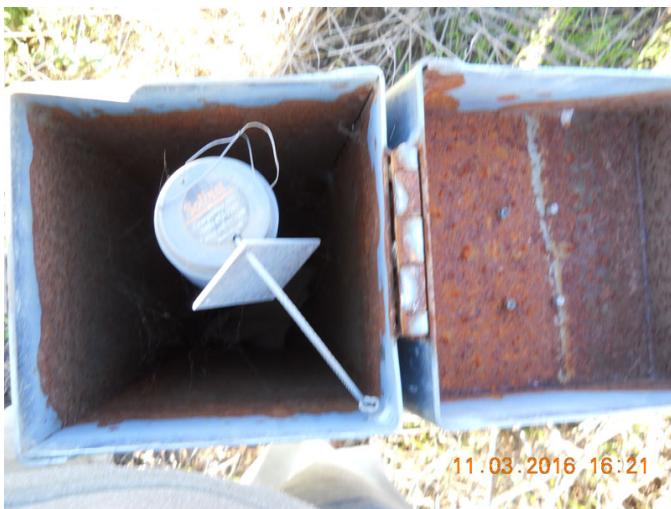
UCD1-063 Interior (photo No. 3253).

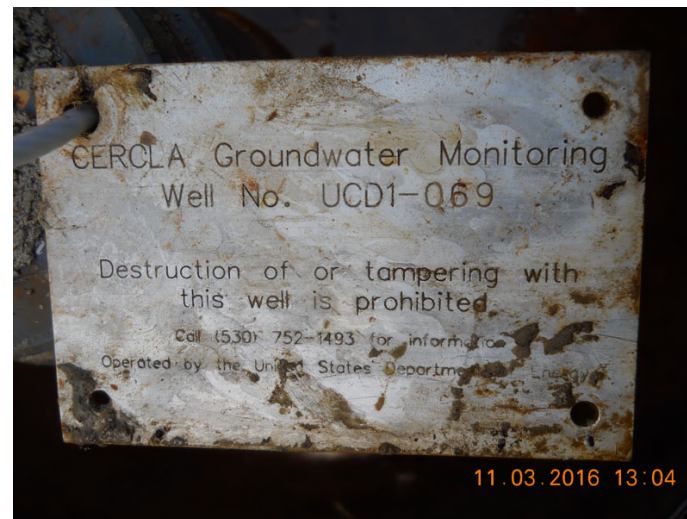
UCD1-069 Interior (photo No. 3206).

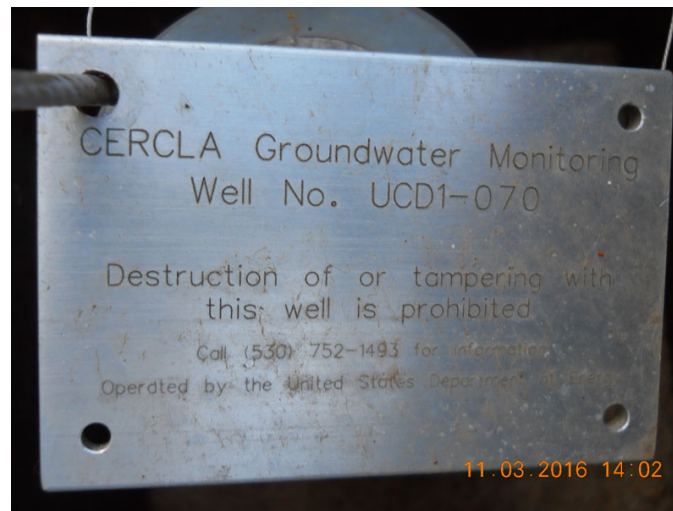
UCD1-070 Interior (photo No. 3224).
