**2017 Annual Land-Use Covenant
Inspection Report
for DOE Areas at the Laboratory
for Energy-Related Health
Research/Old Campus Landfill
Superfund Site
University of California, Davis**

January 2018

U.S. DEPARTMENT OF
ENERGY

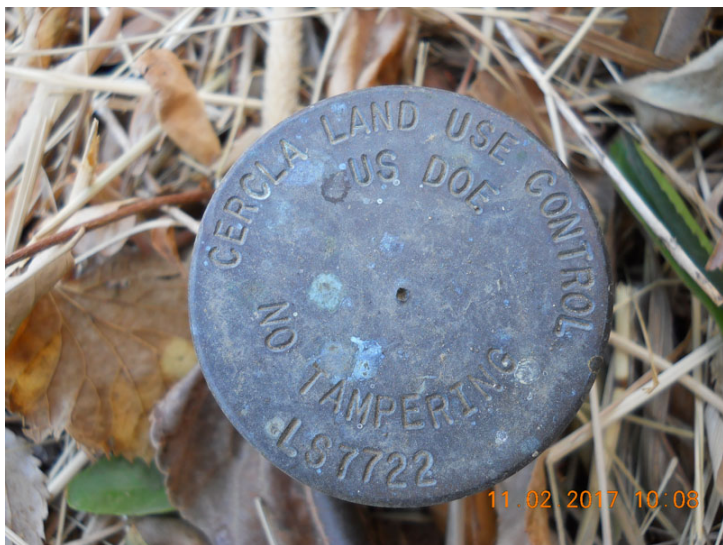
Monument 1: Northwest corner of Dry Wells A–E Area
(photo No. 3296).

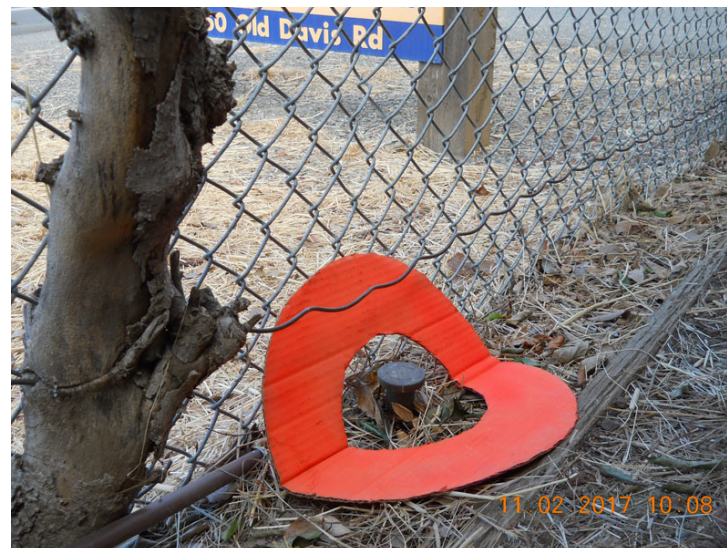
View northwest: Monument 1, within orange ring (outside diameter is 14 inches) in foreground; entrance sign in background (photo No. 3297).
(Delineator shown in Appendix C, photo No. 3309 on page C-15.)

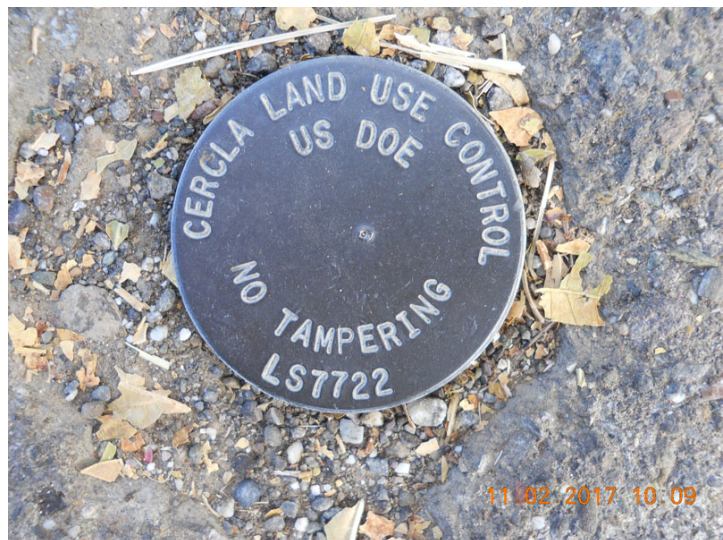
Monument 2: Northeast corner of Dry Wells A–E Area
(photo No. 3299).

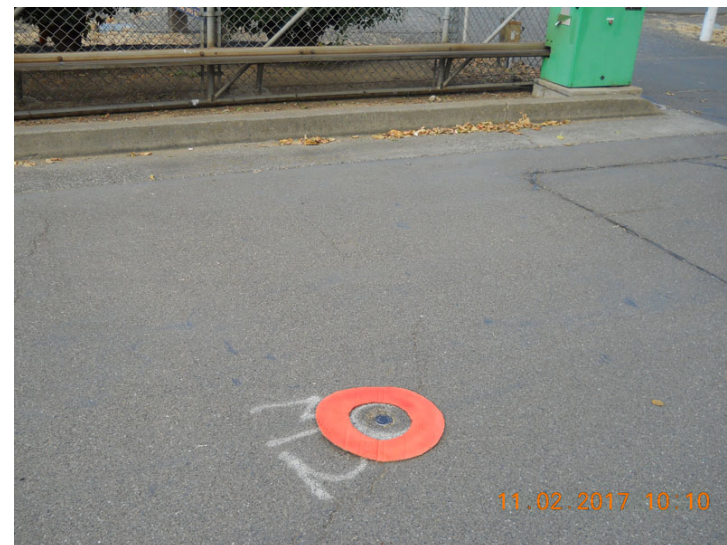
View northwest: Monument 2, within orange ring; entrance and retracted entrance gate in background (photo No. 3300).

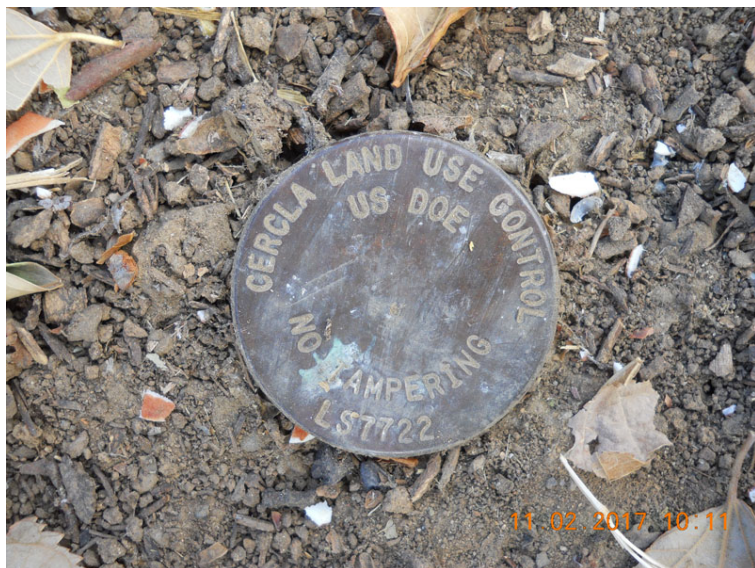
Monument 3: Southwest corner of Dry Wells A–E Area (photo No. 3301).

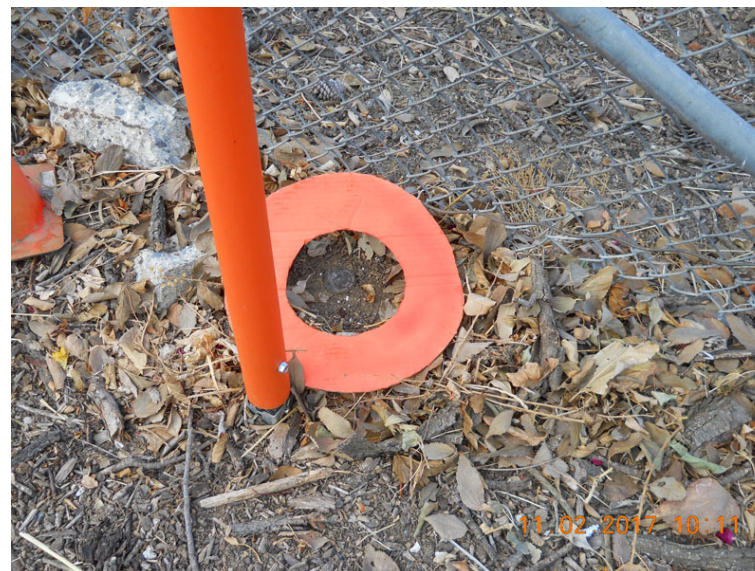
View southwest: Monument 3, within orange ring; west perimeter fence above right; delineator left of monument (photo No. 3302).

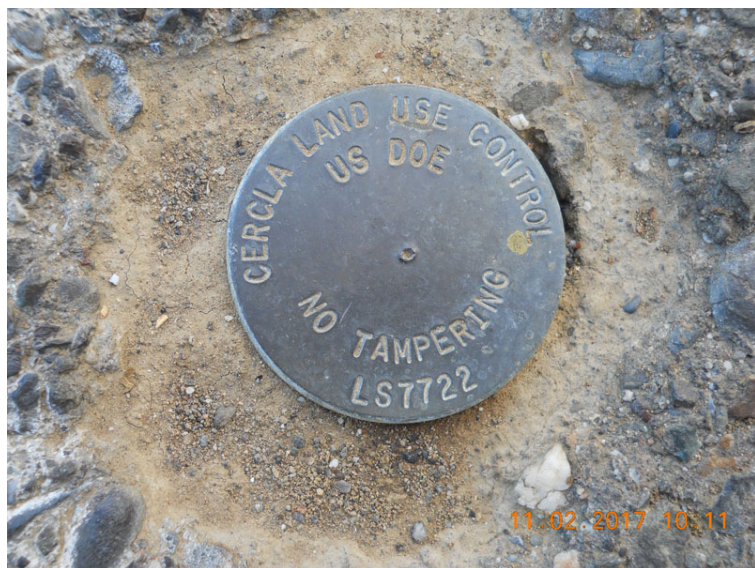
Monument 4: Southeast corner of Dry Wells A–E Area (photo No. 3303).

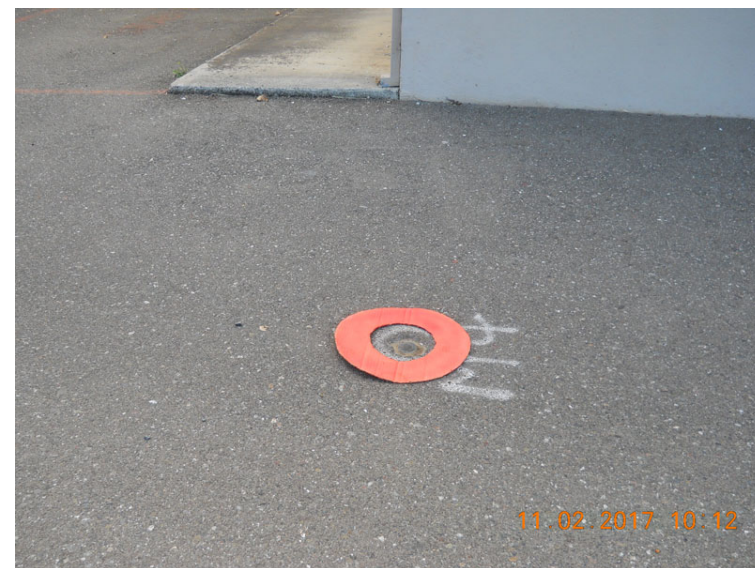
View east: Monument 4, within orange ring; Building H-219 in background (photo No. 3304).

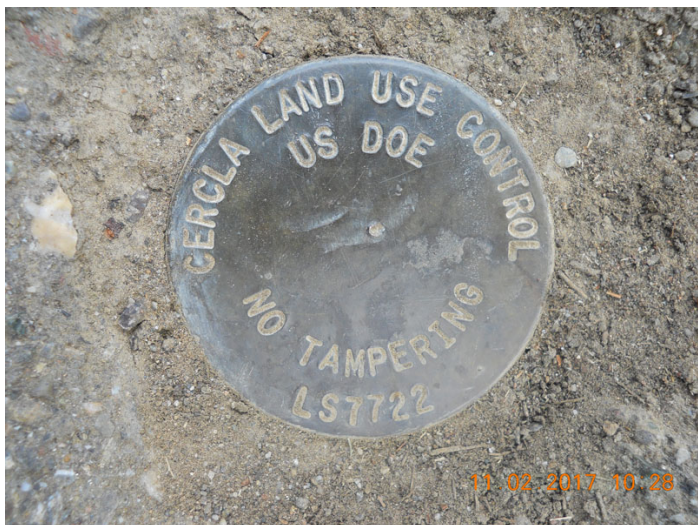
Monument 5: Northwest corner of Domestic Septic System 4 Area (photo No. 3312).

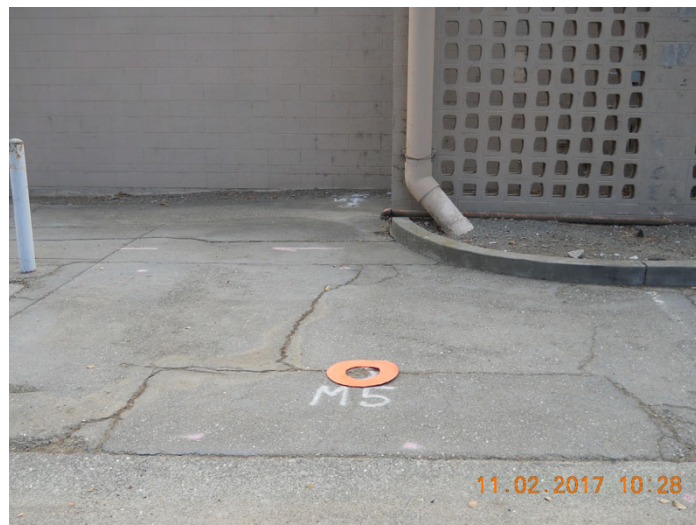
View east: Monument 5, within orange ring; Building H-215 in background (photo No. 3313).

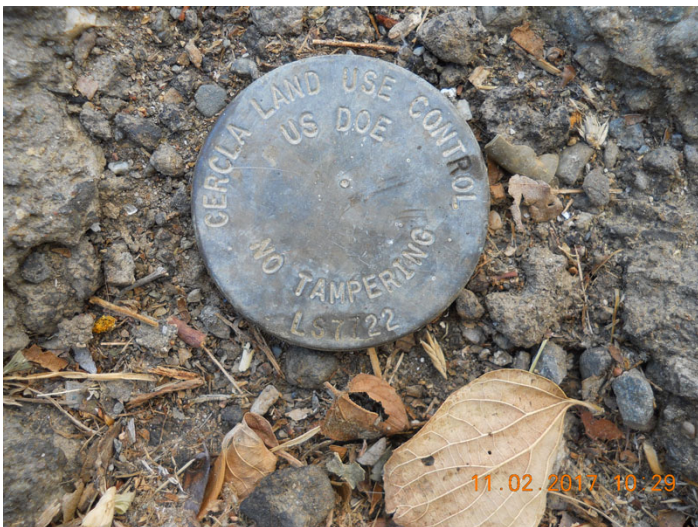
Monument 6: Adjacent to northwest corner of Building H-218; Radium/Strontium Treatment Systems Area (photo No. 3314).

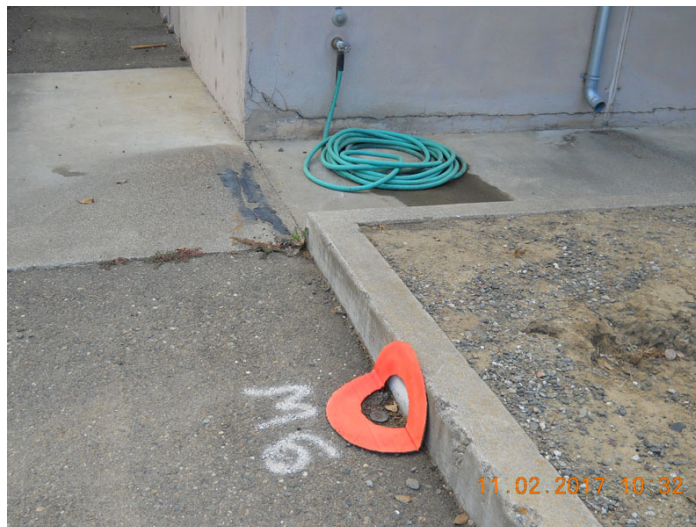
View east: Monument 6, within orange ring; corner of Building H-218 in background (photo No. 3315).

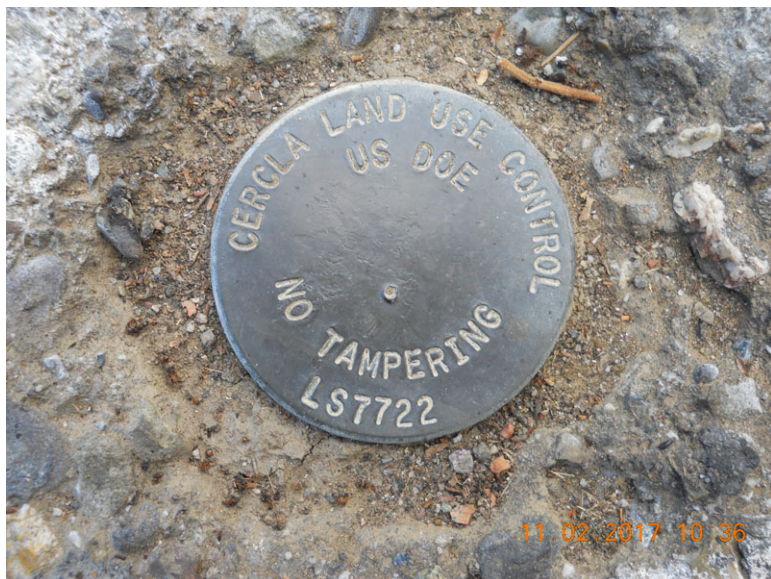
Monument 7: Southwest corner of Domestic Septic System 4 Area (photo No. 3317).

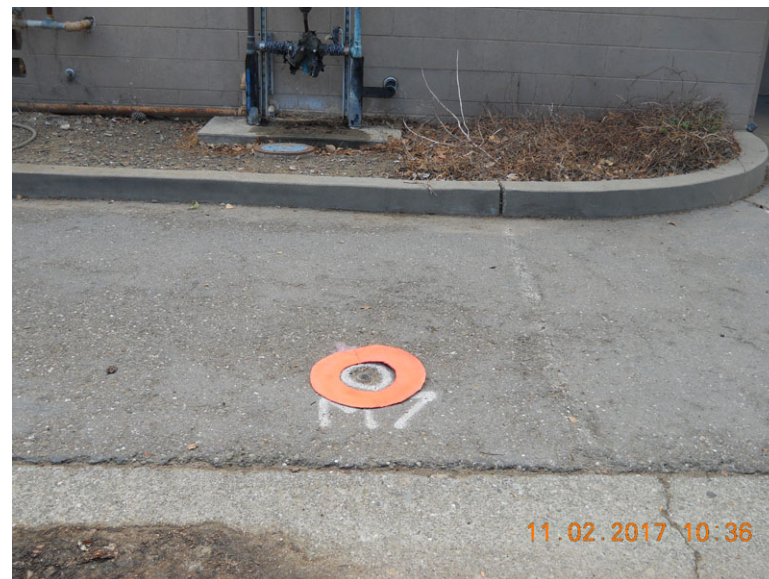
View east: Monument 7, within orange ring; Building H-215 in background (photo No. 3318).

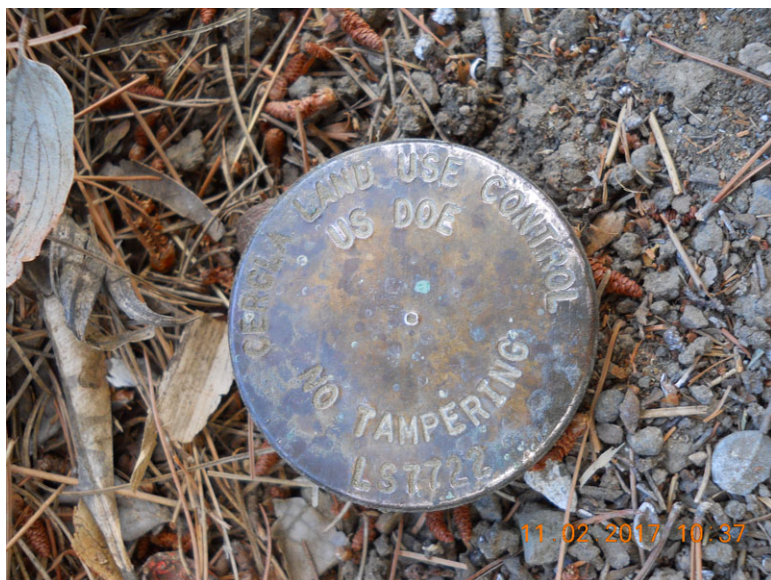
Monument 8: Southwest corner of radium-226 leach trench; Radium/Strontium Treatment Systems Area (photo No. 3319).

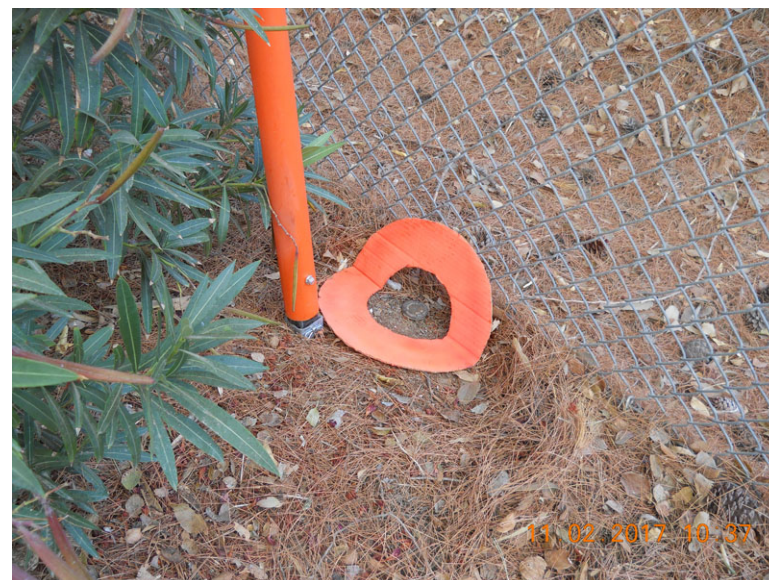
View southwest: Monument 8, within orange ring; west perimeter fence right of monument; delineator left of monument (photo No. 3320).

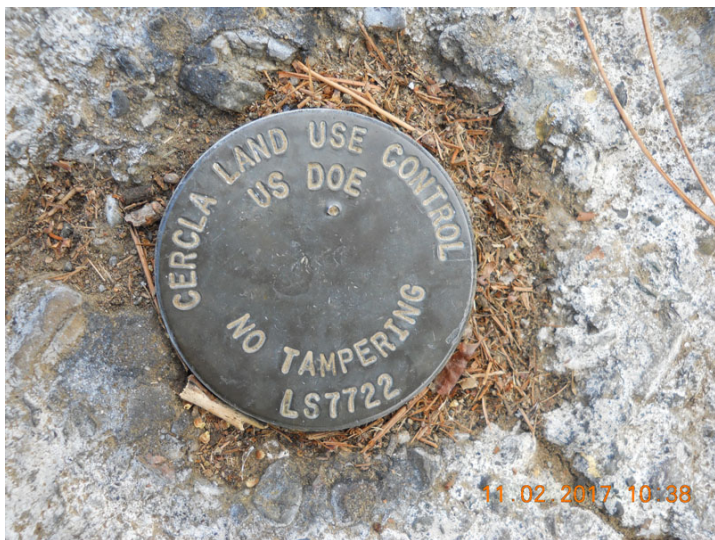
*Monument 9: Southeast corner of radium-226 leach trench;
Radium/Strontium Treatment Systems Area (photo No. 3321).*

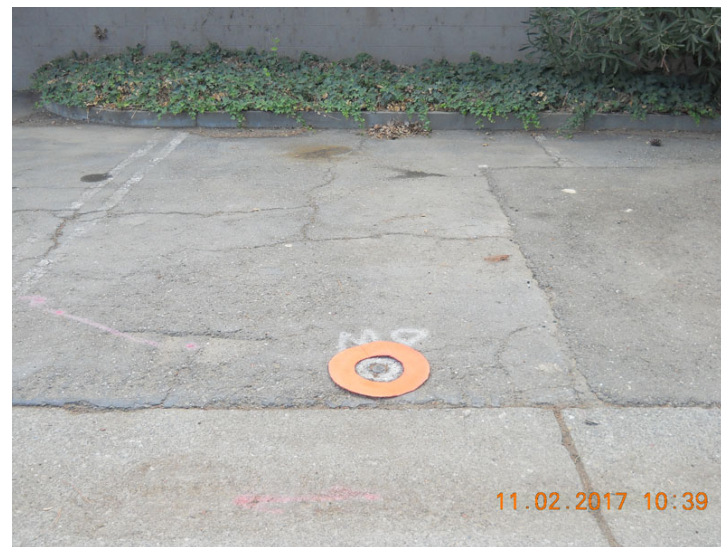
*View east: Monument 9, within orange ring;
Building H-215 in background (photo No. 3322).*

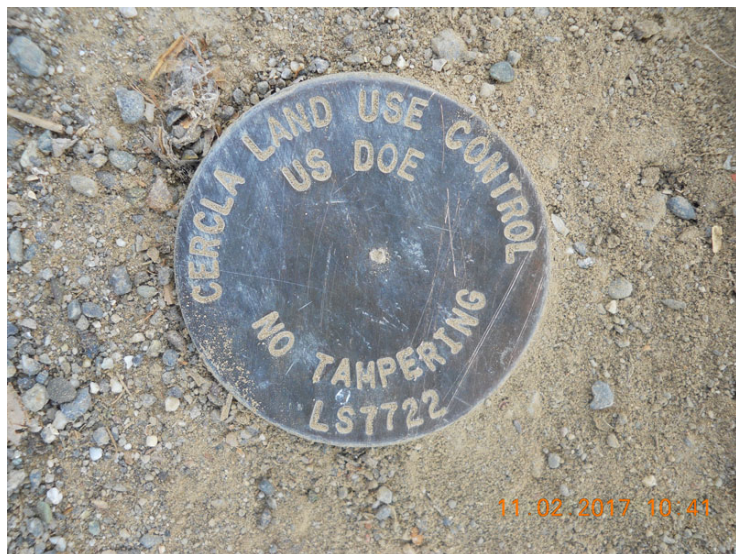
*Monument 10: Northeast corner of former leach field in
Domestic Septic System 3 Area (photo No. 3323).*

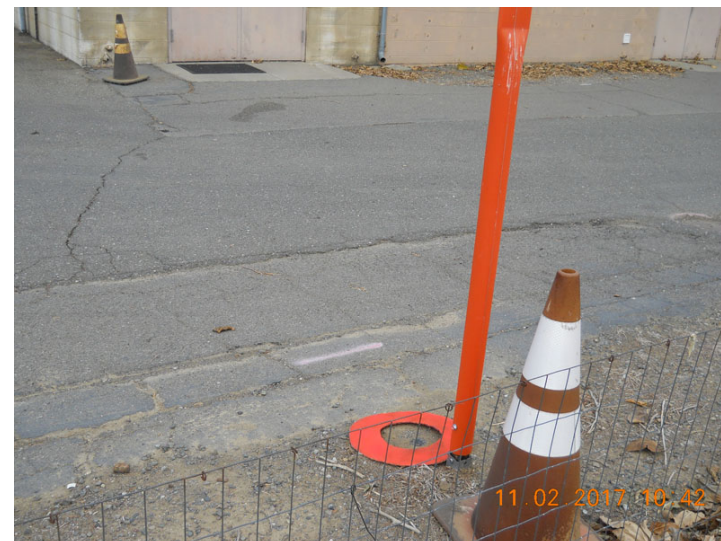
*View northwest: Monument 10, within orange ring in foreground;
delineator right of monument; Building H-216 in background
(photo No. 3324).*

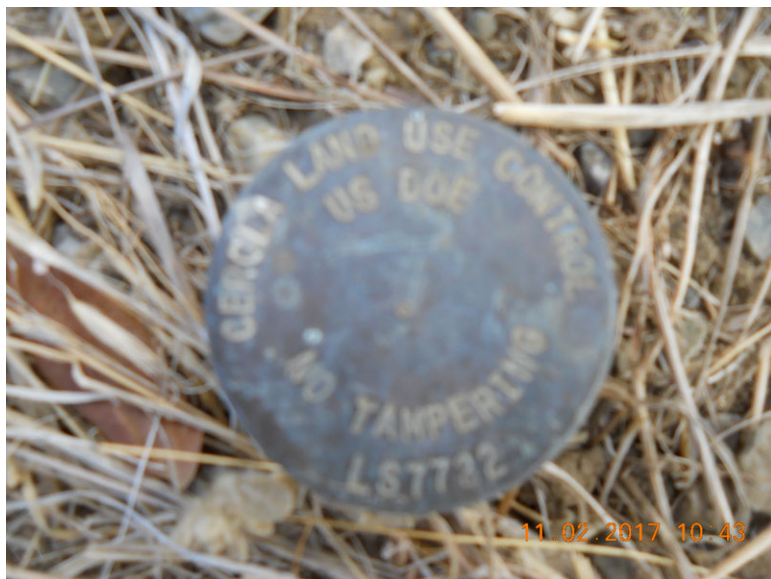
Monument 11: Northeast corner of Eastern Remediation Support Area (photo No. 3325).

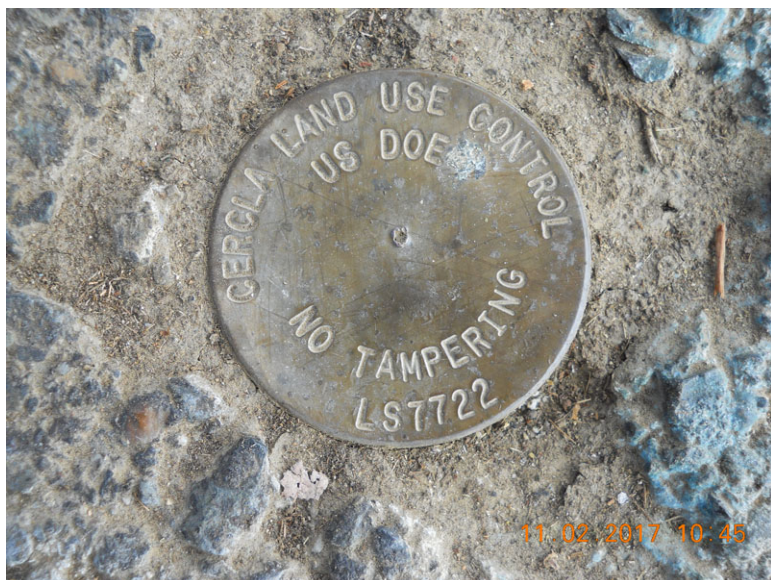
Monument 12: Northwest corner of Southwest Trenches Area (photo No. 3327).

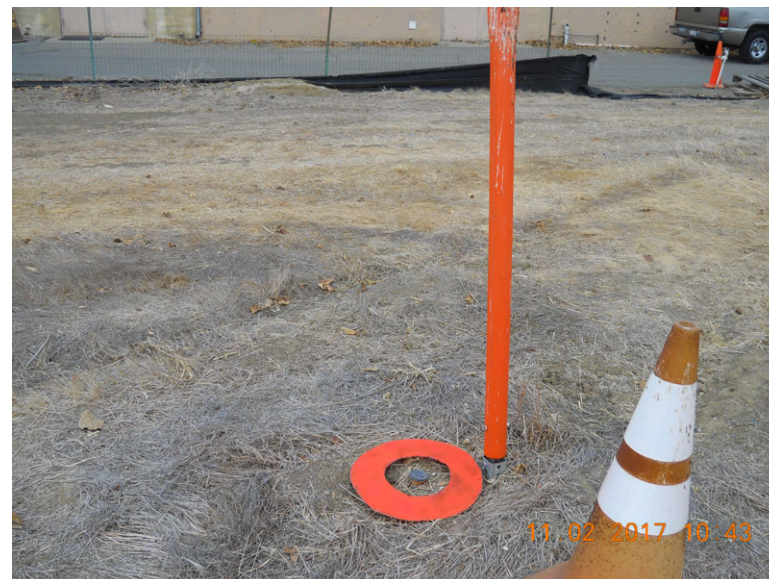
View west: Monument 11, within orange ring; delineator right of monument; Building H-216 in background (photo No. 3326).

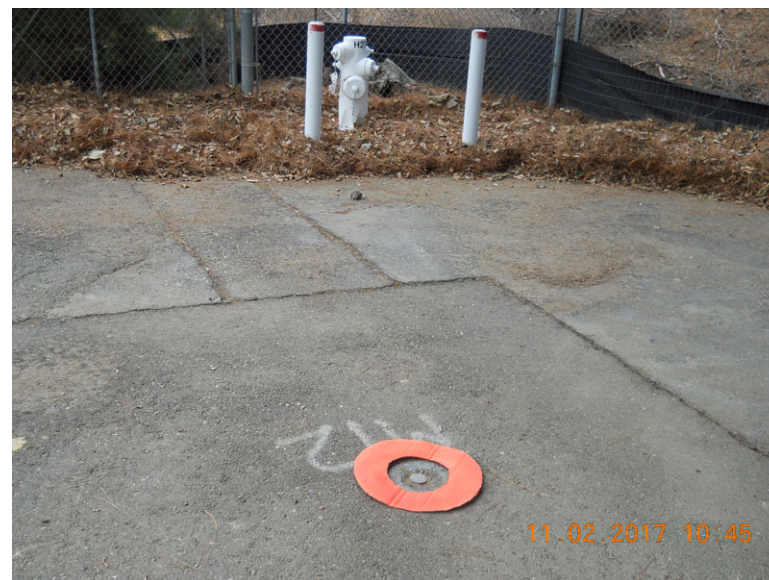
View south: Monument 12, within orange ring in foreground; water hydrant in background (photo No. 3328).

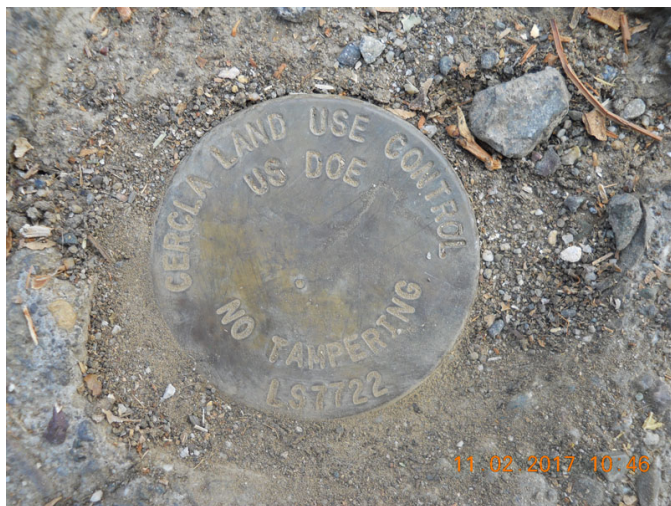
Monument 13: Southwest corner of Domestic Septic System 3 Area, at northern perimeter of Southwest Trenches Area (photo No. 3329).

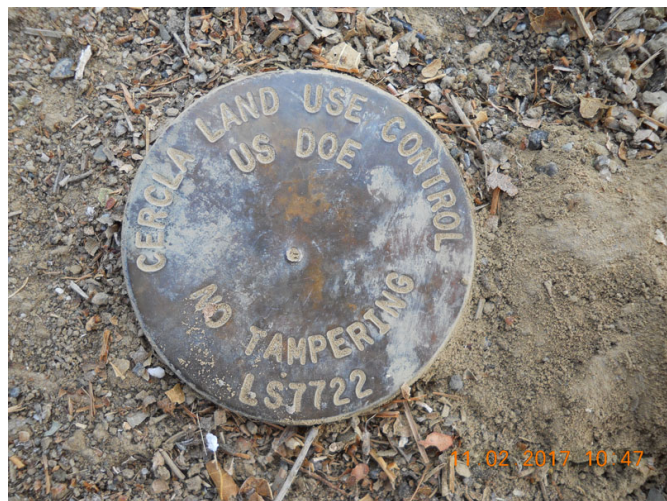
Monument 14: Southeast corner of Domestic Septic System 3 Area (photo No. 3331).

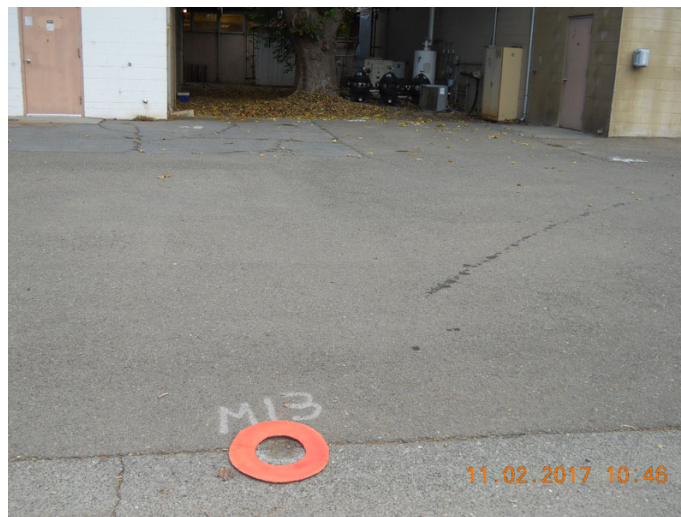
View north: Monument 13, within orange ring at edge of concrete swale; Buildings H-215 and H-216 in background (photo No. 3330).

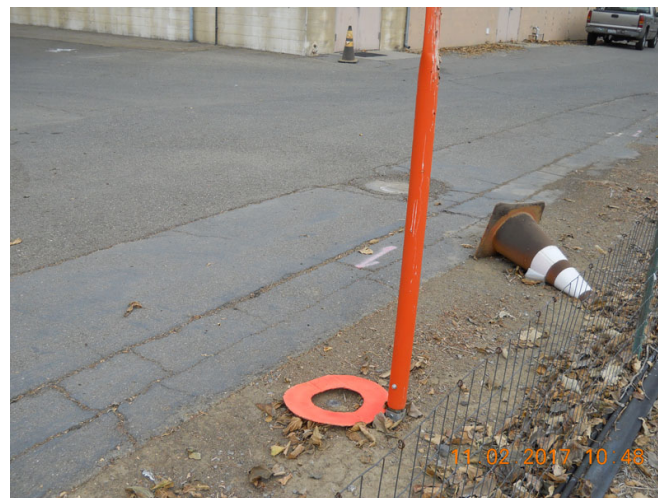
View northwest: Monument 14, within orange ring; delineator right of monument; Building H-216 in background (photo No. 3332).

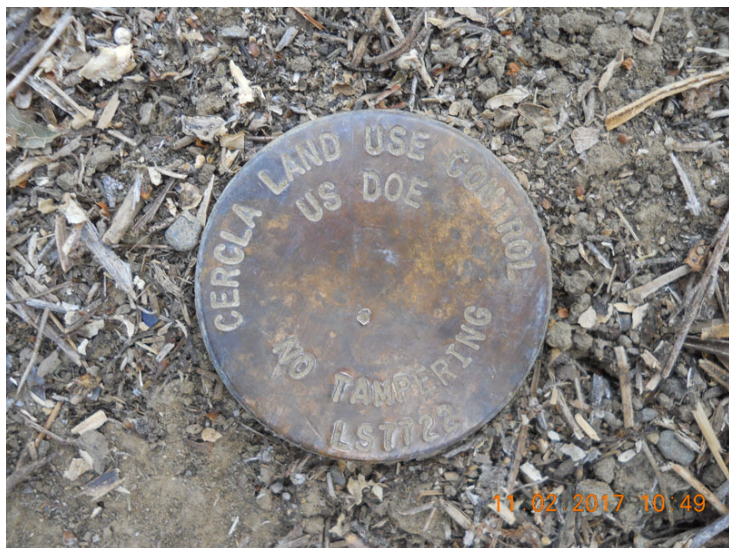
Monument 15: Eastern corner of Southwest Trenches Area (photo No. 3333).

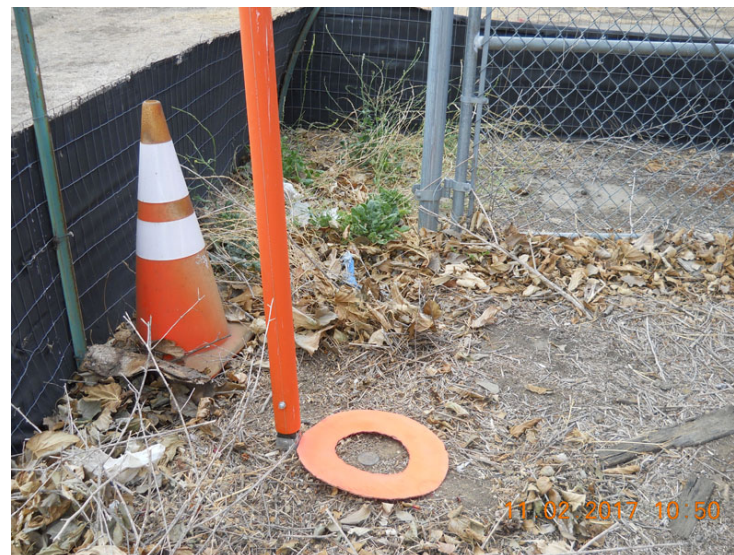
View southeast: Monument 15, within orange ring; delineator left of monument; former Western Dog Pens silt fence in left of background; trailer shed fence in right of background (photo No. 3334).

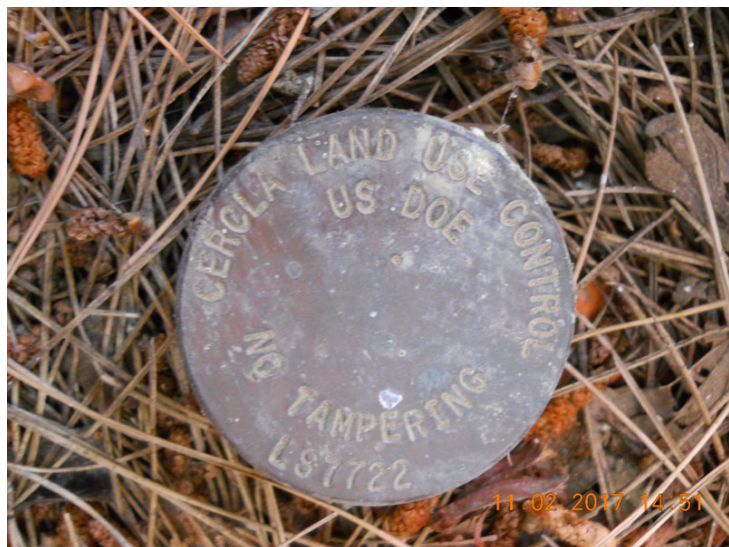
Monument 16: Southwest corner of Southwest Trenches Area (photo No. 3401).

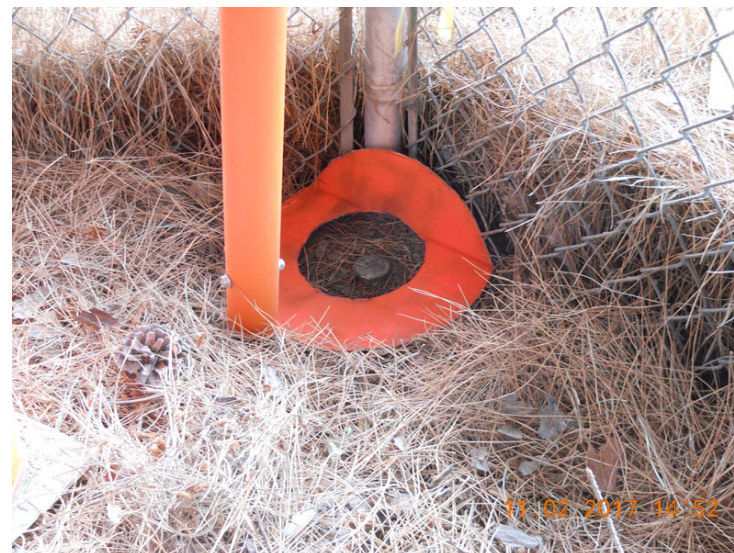
View southwest: Monument 16, within orange ring; delineator left of monument; southwest corner post of perimeter fence behind monument (photo No. 3402).

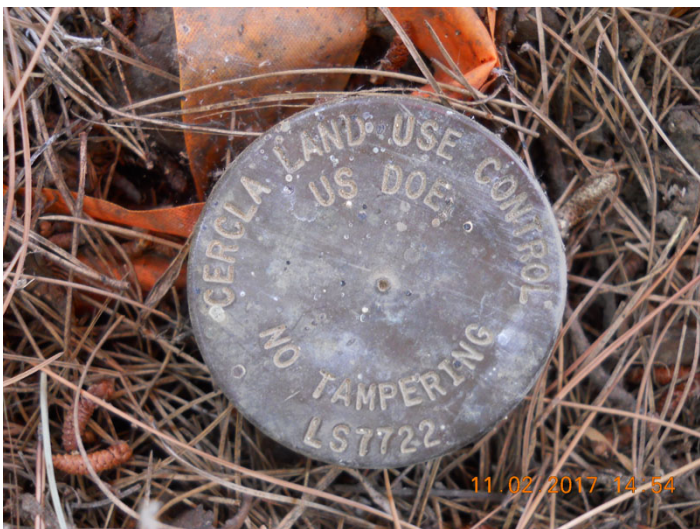
Monument 17: Southeast corner of Southwest Trenches Area (photo No. 3404).

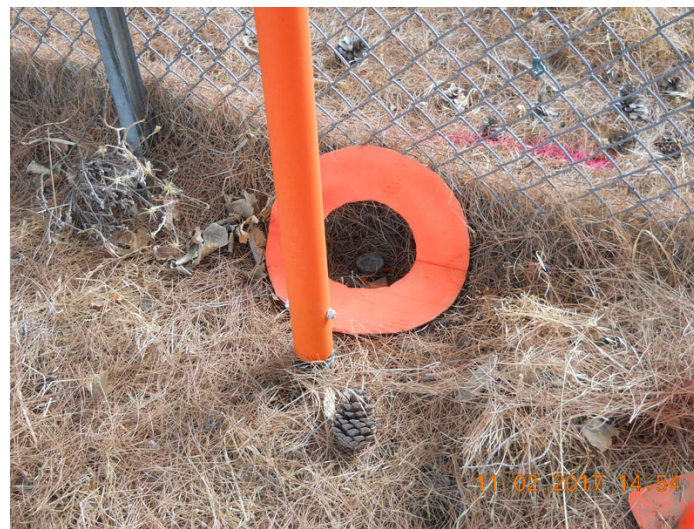
View southeast: Monument 17, within orange ring; delineator left of monument; south perimeter fence behind monument; foot of North Levee in background (photo No. 3405).

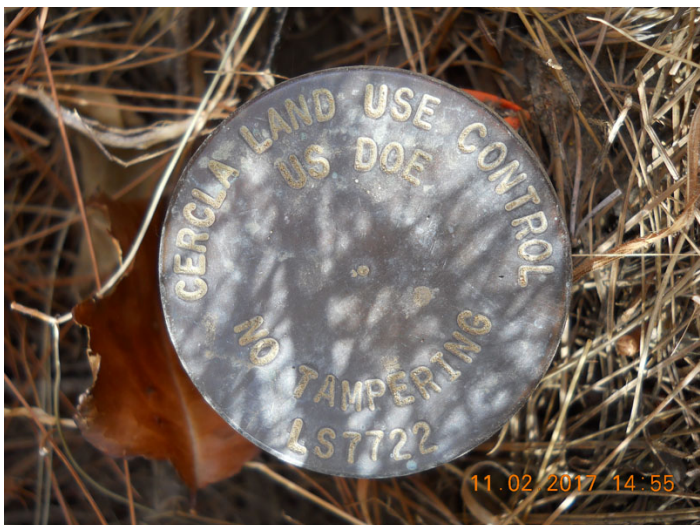
Monument 18: Southeast corner of Eastern Remediation Support Area (photo No. 3406).

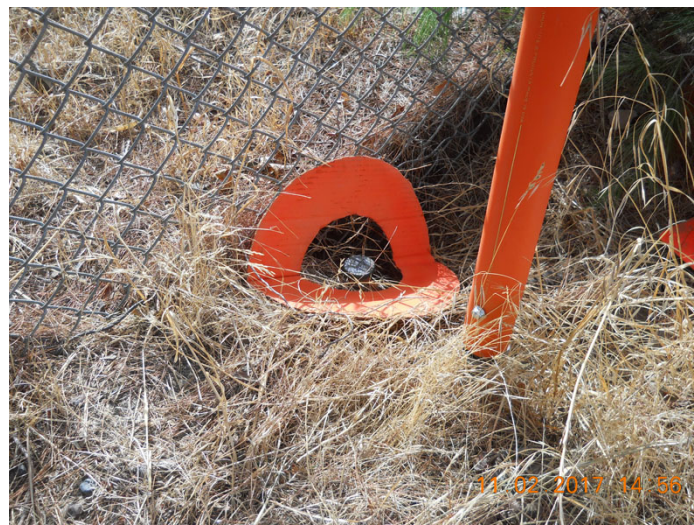
View southwest: Monument 18, within orange ring; delineator near foot of North Levee (photo No. 3407).

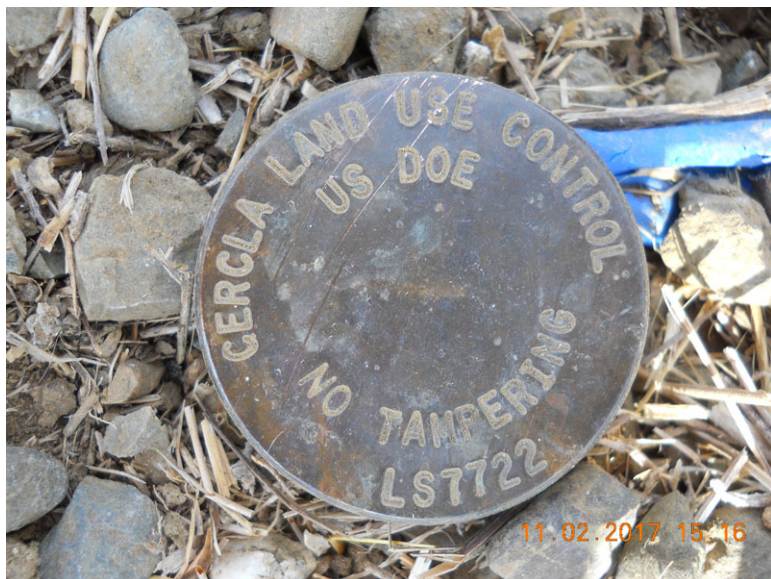
Monument 19: Northwest corner of Eastern Dog Pens Area (photo No. 3413).

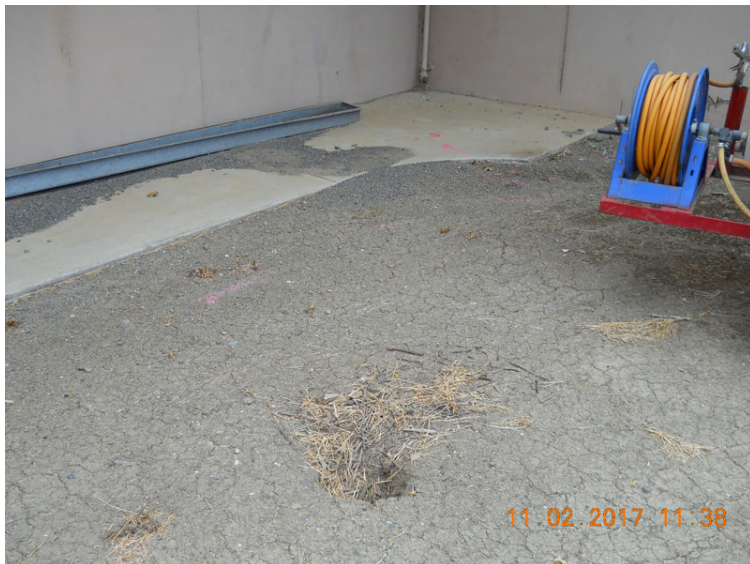
View southeast in unpaved courtyard of Radium/Strontium Treatment Systems Area: Burrowing animal hole in foreground; Building H-218 in background (photo No. 3354).

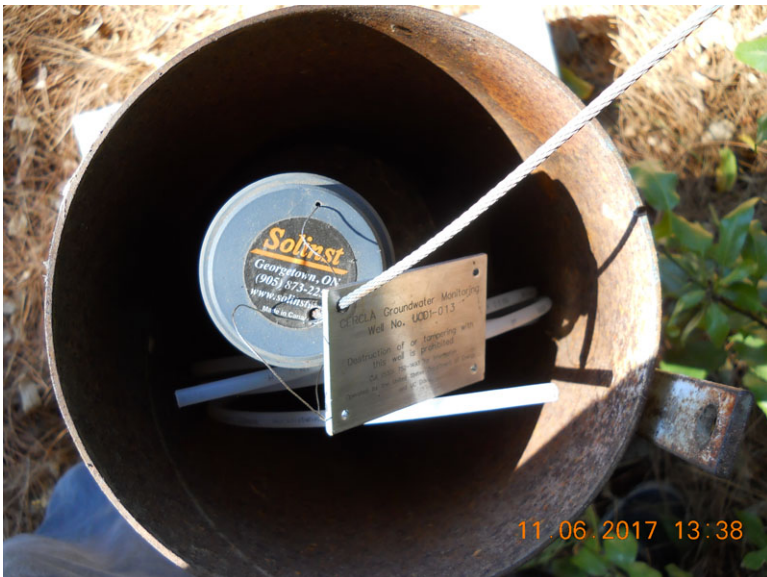
UCD1-013 Wellhead plaque (photo No. 3462).

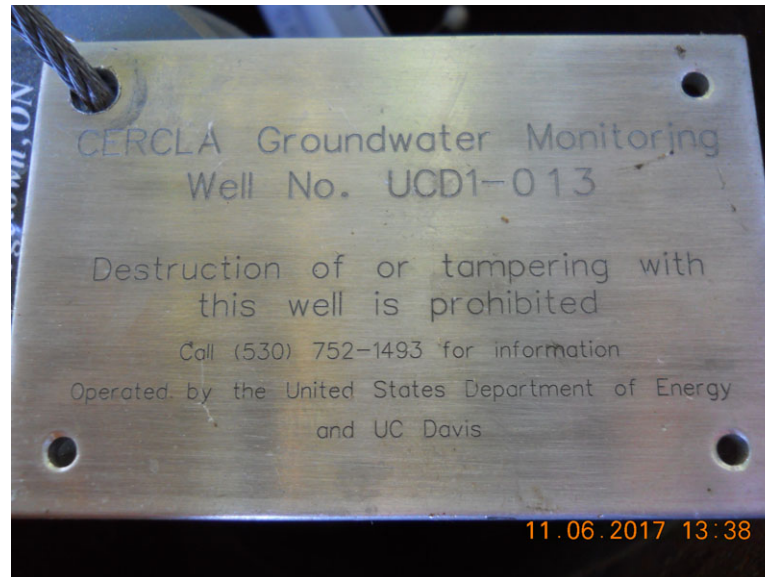
UCD1-013 Interior (photo No. 3463).

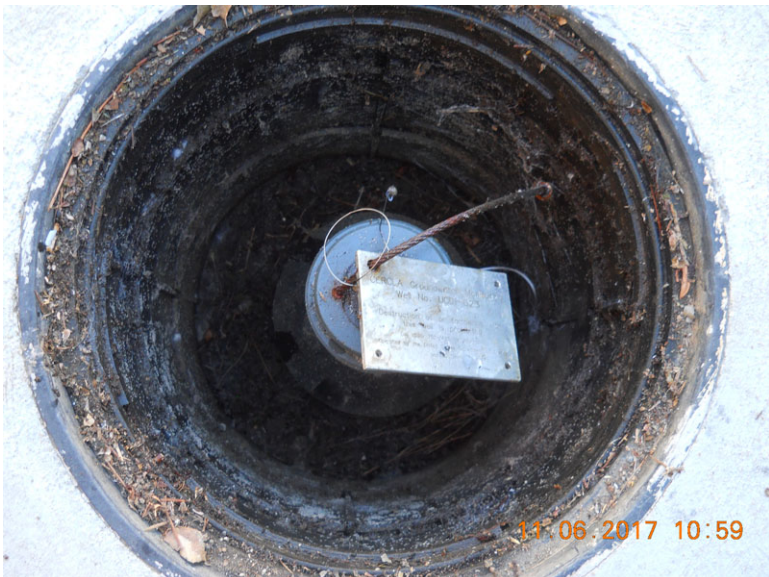
UCD1-023 Wellhead plaque (photo No. 3433).

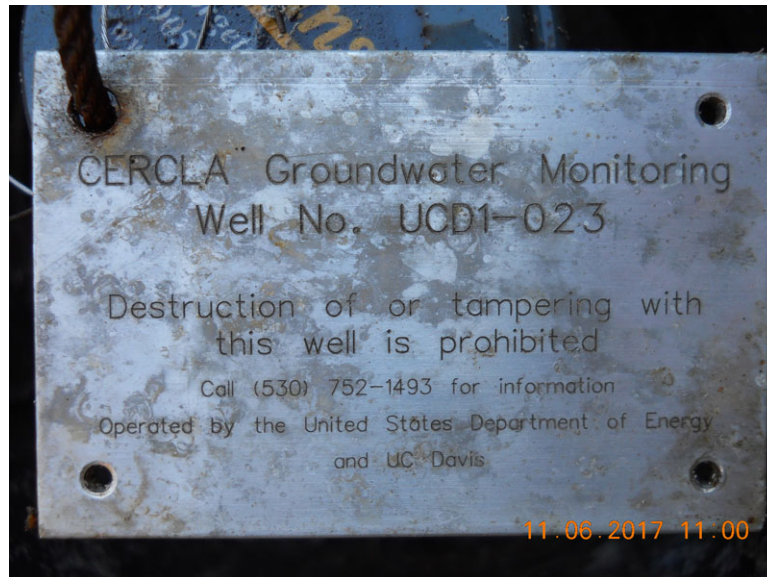
UCD1-023 Interior (photo No. 3434).

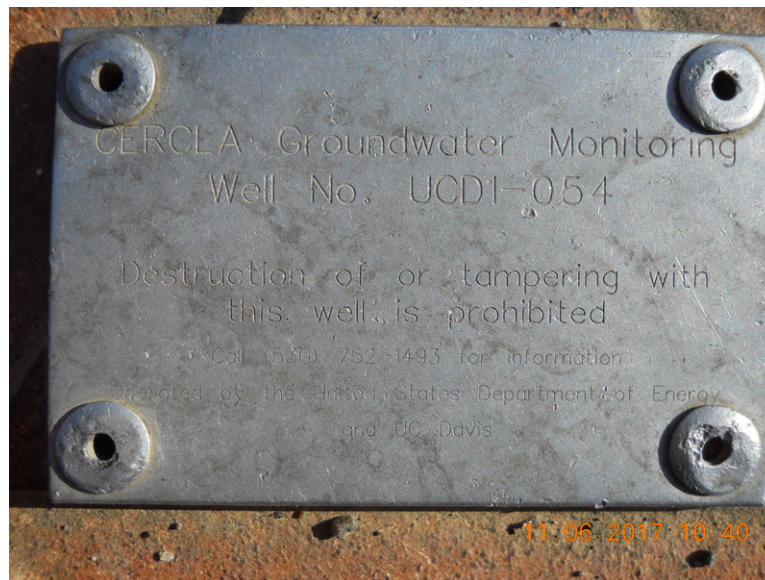
UCD1-054 Wellhead (photo No. 3427).

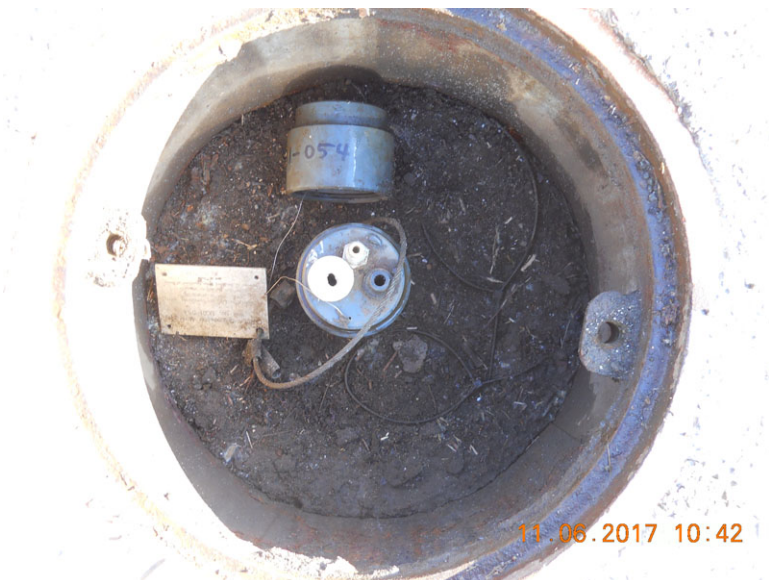
UCD1-054 Wellhead plaque (photo No. 3428).

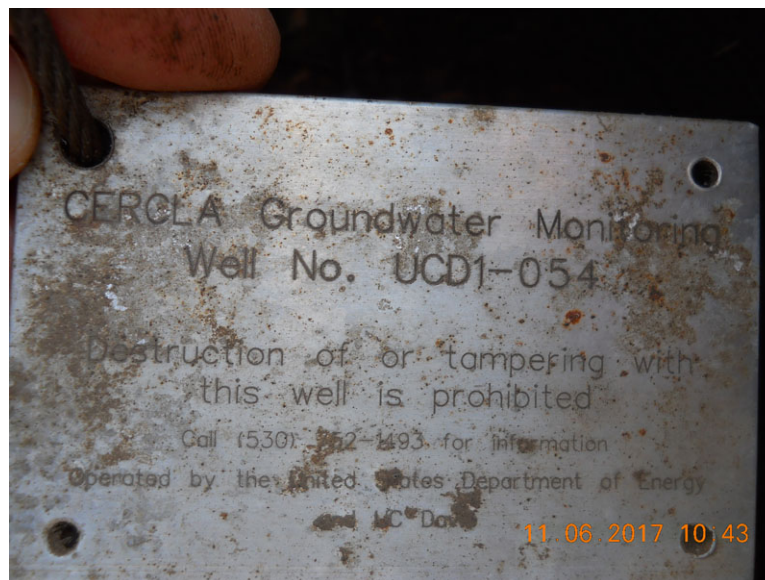
UCD1-054 Interior (photo No. 3429).

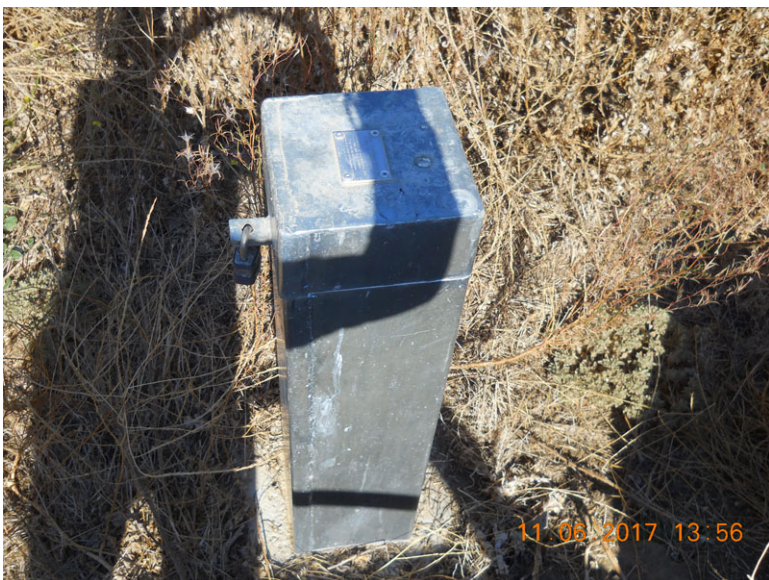
UCD1-054 Interior plaque (photo No. 3430).

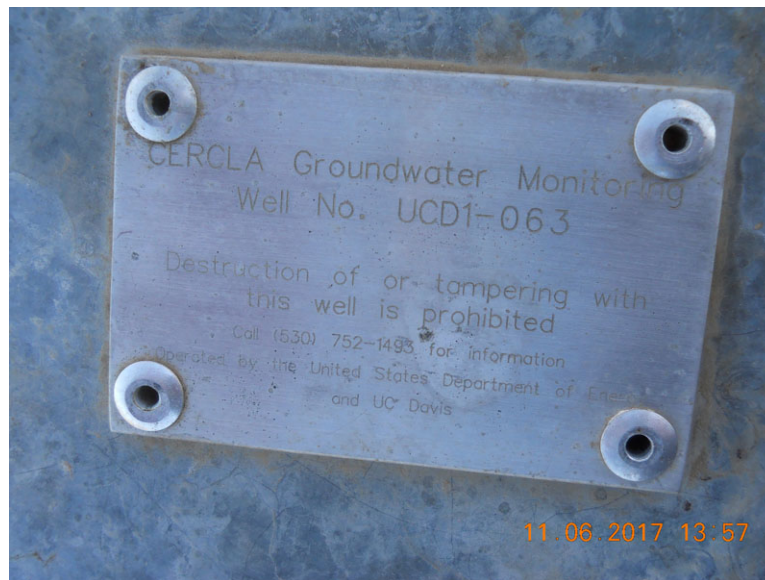
UCD1-063 Wellhead (photo No. 3466).

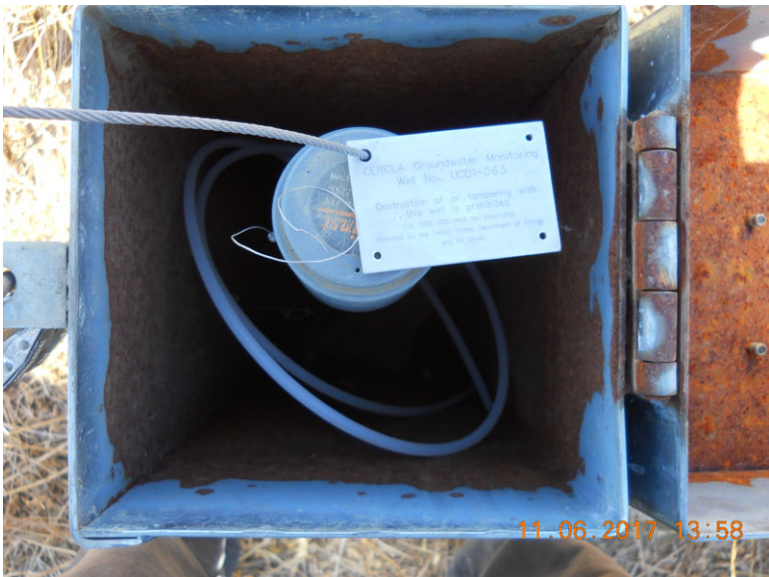
UCD1-063 Wellhead plaque (photo No. 3467).

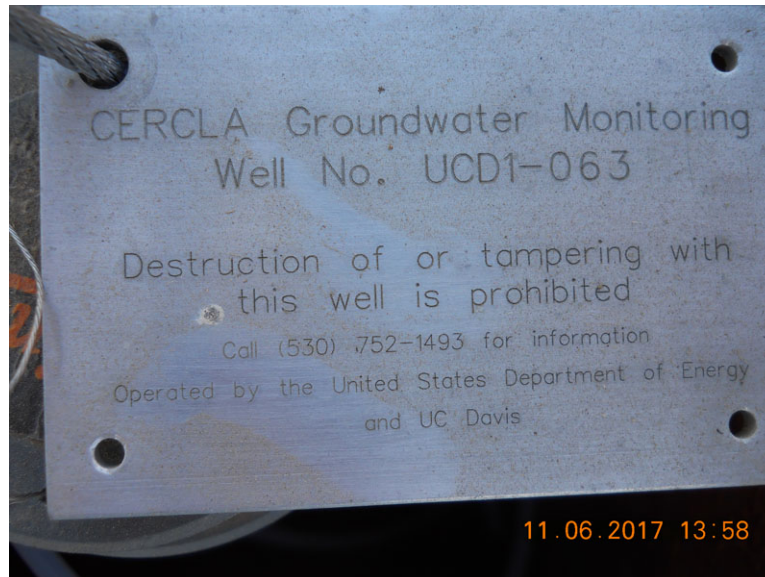
UCD1-063 Interior (photo No. 3468).

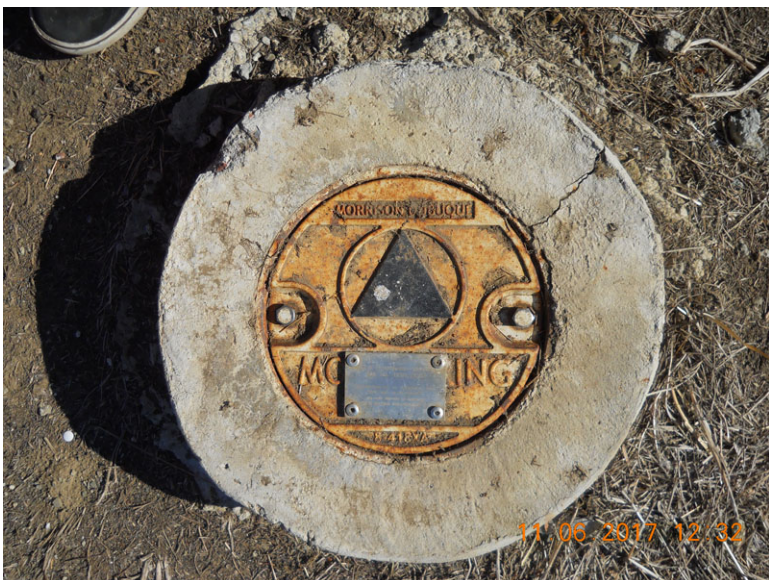
UCD1-063 Interior plaque (photo No. 3469).

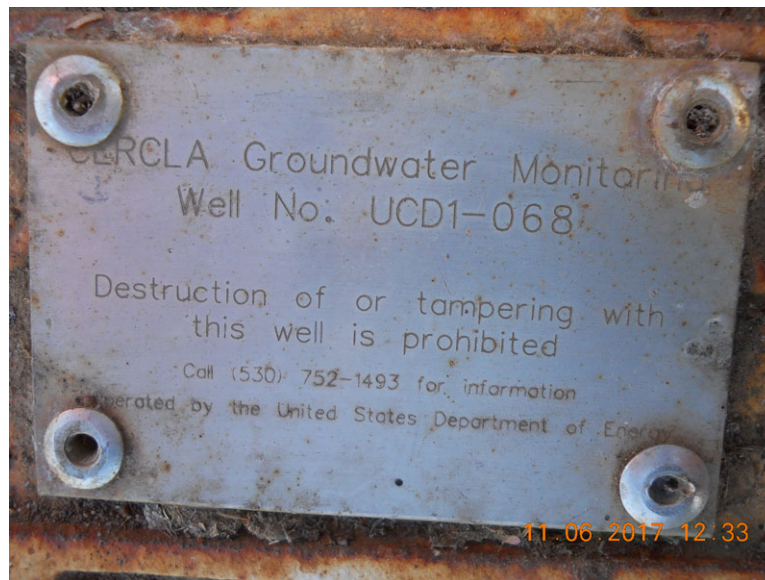
UCD1-068 Wellhead (photo No. 3452).

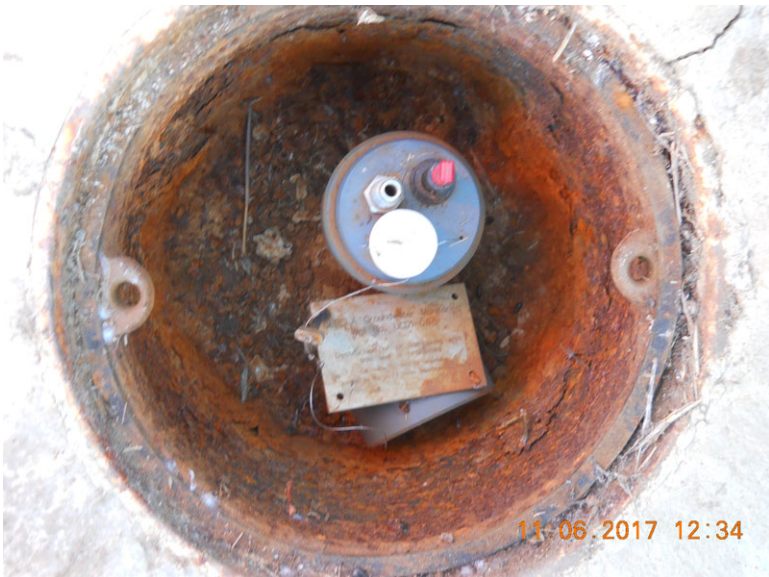
UCD1-068 Wellhead plaque (photo No. 3453).

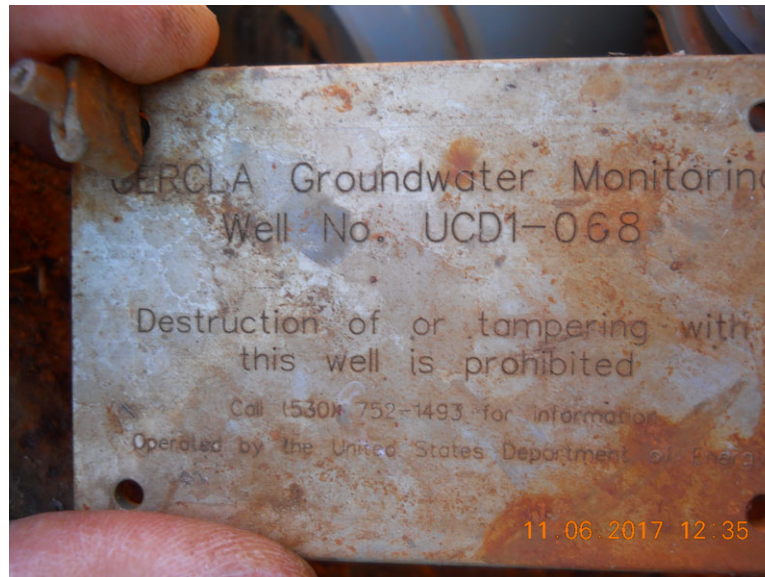
UCD1-068 Interior (photo No. 3454).
