**2017 Annual Land-Use Covenant
Inspection Report
for DOE Areas at the Laboratory
for Energy-Related Health
Research/Old Campus Landfill
Superfund Site
University of California, Davis**

January 2018

U.S. DEPARTMENT OF
ENERGY

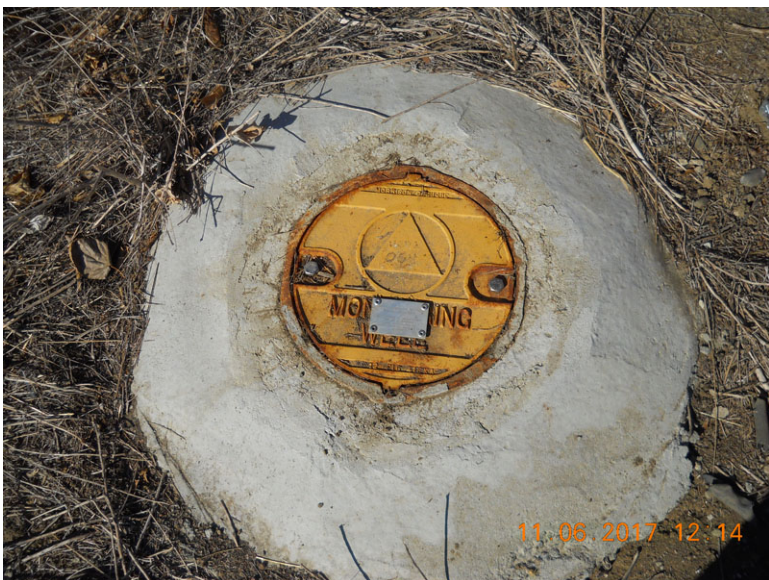
UCD1-068 Interior plaque (photo No. 3455).

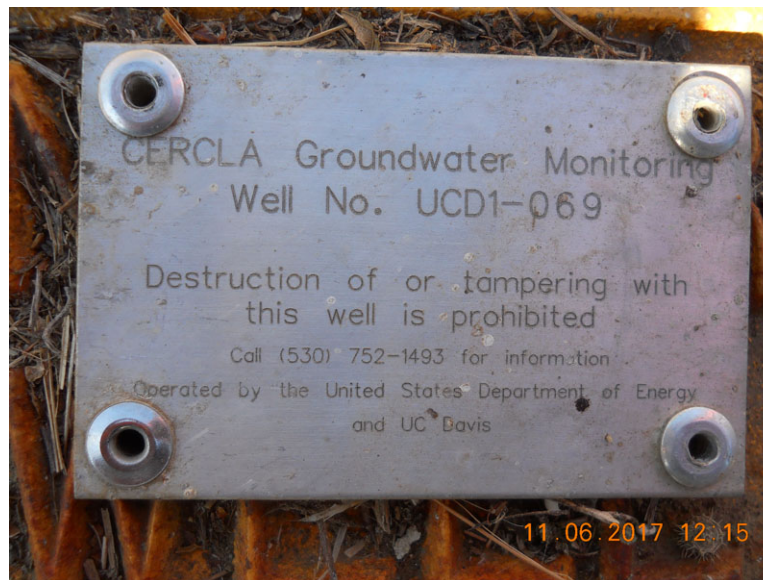
UCD1-069 Wellhead (photo No. 3448).

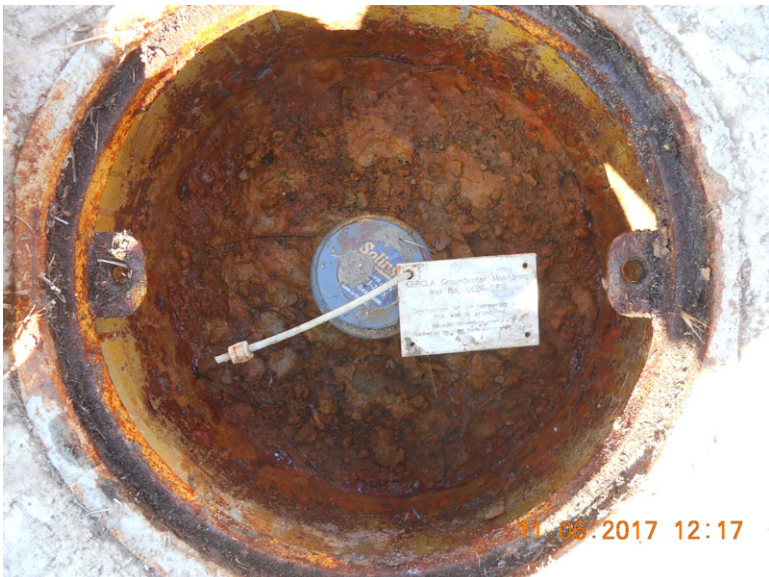
UCD1-069 Wellhead plaque (photo No. 3449).

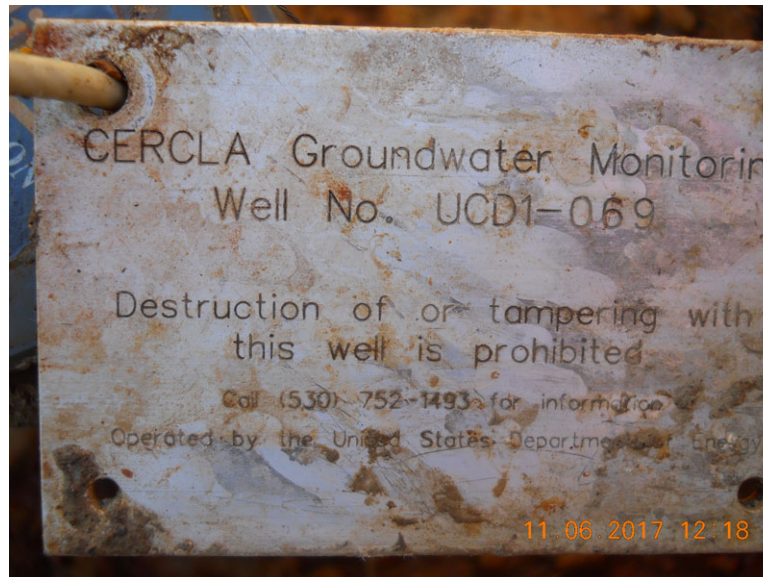
UCD1-069 Interior (photo No. 3450).

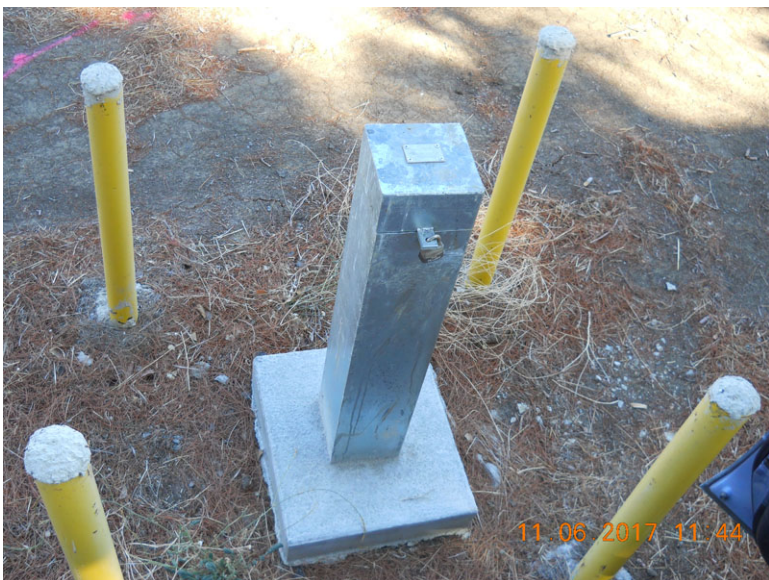
UCD1-069 Interior plaque (photo No. 3451).

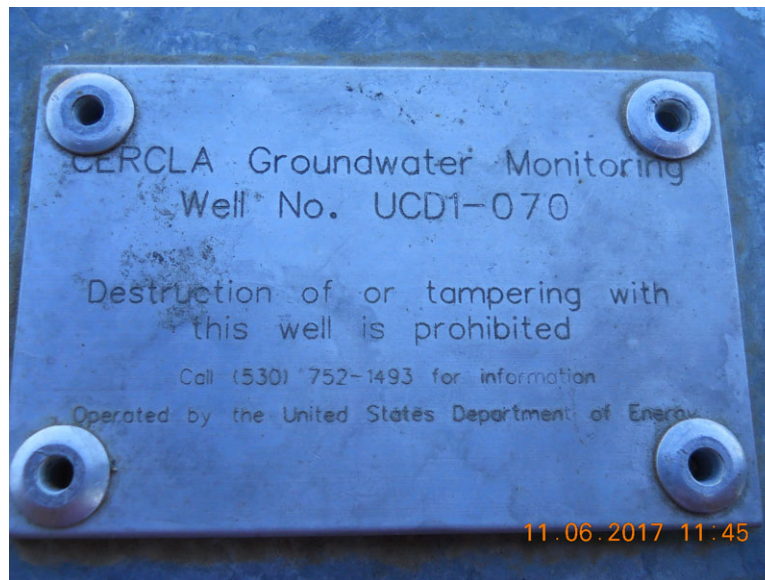
UCD1-070 Wellhead (photo No. 3443).

*Well UCD1-070 after concrete apron replacement
(photo No. 3443).*

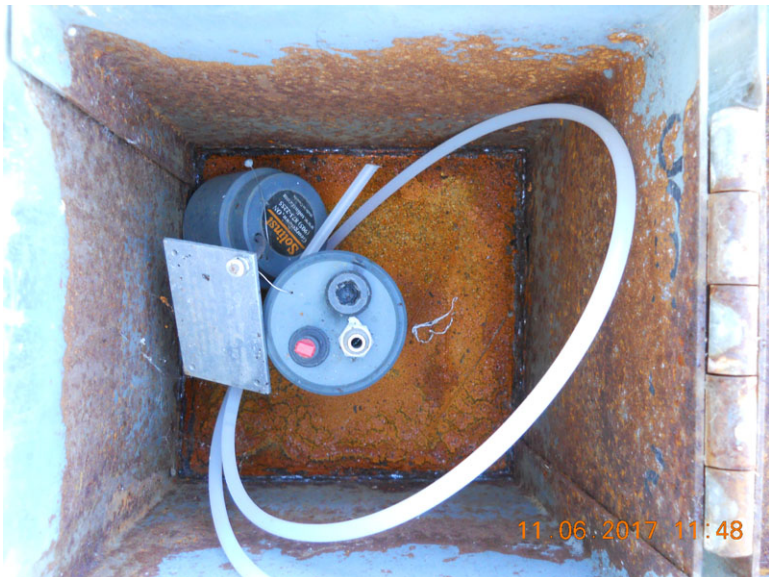
UCD1-070 Wellhead plaque (photo No. 3444).

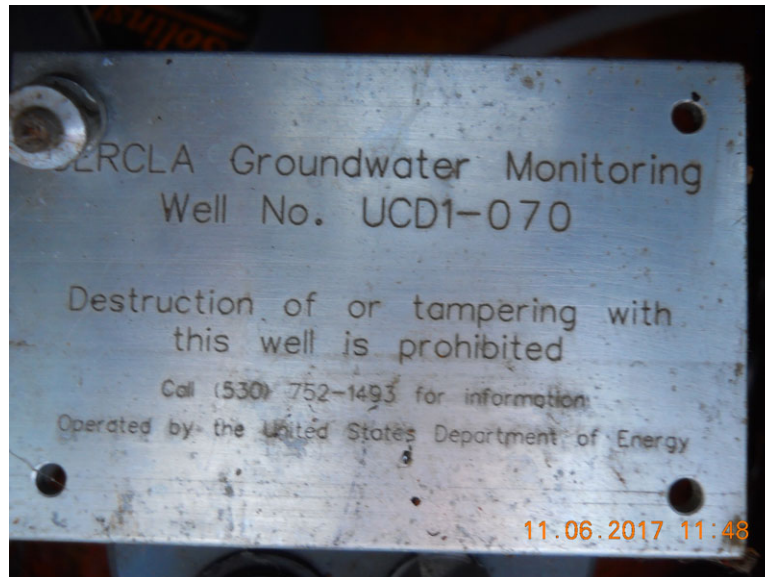
UCD1-070 Interior (photo No. 3446).

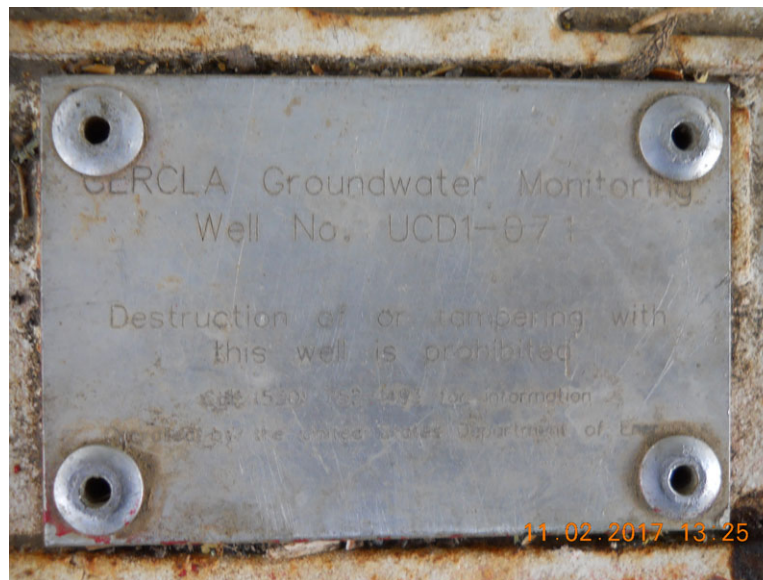
UCD1-071 Wellhead (photo No. 3377).

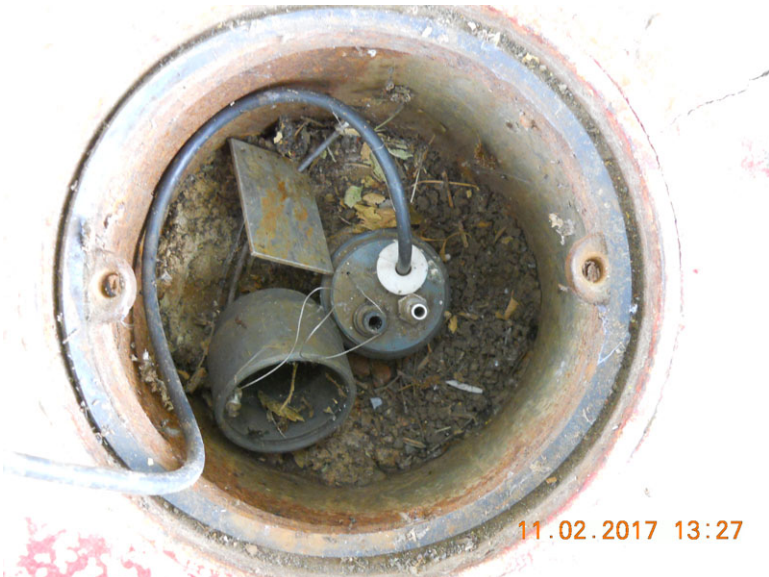
UCD1-071 Wellhead plaque (photo No. 3378).

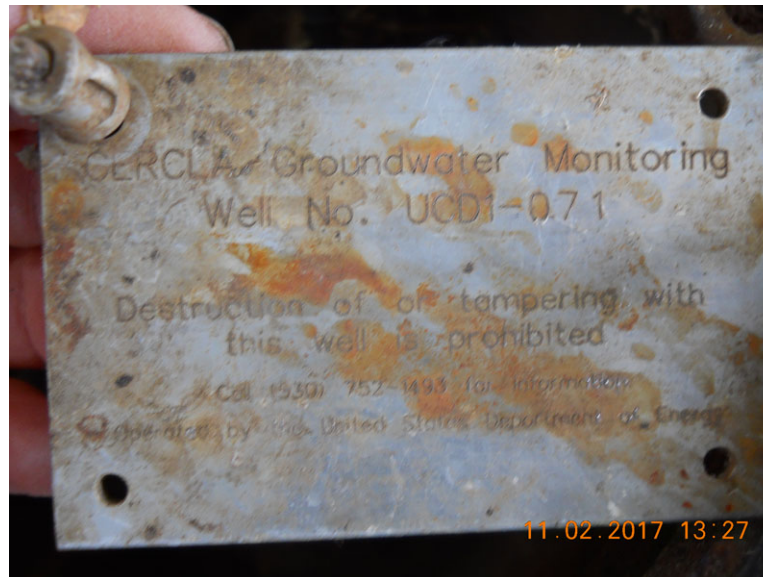
UCD1-071 Interior (photo No. 3379).

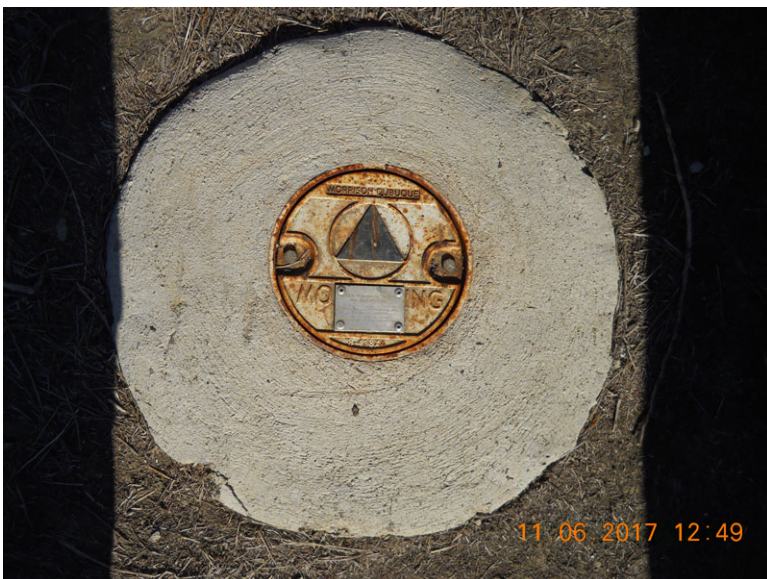
UCD1-071 Interior plaque (photo No. 3380).

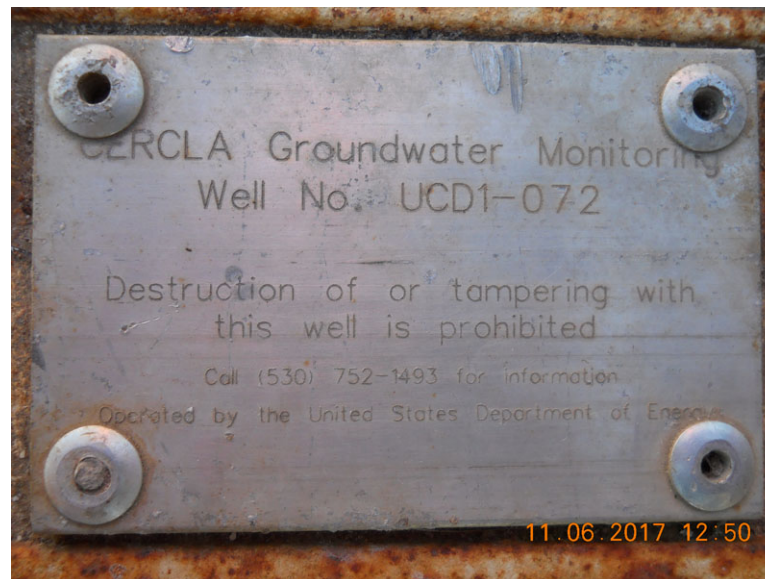
UCD1-072 Wellhead (photo No. 3456).

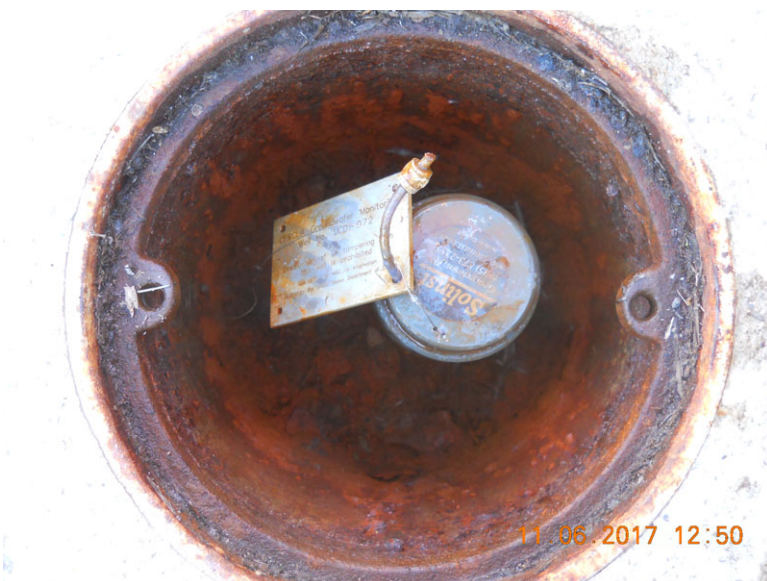
UCD1-072 Wellhead plaque (photo No. 3457).

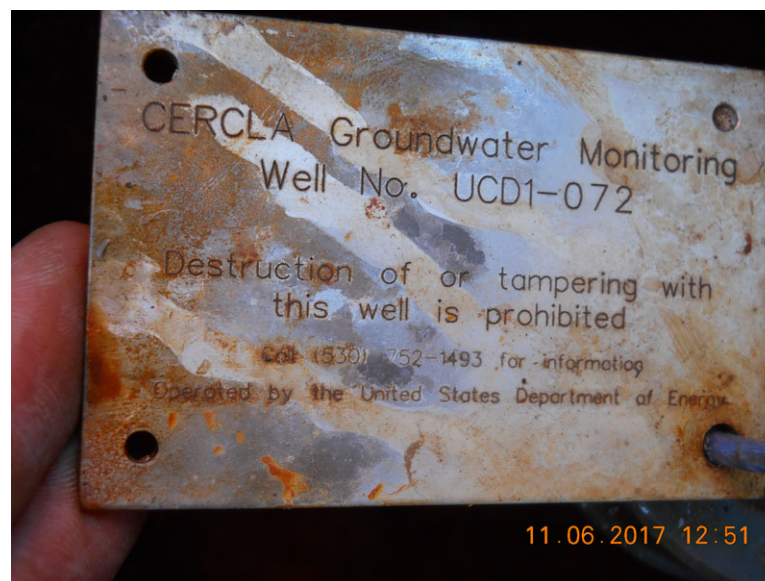
UCD1-072 Interior (photo No. 3458).

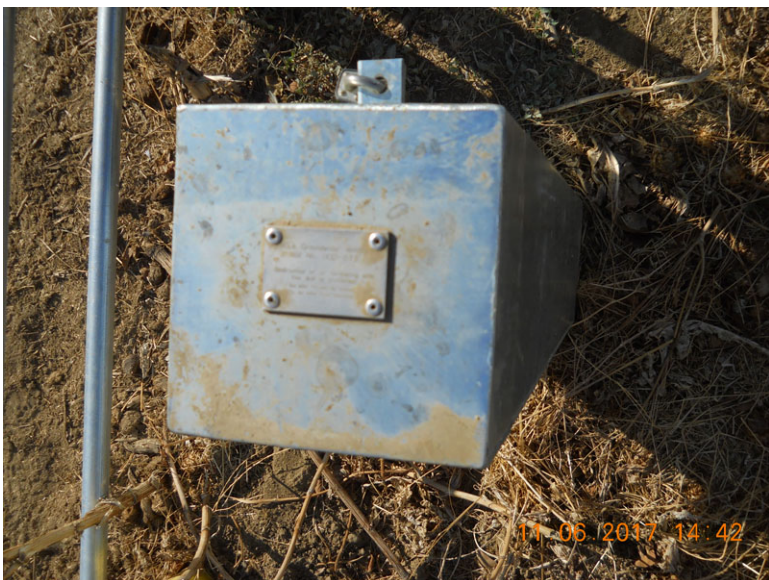
UCD1-073 Wellhead (photo No. 3476).

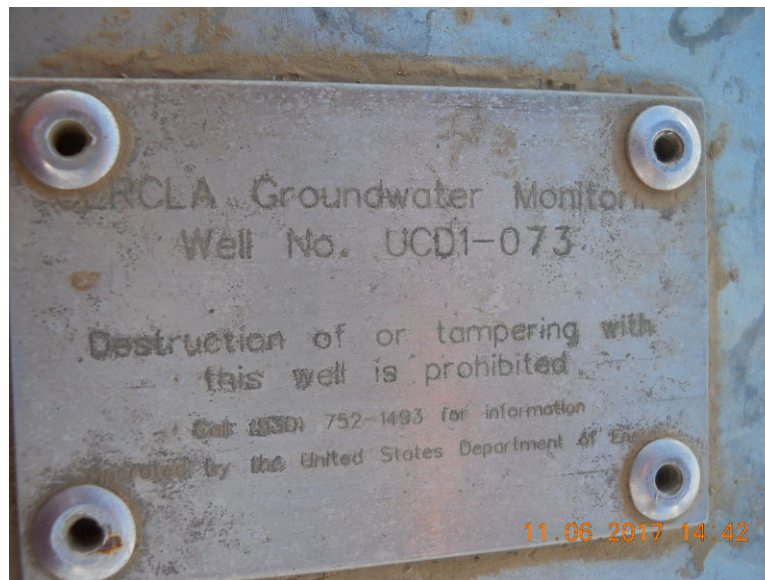
UCD1-073 Wellhead plaque (photo No. 3477).

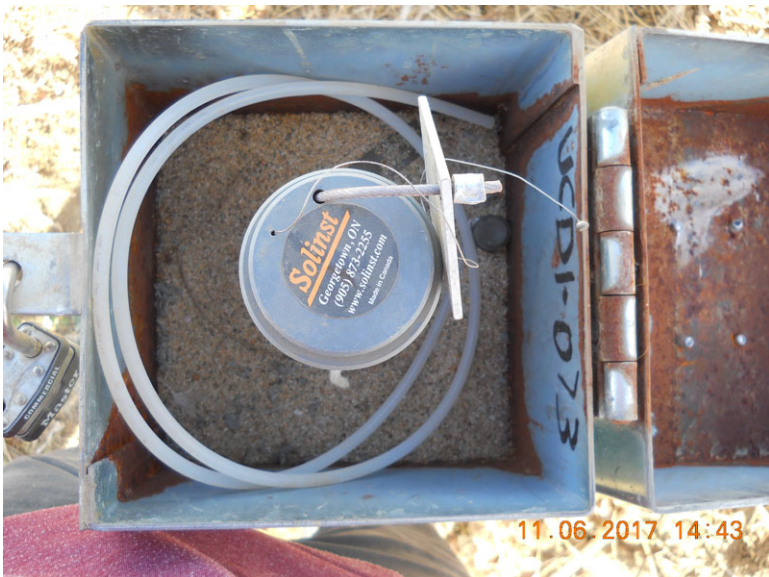
UCD1-073 Interior (photo No. 3478).

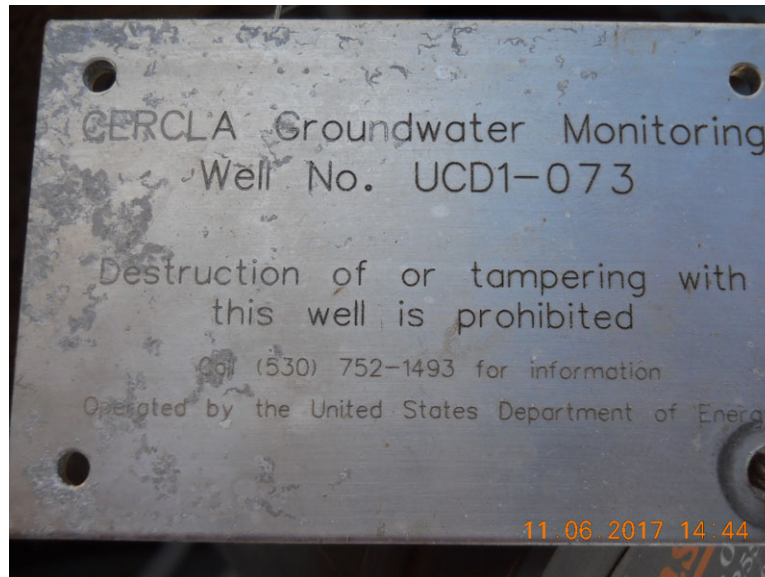
UCD1-073 Interior plaque (photo No. 3479).

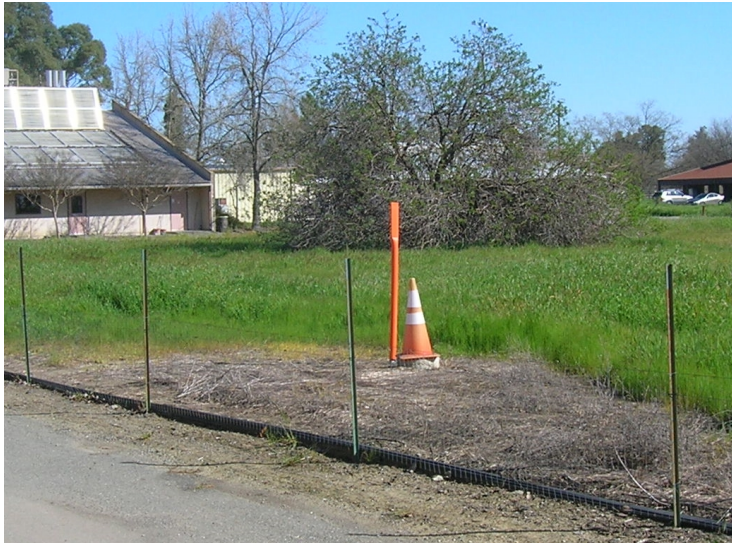
Well UCD1-068 delineator.

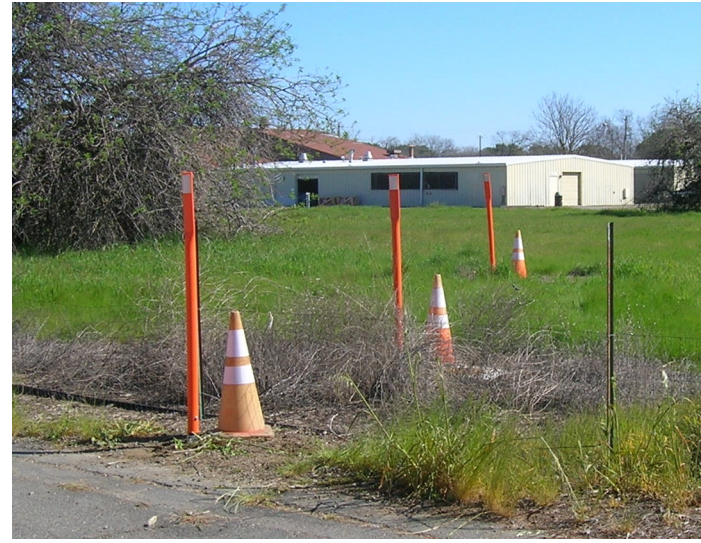
Well UCD1-069 delineator center. Monument 10 delineator foreground left. Monument 11 delineator background right.

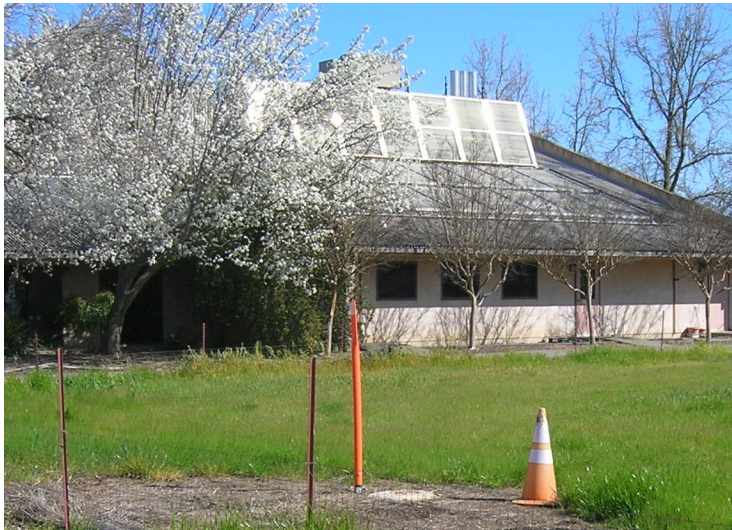
Well UCD1-072 delineator.
