**2018 Annual Land-Use Covenant
Inspection Report
for DOE Areas at the Laboratory
for Energy-Related Health
Research/Old Campus Landfill
Superfund Site
University of California, Davis**

January 2019

U.S. DEPARTMENT OF
ENERGY

Legacy
Management

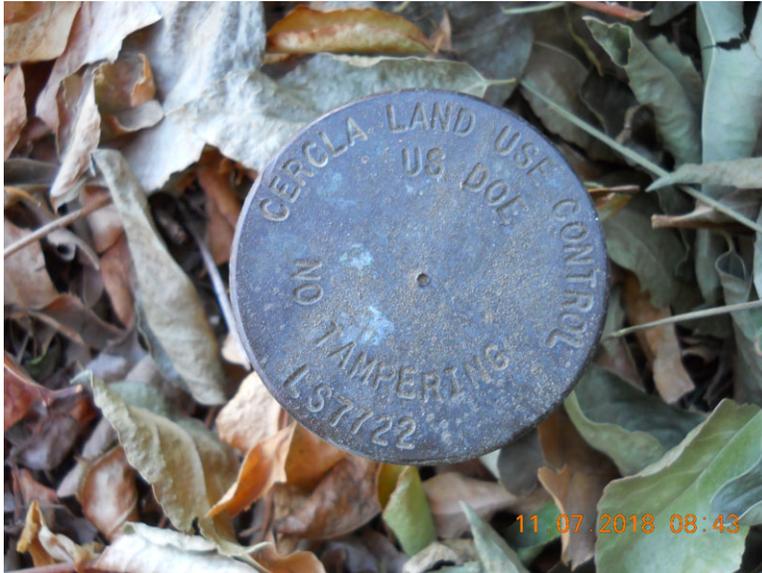
Survey Monument 1: Northwest corner of Dry Wells A-E Area (photo No. 3588).

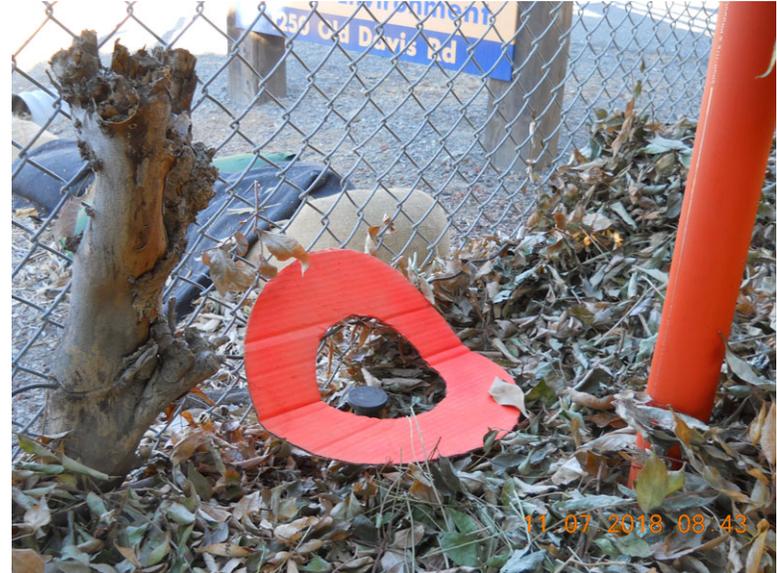
View northwest: Survey Monument 1, within orange ring (outside diameter is 14 inches) in foreground; entrance sign in background (photo No. 3589).

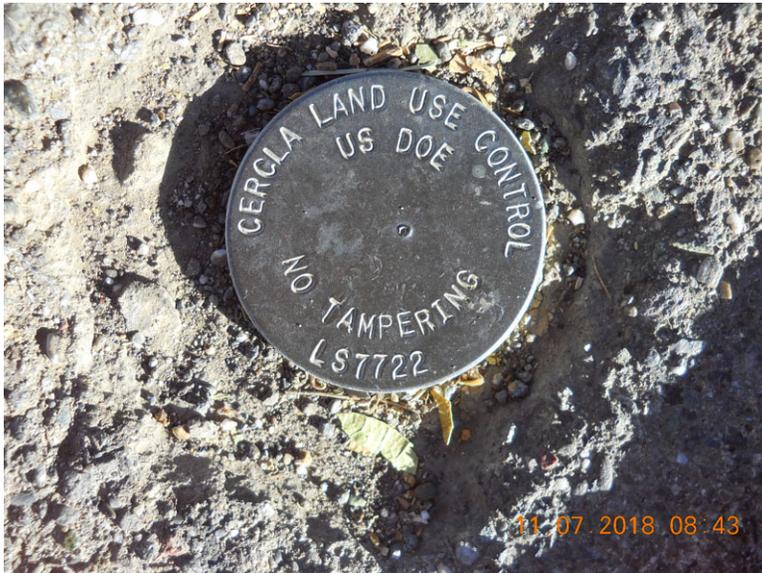
Survey Monument 2: Northeast corner of Dry Wells A-E Area (photo No. 3590).

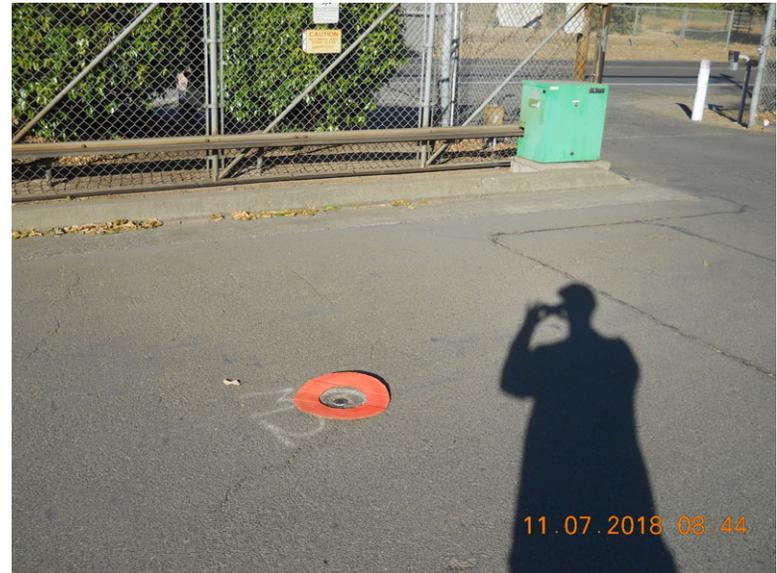
View northwest: Survey Monument 2, within orange ring; entrance and retracted entrance gate in background (photo No. 3591).

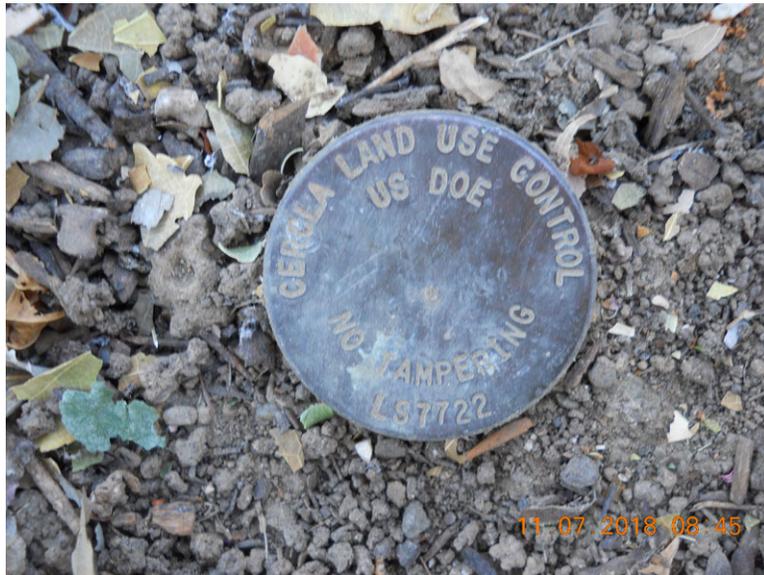
Survey Monument 3: Southwest corner of Dry Wells A–E Area (photo No. 3592).

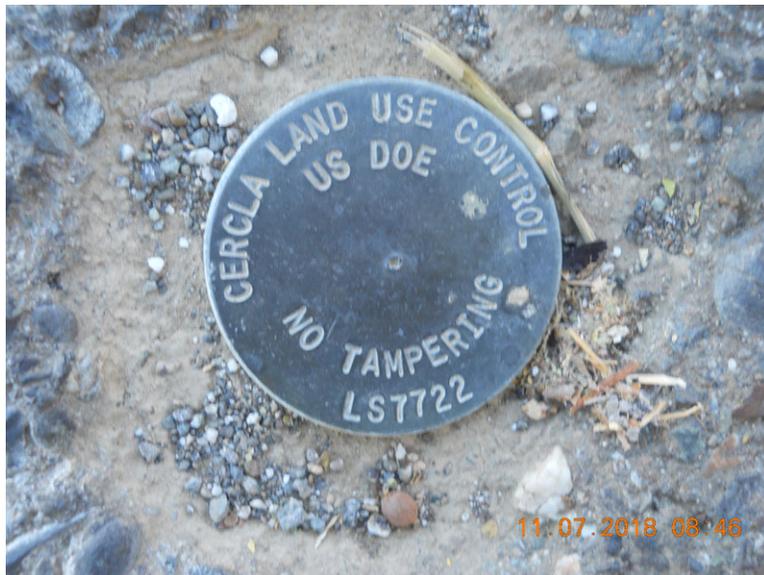
Survey Monument 4: Southeast corner of Dry Wells A–E Area (photo No. 3594).

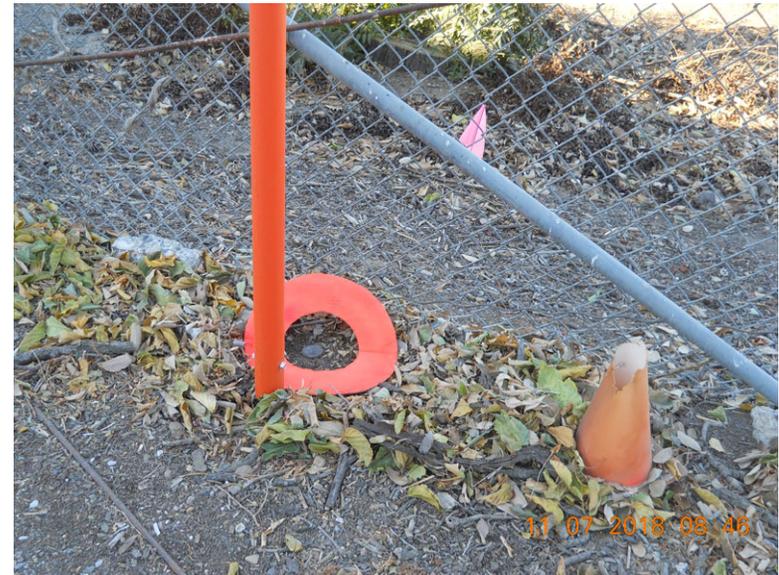
View southwest: Survey Monument 3, within orange ring; west perimeter fence behind survey monument; delineator left of survey monument (photo No. 3593).

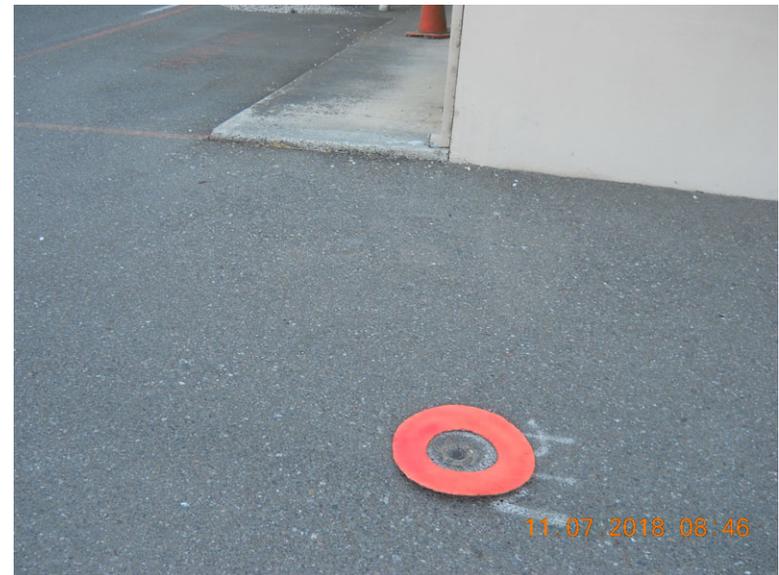
View east: Survey Monument 4, within orange ring; Building H-219 in background (photo No. 3595).

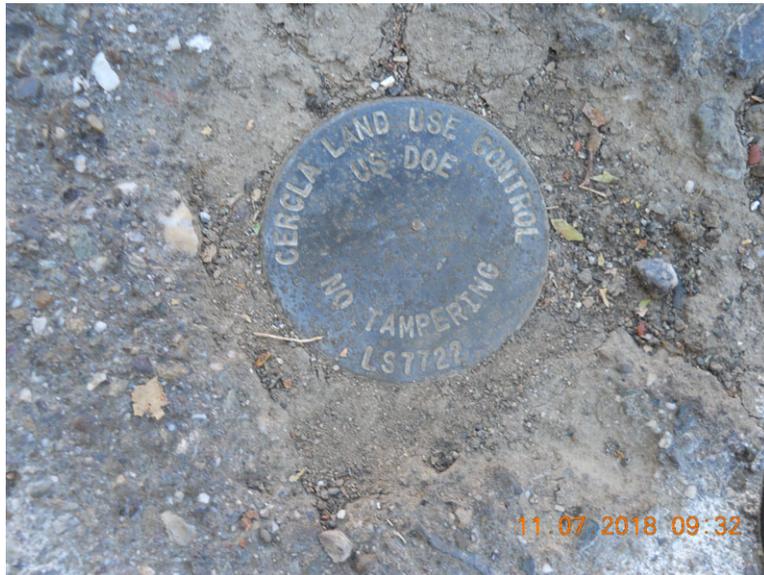
Survey Monument 5: Northwest corner of Domestic Septic System 4 Area (photo No. 3613).

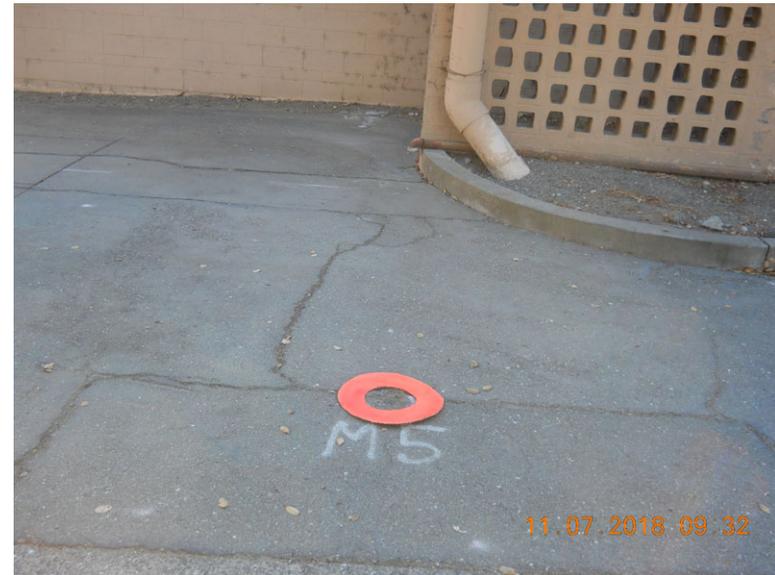
View east: Survey Monument 5, within orange ring; Building H-215 in background (photo No. 3614).

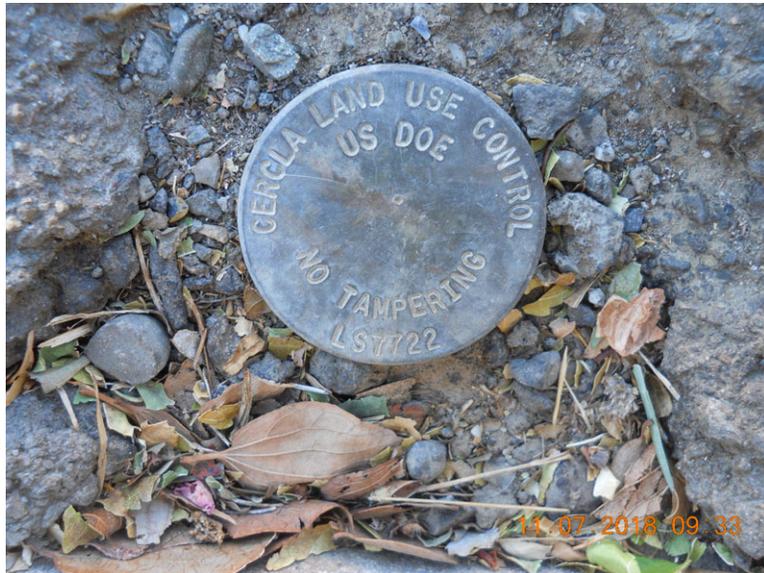
Survey Monument 6: Adjacent to northwest corner of Building H-218; Radium/Strontium Treatment Systems Area (photo No. 3615).

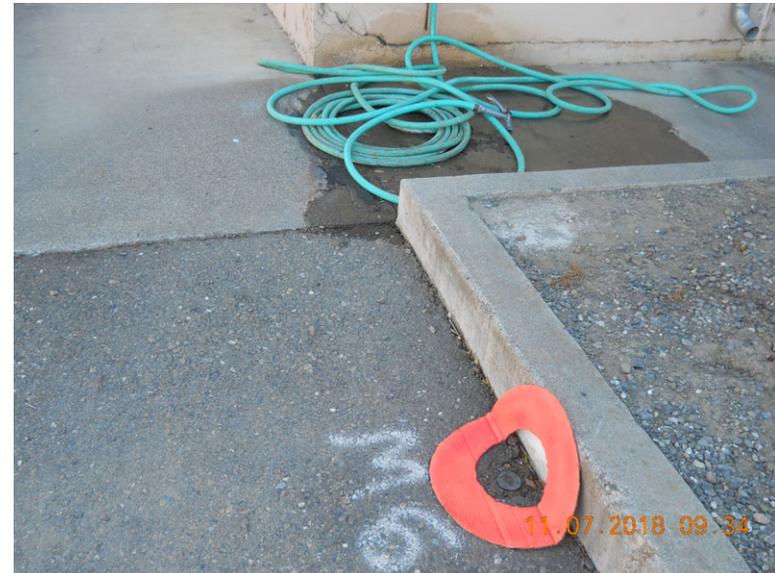
View east: Survey Monument 6, within orange ring; corner of Building H-218 in background (photo No. 3616).

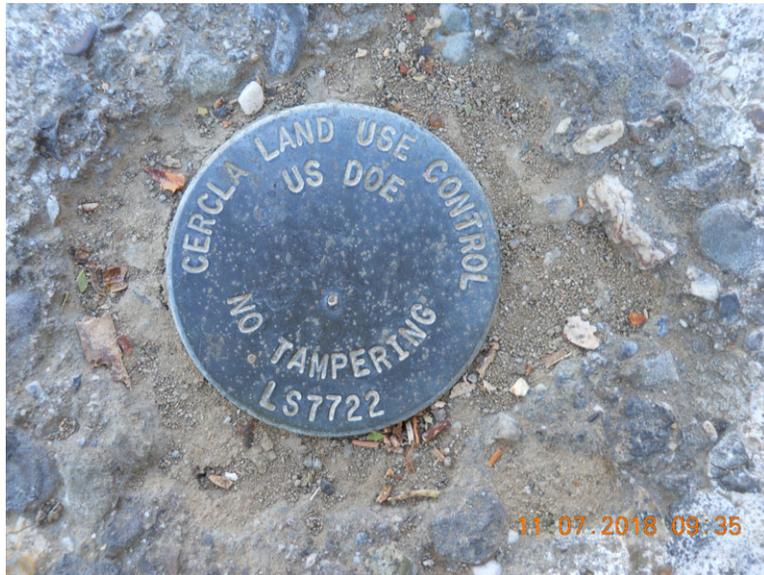
Survey Monument 7: Southwest corner of Domestic Septic System 4 Area (photo No. 3617).

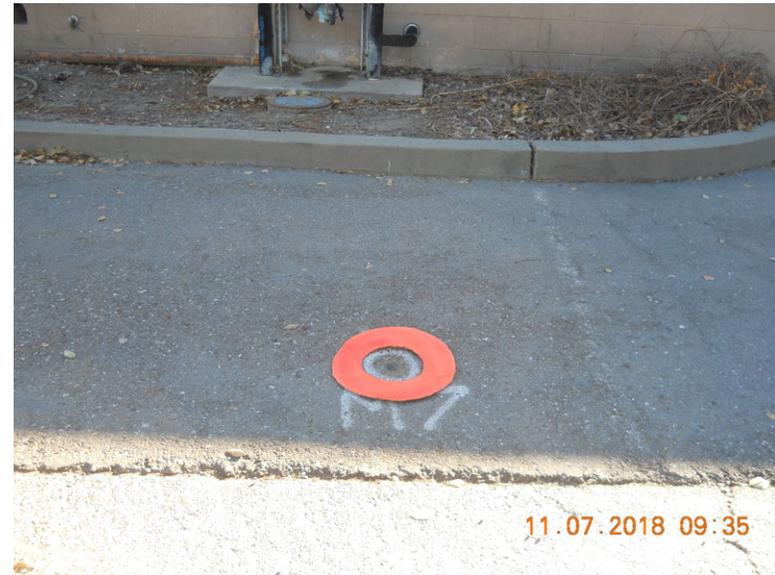
View east: Survey Monument 7, within orange ring; Building H-215 in background (photo No. 3618).

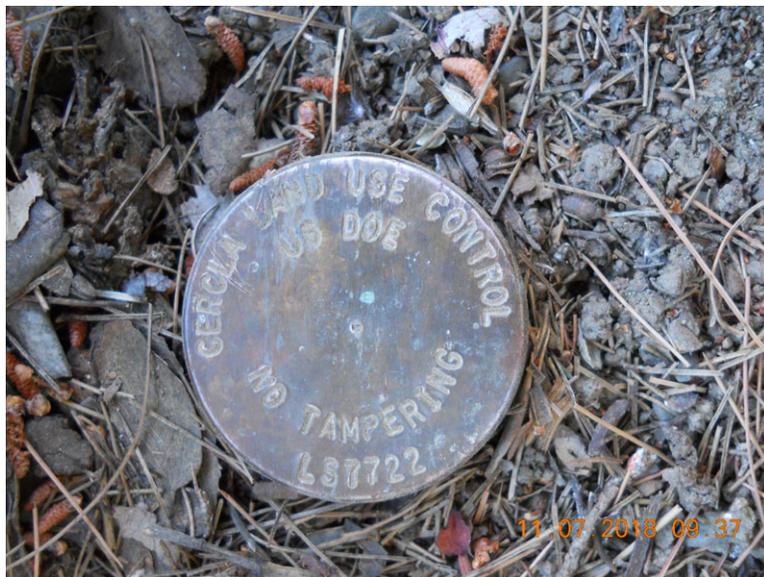
Survey Monument 8: Southwest corner of radium-226 leach trench; Radium/Strontium Treatment Systems Area (photo No. 3619).

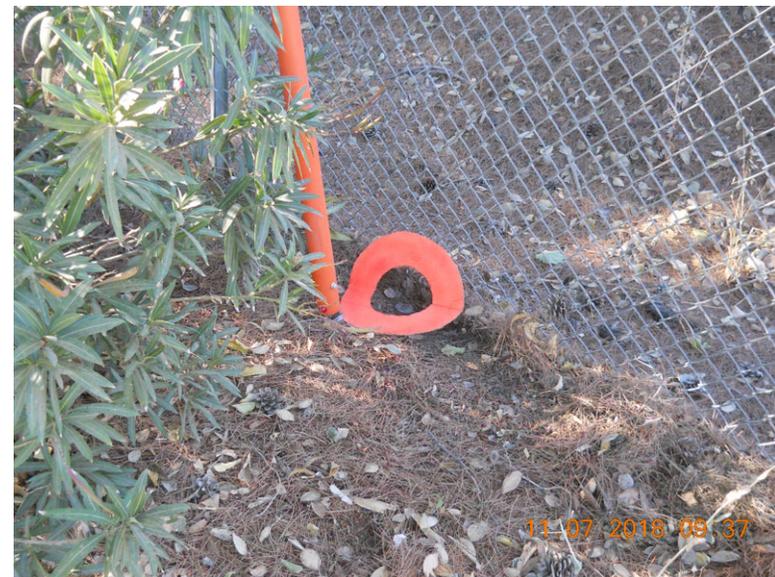
View southwest: Survey Monument 8, within orange ring; west perimeter fence right of survey monument; delineator left of survey monument (photo No. 3620).

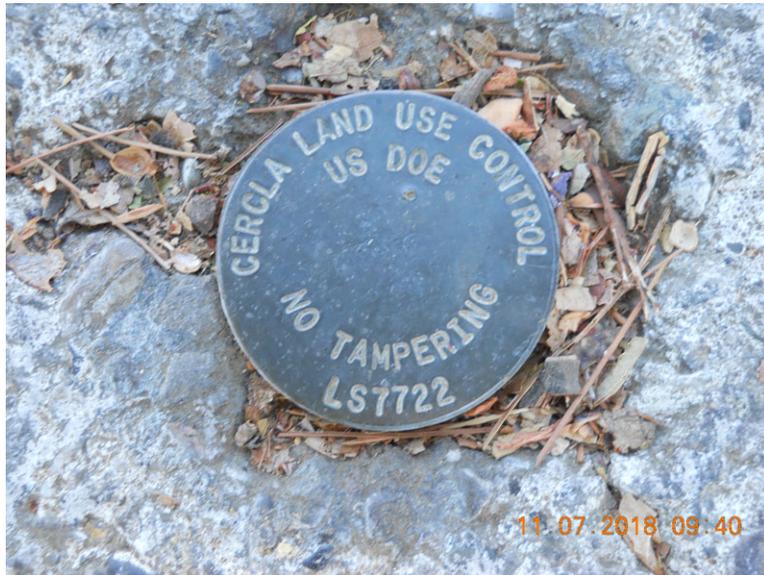
Survey Monument 9: Southeast corner of radium-226 leach trench; Radium/Strontium Treatment Systems Area (photo No. 3621).

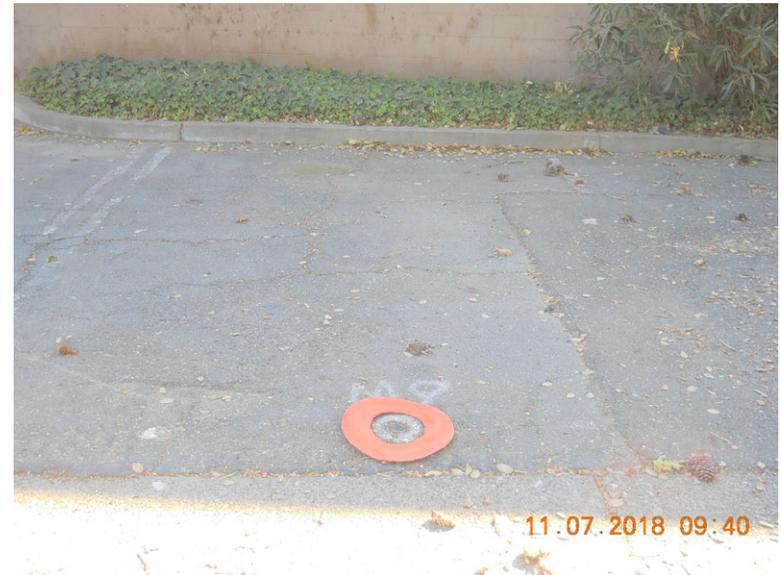
View east: Survey Monument 9, within orange ring; Building H-215 in background (photo No. 3622).

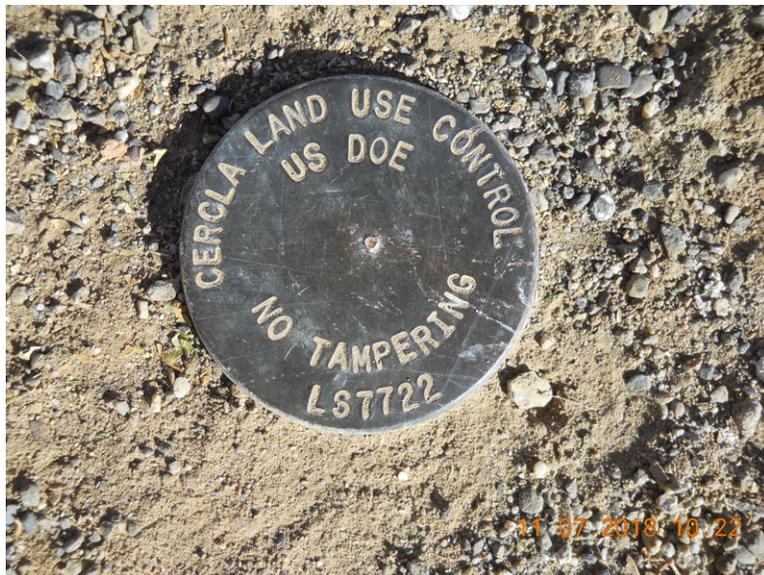
Survey Monument 10: Northeast corner of former leach field in Domestic Septic System 3 Area (photo No. 3636).

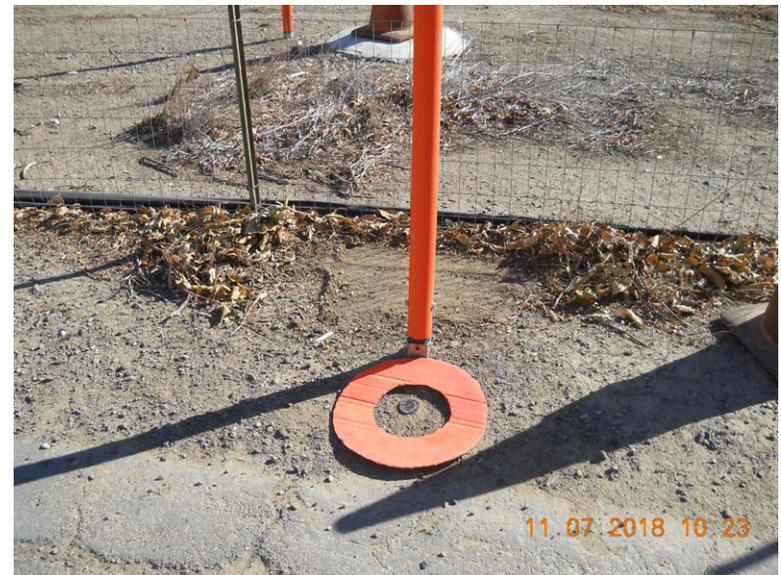
View east: Survey Monument 10, within orange ring in foreground; delineator behind survey monument; well UCD1-069 in background (photo No. 3638).

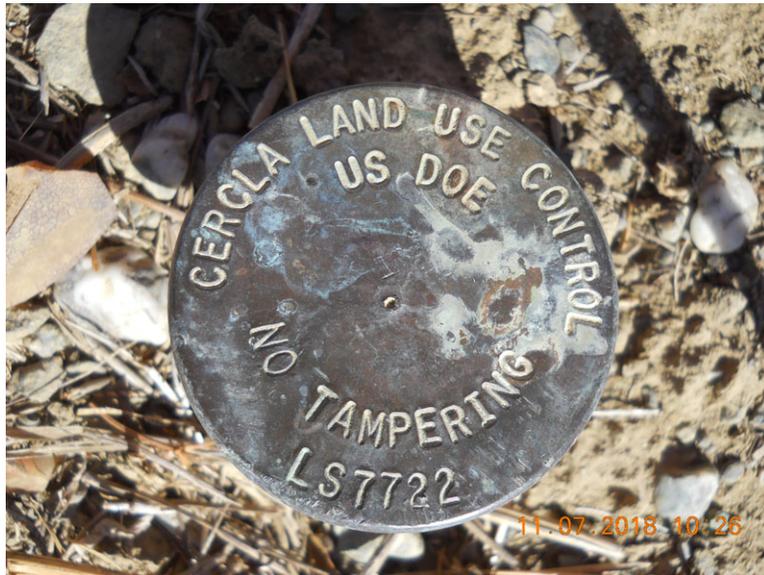
Survey Monument 11: Northeast corner of Eastern Remediation Support Area (photo No. 3639).

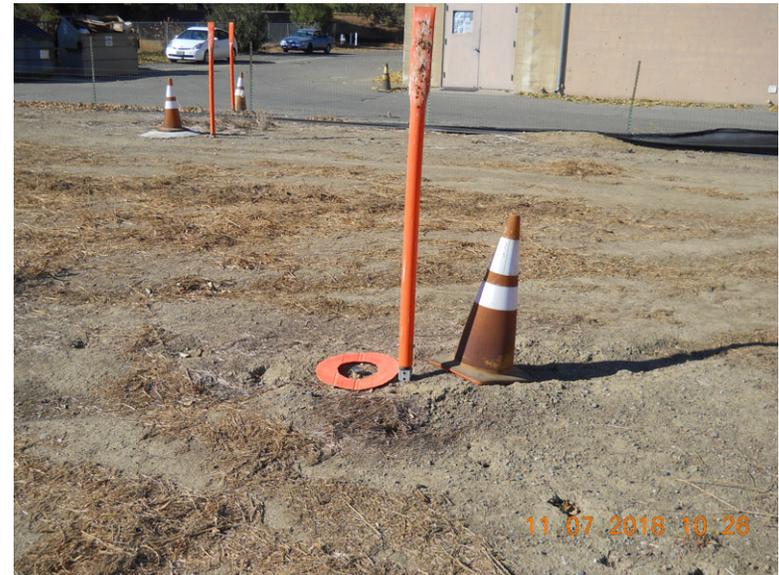
View west: Survey Monument 11, within orange ring; delineator right of survey monument; Building H-216 in background (photo No. 3640).

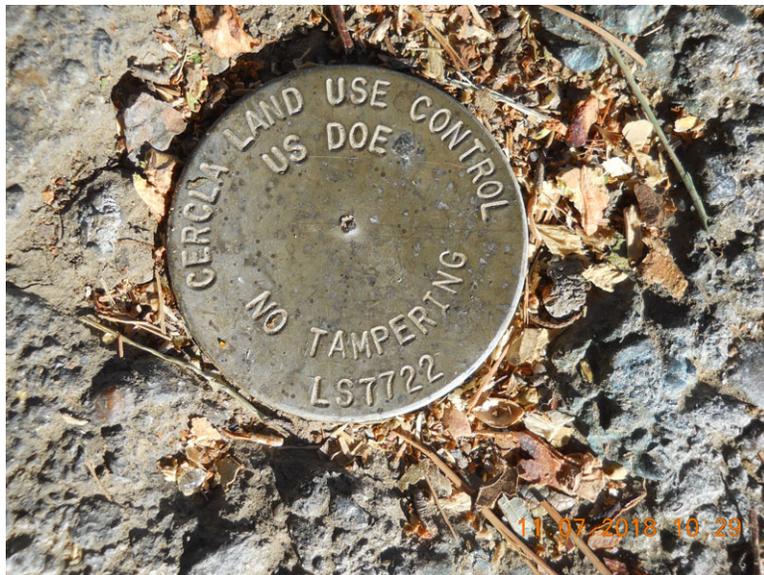
Survey Monument 12: Northwest corner of Southwest Trenches Area (photo No. 3641).

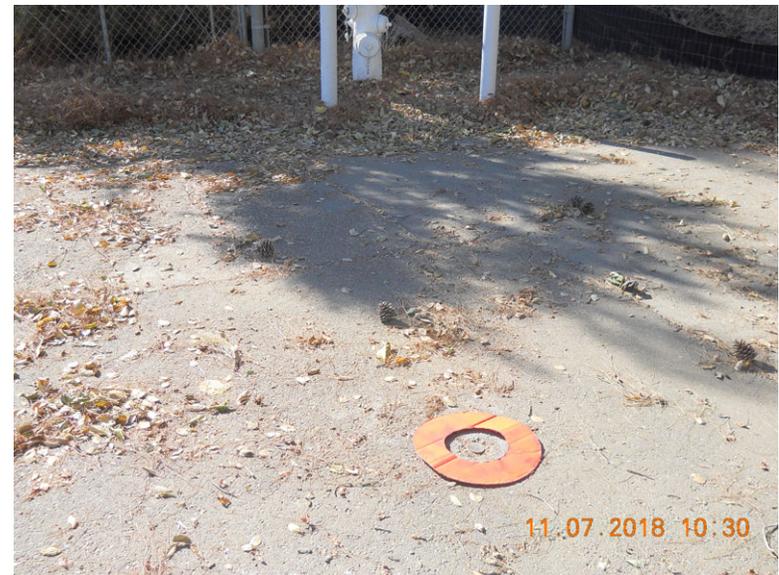
View south: Survey Monument 12, within orange ring in foreground; water hydrant in background (photo No. 3642).

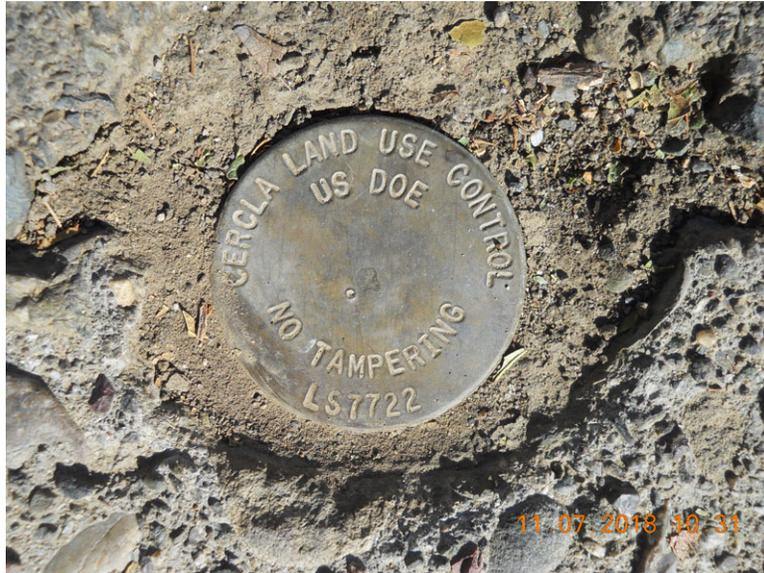
Survey Monument 13: Southwest corner of Domestic Septic System 3 Area, at northern perimeter of Southwest Trenches Area (photo No. 3643).

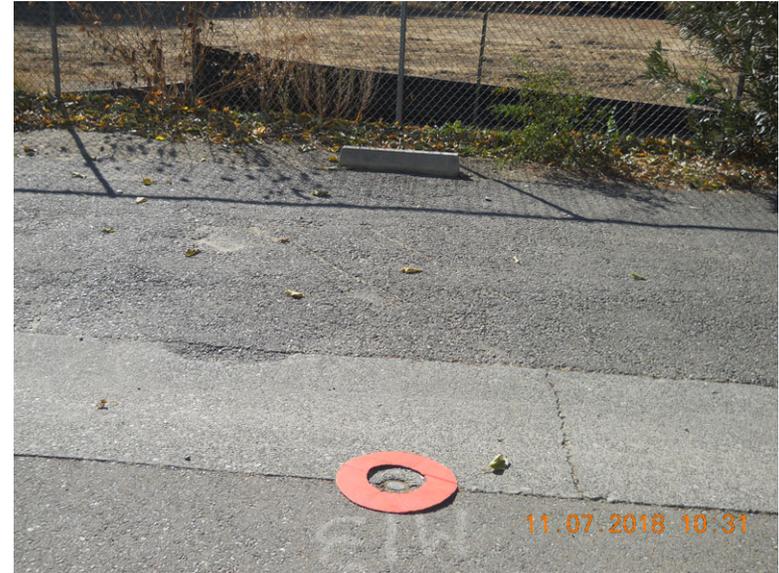
View south: Survey Monument 13, within orange ring at edge of concrete swale; Southwest Trenches Area in background (photo No. 3644).

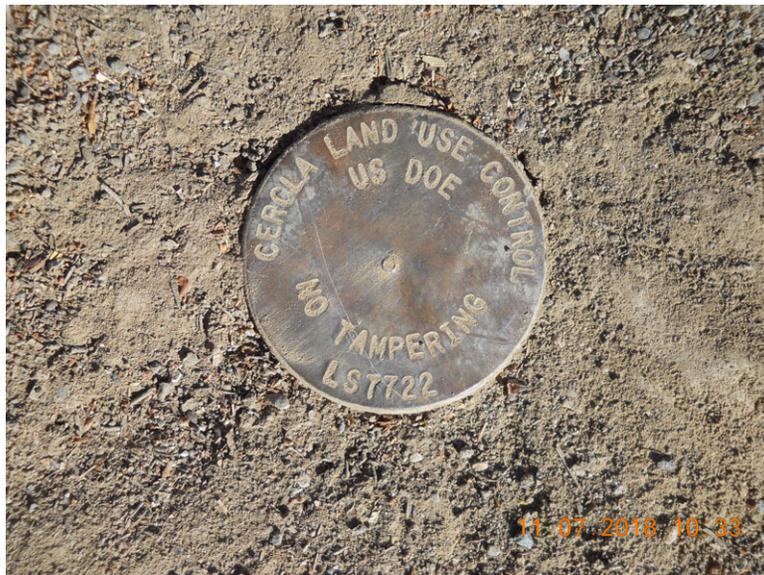
Survey Monument 14: Southeast corner of Domestic Septic System 3 Area (photo No. 3645).

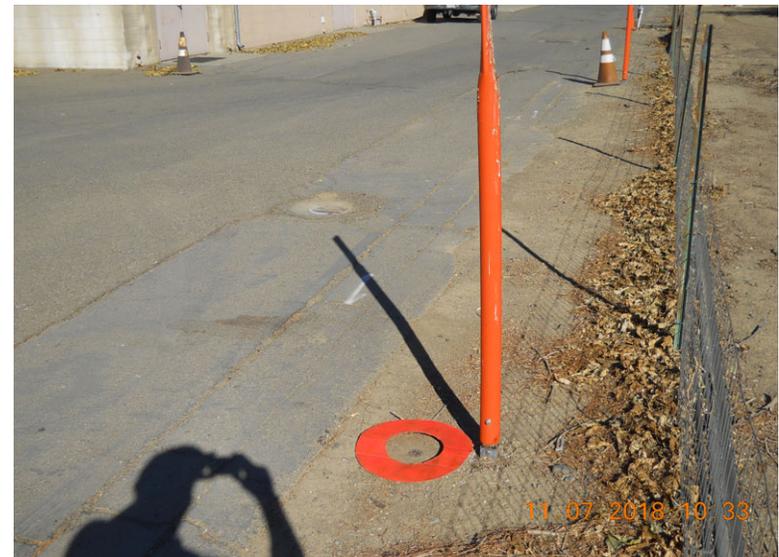
View north: Survey Monument 14, within orange ring; delineator right of survey monument; Building H-216 in background (photo No. 3646).

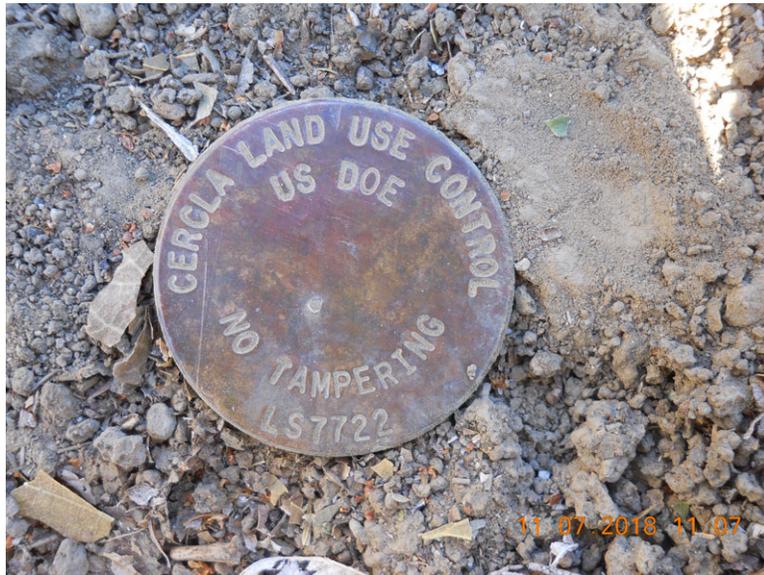
Survey Monument 15: Eastern corner of Southwest Trenches Area (photo No. 3662).

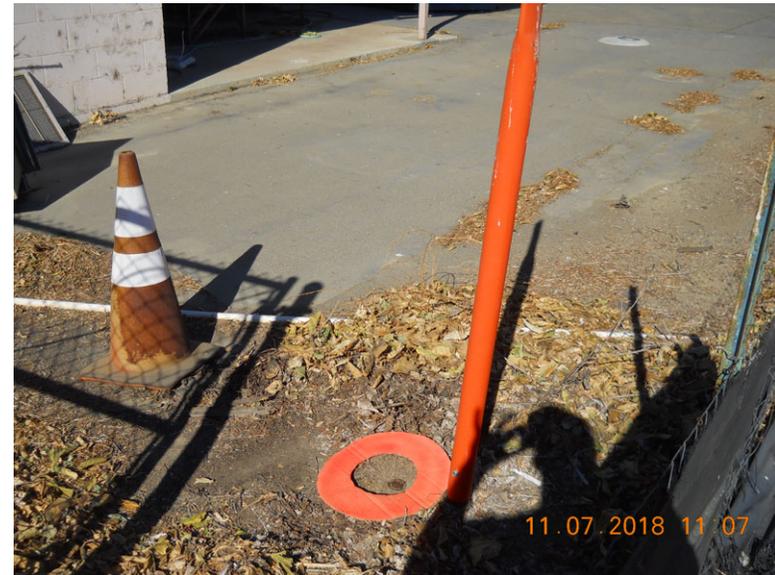
View northwest: Survey Monument 15, within orange ring; delineator right of survey monument, trailer storage unit in left of background (photo No. 3663).

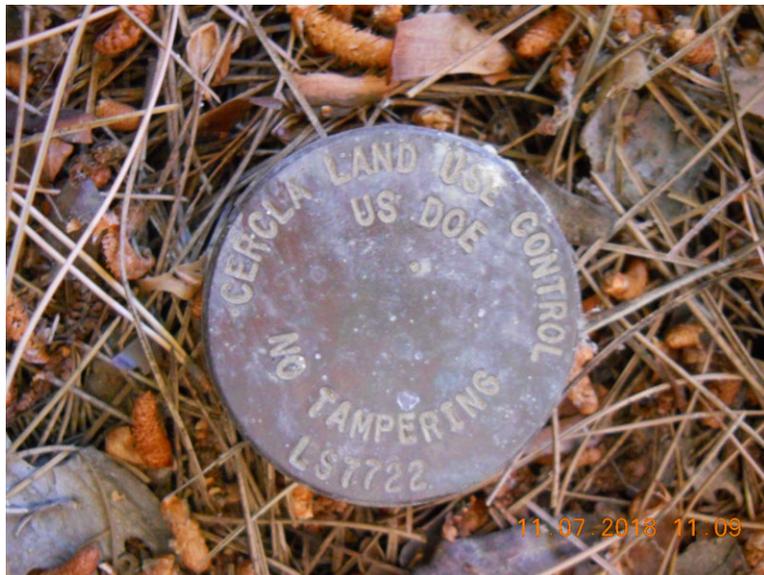
Survey Monument 16: Southwest corner of Southwest Trenches Area (photo No. 3664).

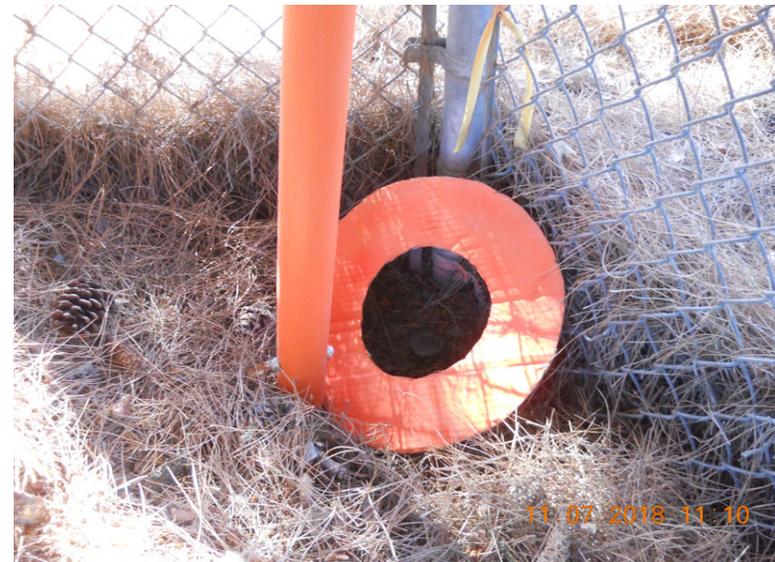
View southwest: Survey Monument 16, within orange ring; delineator left of survey monument; southwest corner post of perimeter fence behind survey monument (photo No. 3665).

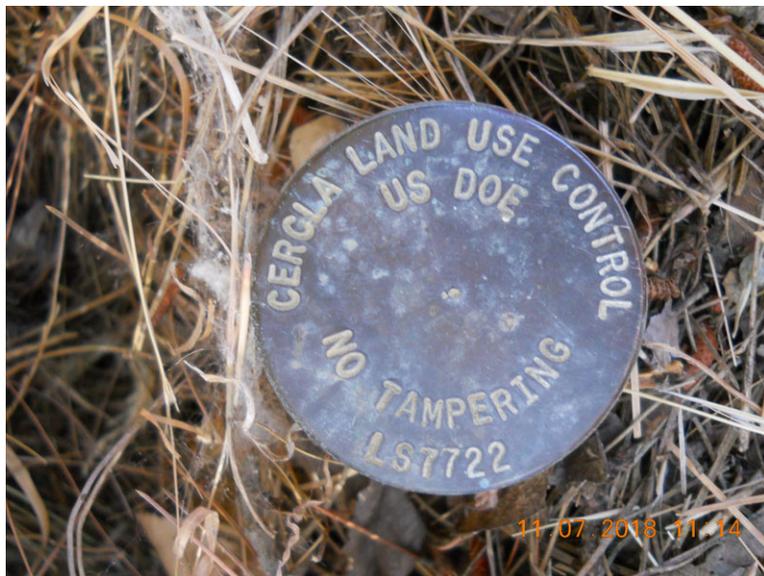
Survey Monument 18: Southeast corner of Eastern Remediation Support Area (photo No. 3670).

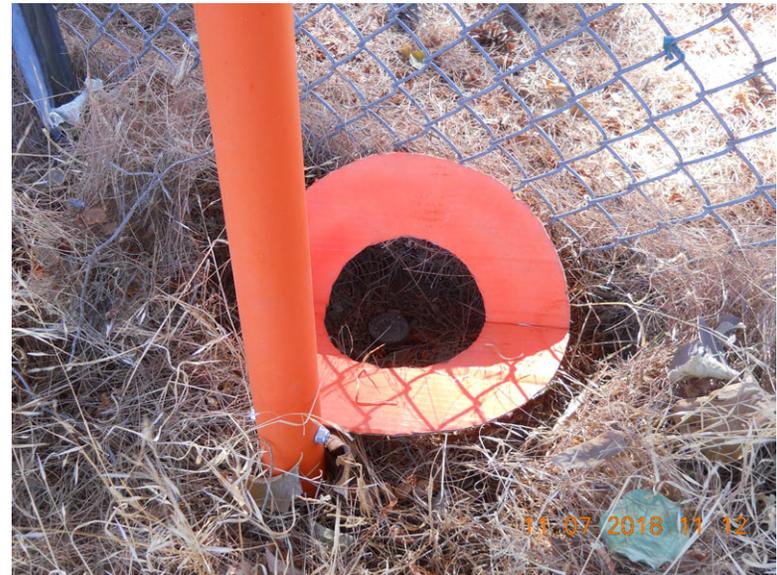
View southeast: Survey Monument 17, within orange ring; delineator left of survey monument; south perimeter fence behind survey monument; foot of North Levee in background (photo No. 3668).

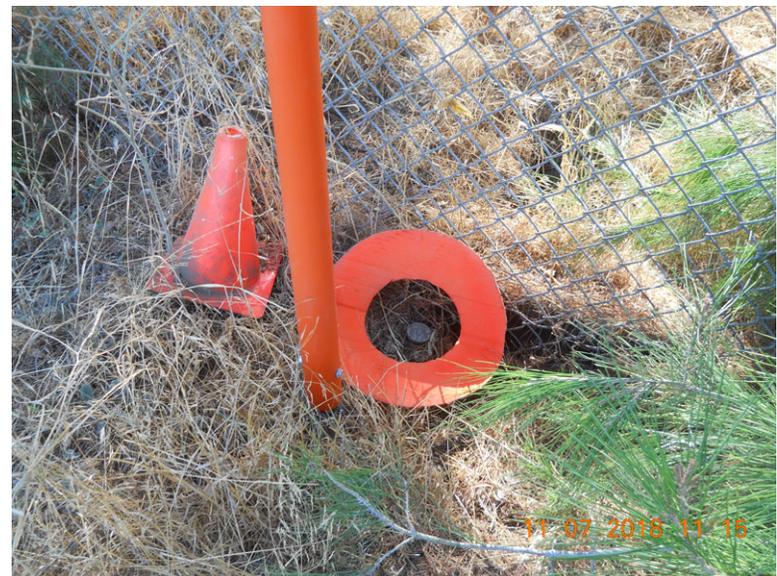
View southeast: Survey Monument 18, within orange ring; delineator left of survey monument; south perimeter fence behind survey monument; foot of North Levee in background (photo No. 3671).

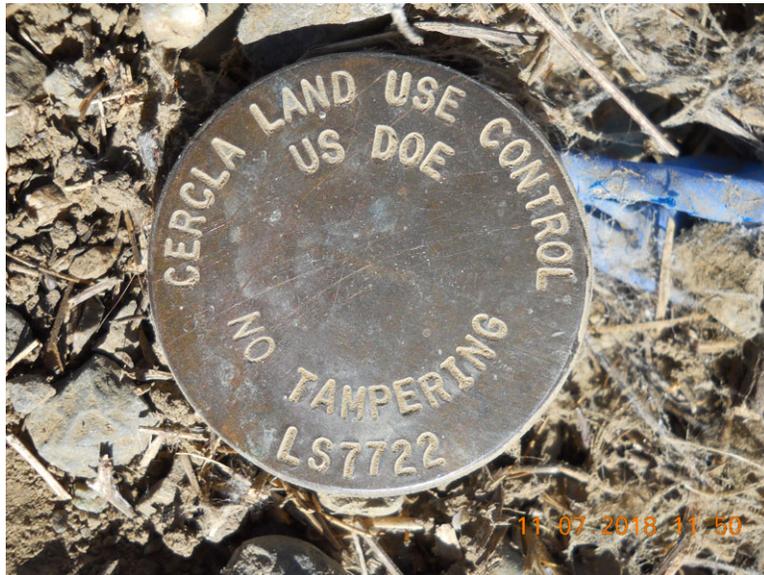
Survey Monument 19: Northwest corner of Eastern Dog Pens Area (photo No. 3681).

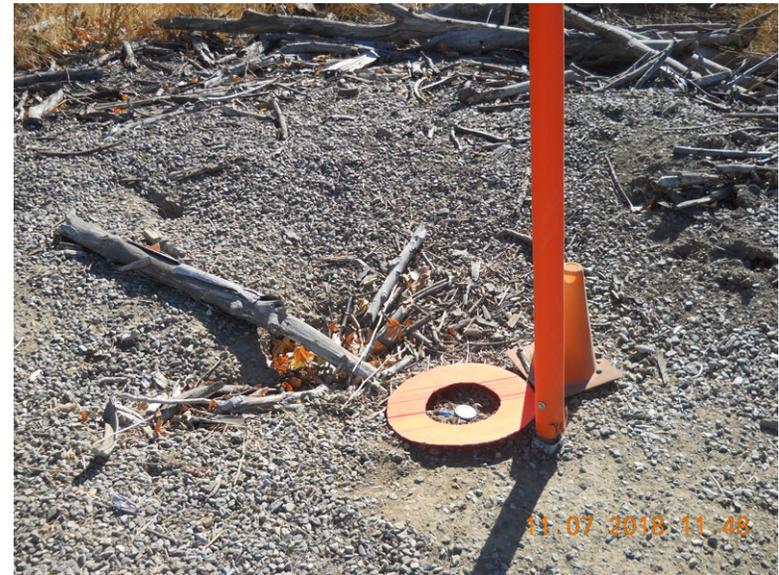
View southeast: Survey Monument 19, within orange ring; delineator right of survey monument; Eastern Dog Pens Area in background (photo No. 3680).

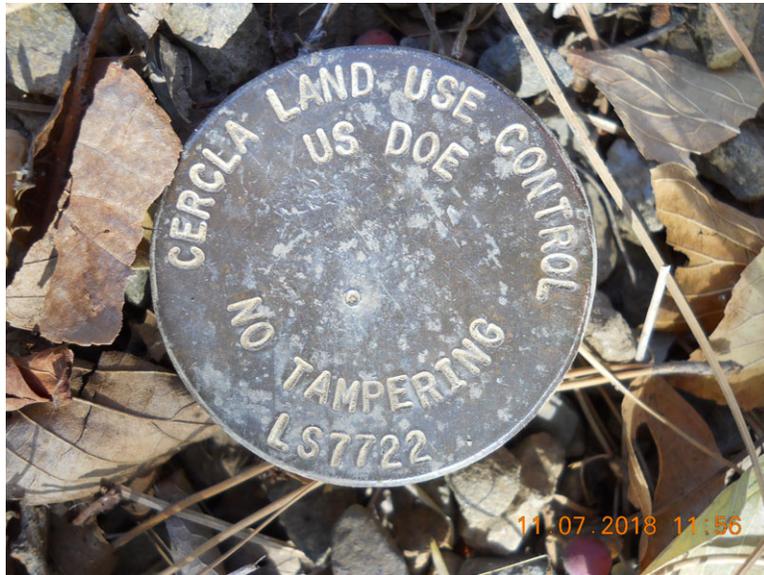
Survey Monument 20: Northeast corner of Eastern Dog Pens Area (photo No. 3684).

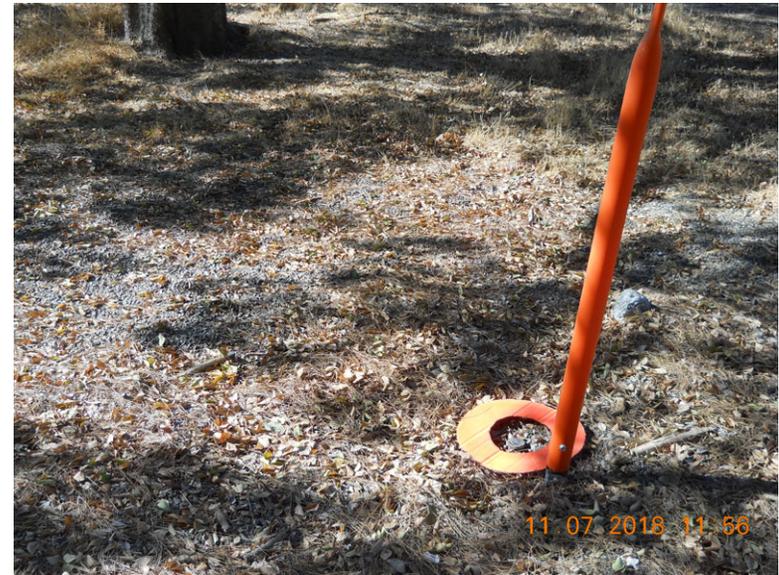
View west: Survey Monument 20, within orange ring; delineator right of survey monument; Eastern Dog Pens Area in background (photo No. 3685).

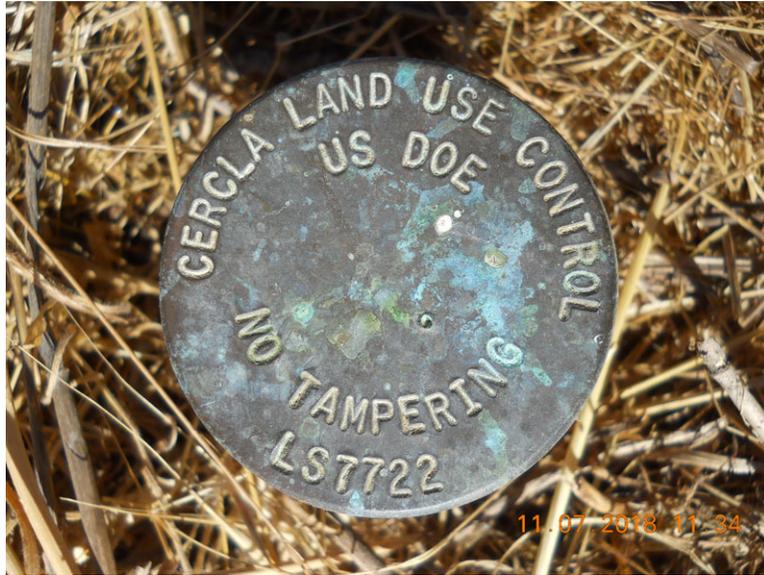
Survey Monument 21: Southwest corner of Eastern Dog Pens Area (photo No. 3675).

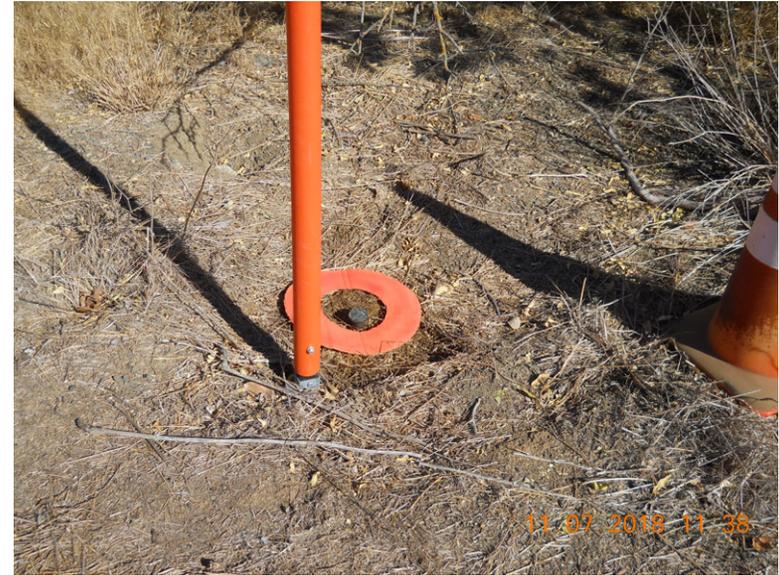
View northeast: Survey Monument 21, within orange ring; delineator left of survey monument; Eastern Dog Pens Area in background (photo No. 3676).

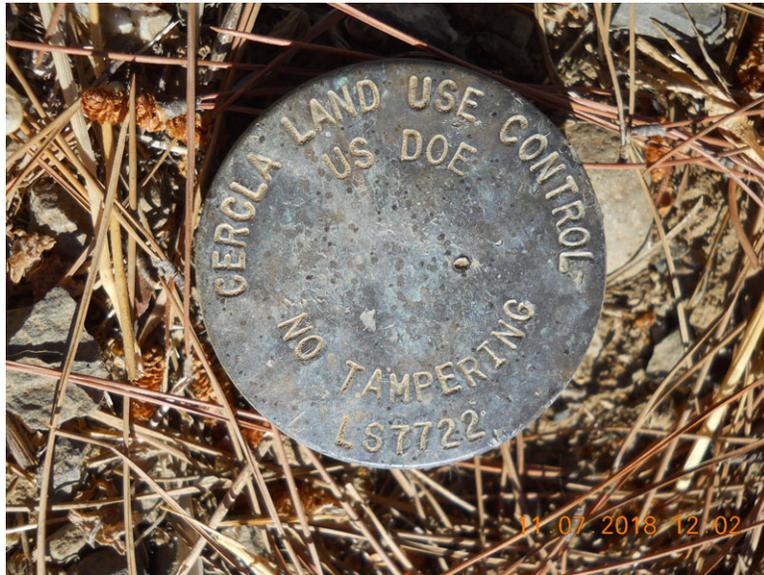
Survey Monument 22: Southeast corner of Eastern Dog Pens Area (photo No. 3688).

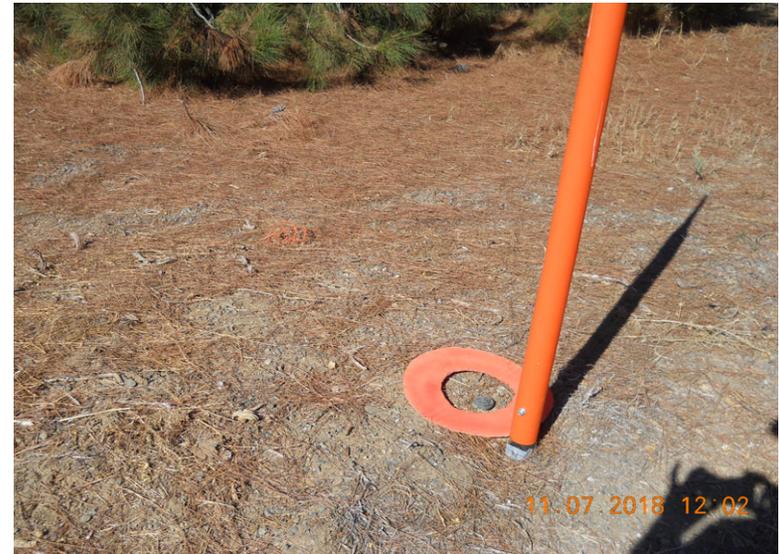
View northwest: Survey Monument 22, within orange ring; delineator right of survey monument; Eastern Dog Pens Area in background (photo No. 3689).

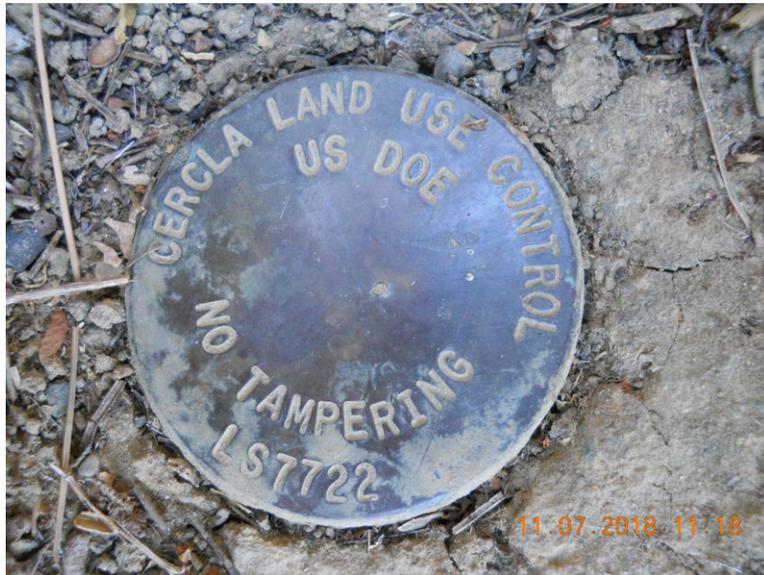
Survey Monument 23: Western perimeter point of Southwest Trenches Area (photo No. 3672).

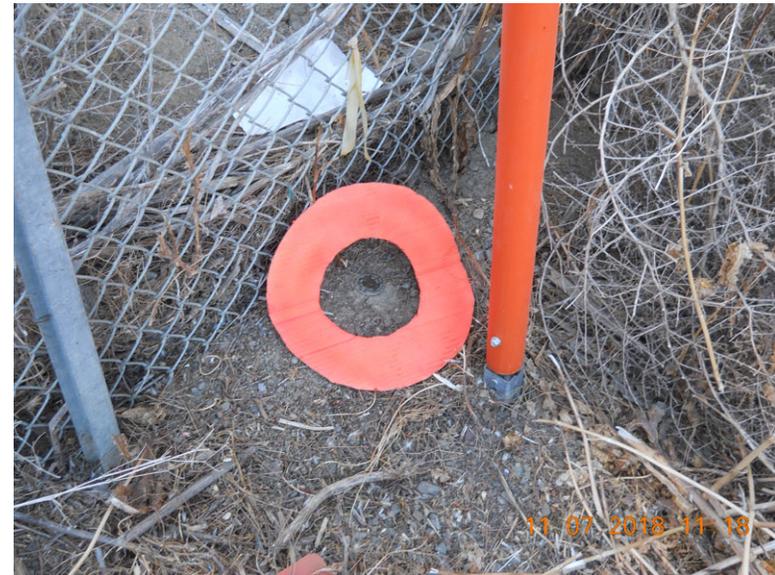
View northwest: Survey Monument 23, within orange ring; delineator right of survey monument; west perimeter fence behind and left of survey monument (photo No. 3673).

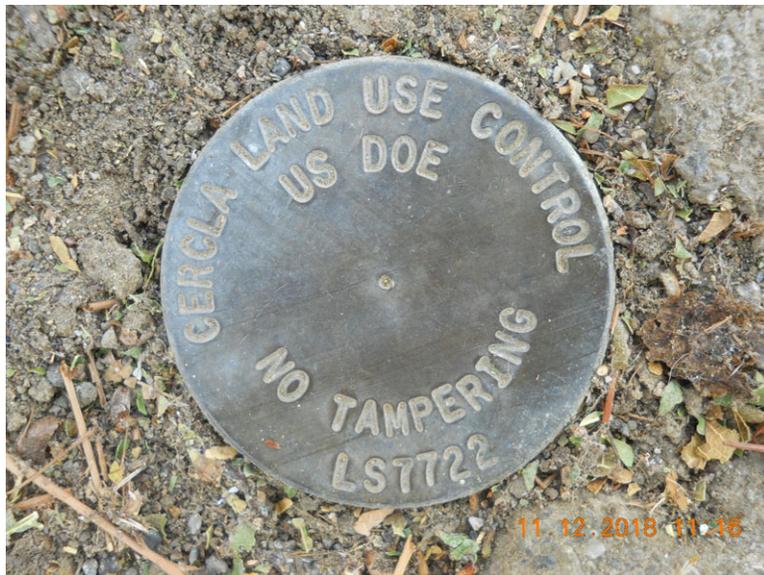
Survey Monument 24: Northeast corner of Southwest Trenches Area, at southern perimeter of Domestic Septic System 3 Area (photo No. 3732).

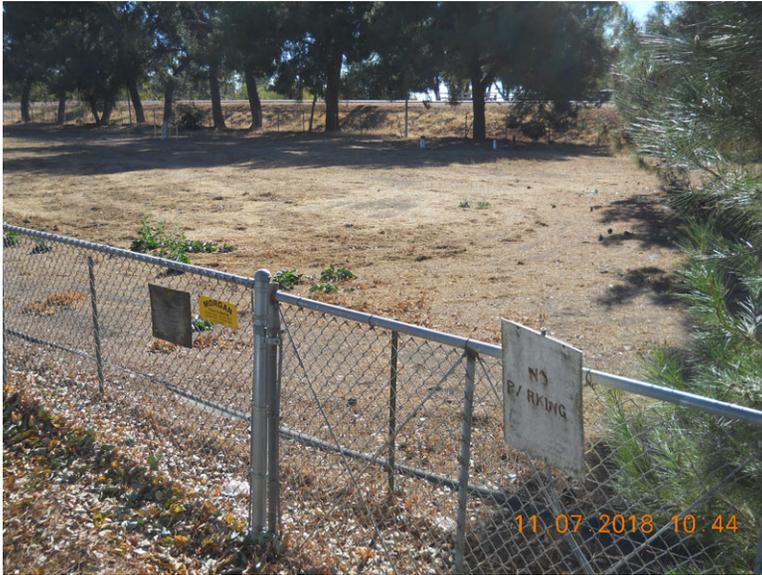
*View southeast over Southwest Trenches Area:
North Levee in background (photo No. 3647).*

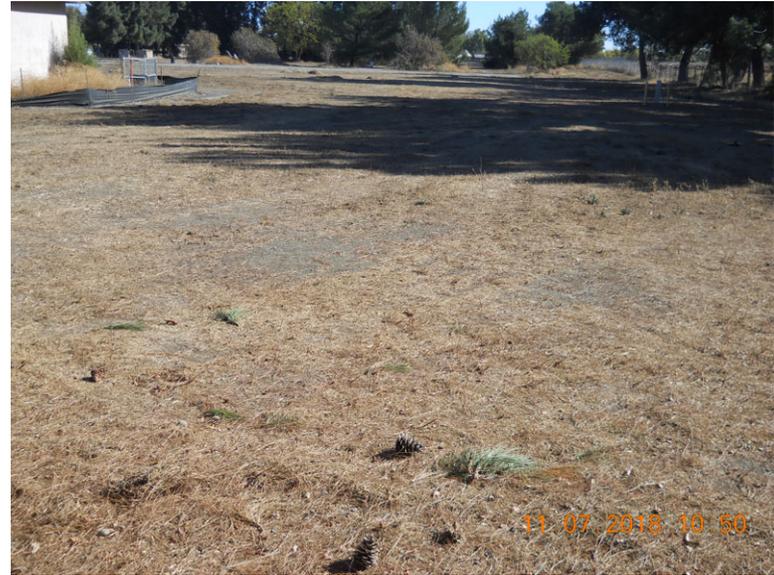
*View east over Southwest Trenches Area: Western Dog Pens
Area and UC Davis Southern Trenches Area in background
(photo No. 3650).*
