**2018 Annual Land-Use Covenant
Inspection Report
for DOE Areas at the Laboratory
for Energy-Related Health
Research/Old Campus Landfill
Superfund Site
University of California, Davis**

January 2019

U.S. DEPARTMENT OF
ENERGY

Legacy
Management

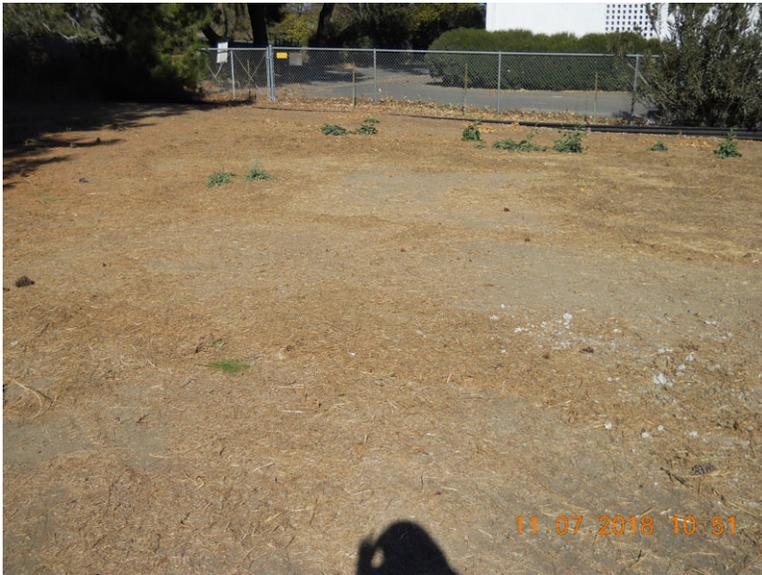
Northwest corner of Southwest Trenches Area (photo No. 3651).

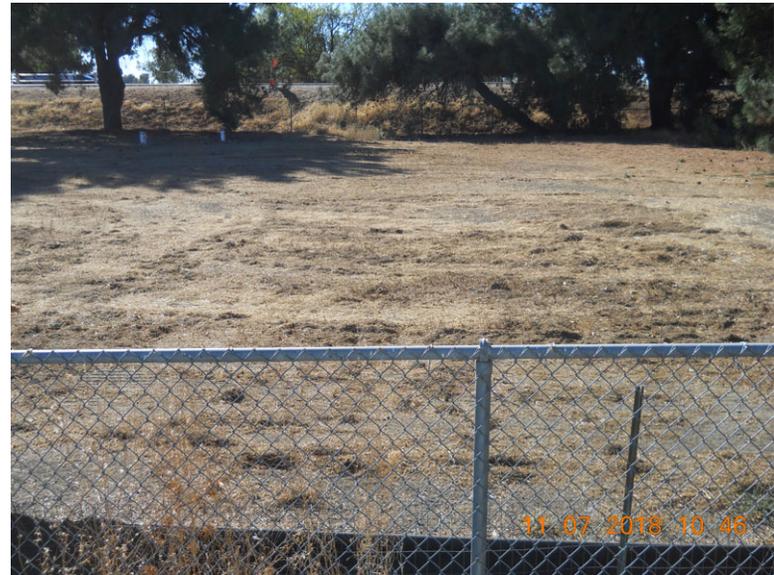
*View south over Southwest Trenches Area:
North Levee in background (photo No. 3648).*

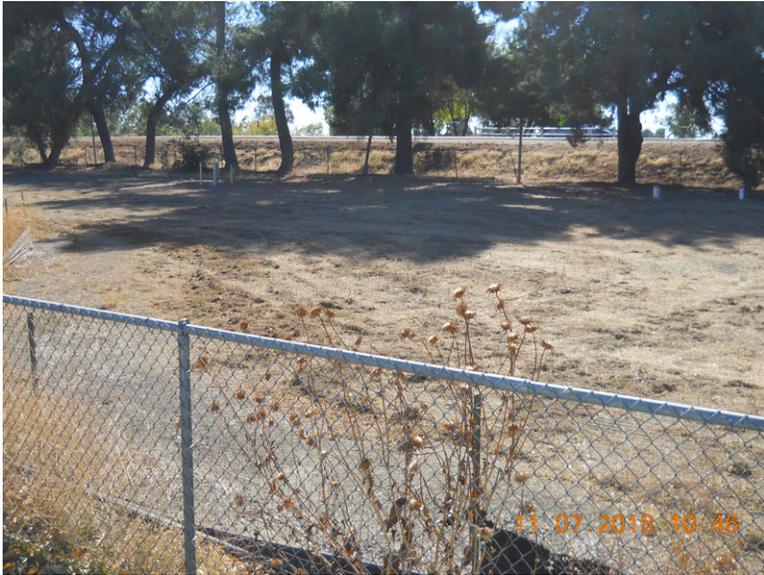
View southeast over Southwest Trenches Area (photo No. 3649).

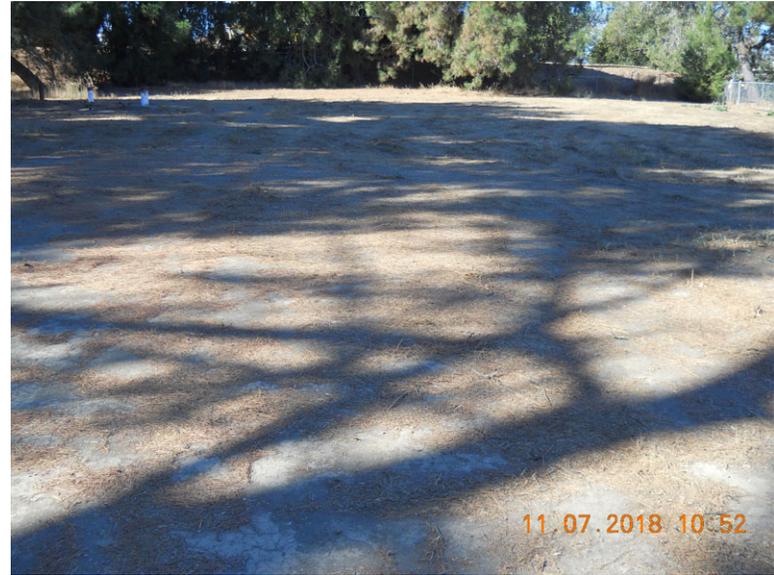
View west over Southwest Trenches Area: Shoulder of Old Davis Road in background (photo No. 3652).

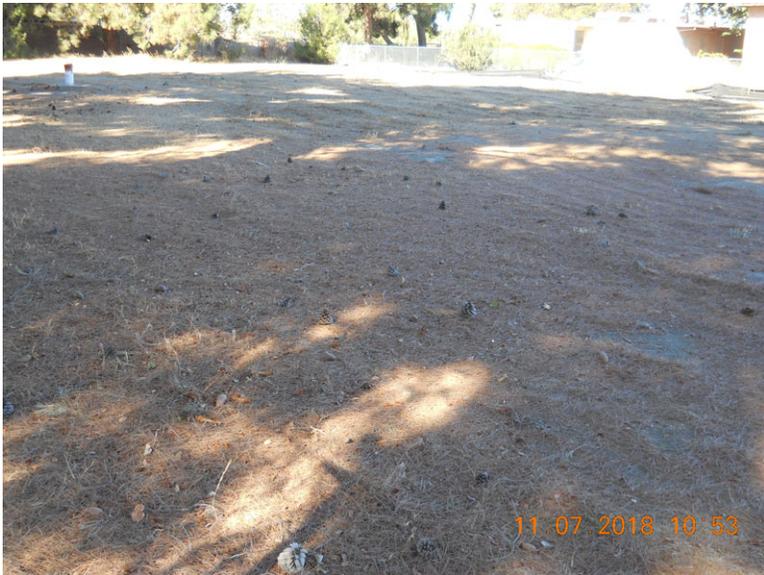
View northwest over Southwest Trenches Area (photo No. 3653).

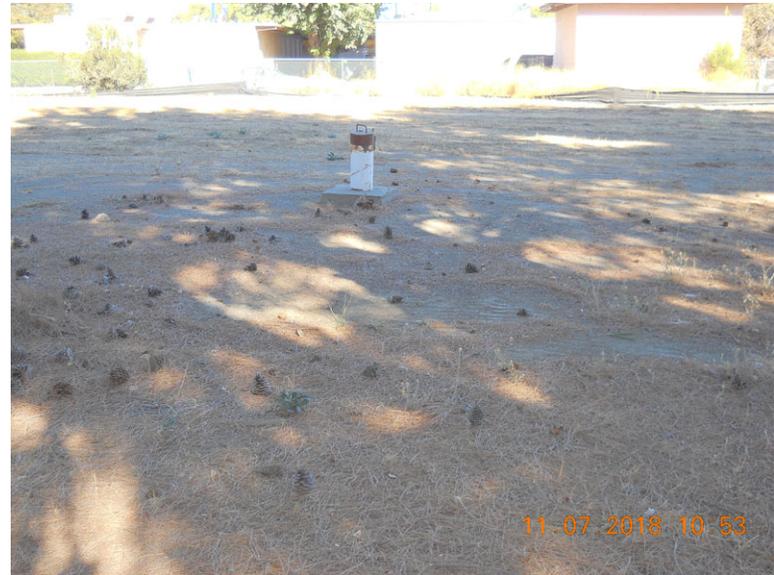
View north over Southwest Trenches Area (photo No. 3654).

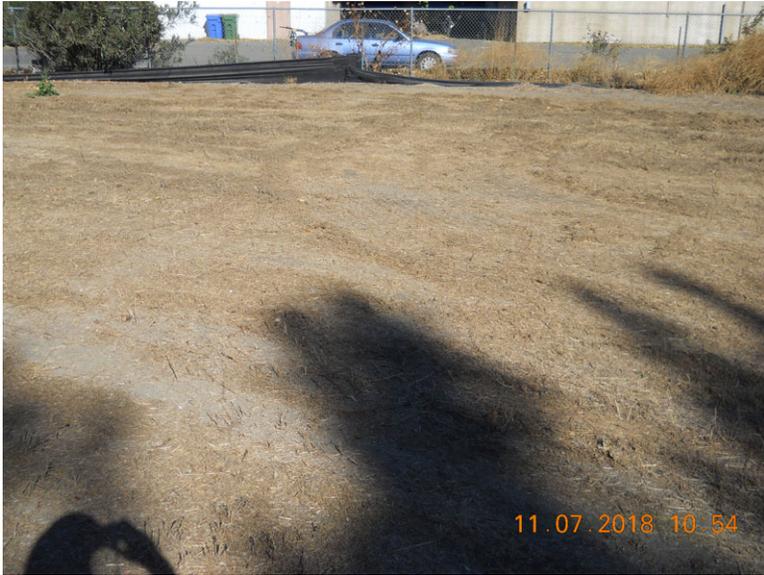
*View north from center of Southwest Trenches Area
(photo No. 3655).*

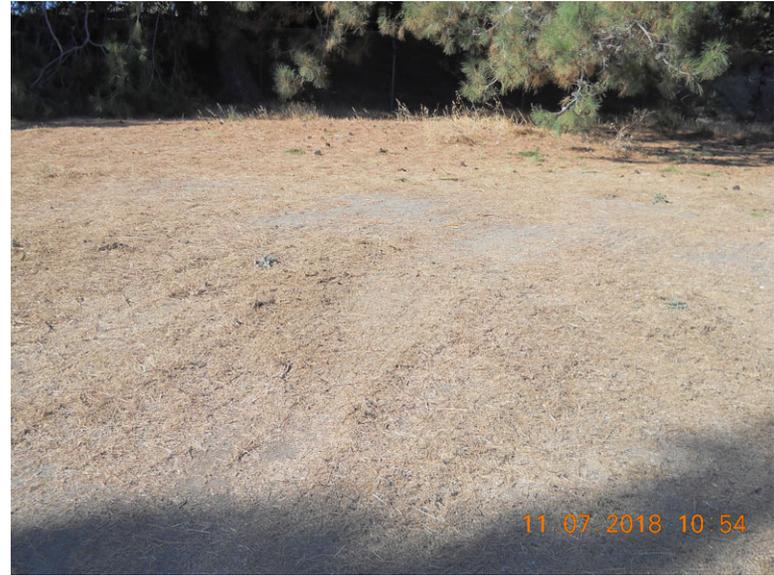
*View west from center of Southwest Trenches Area
(photo No. 3656).*

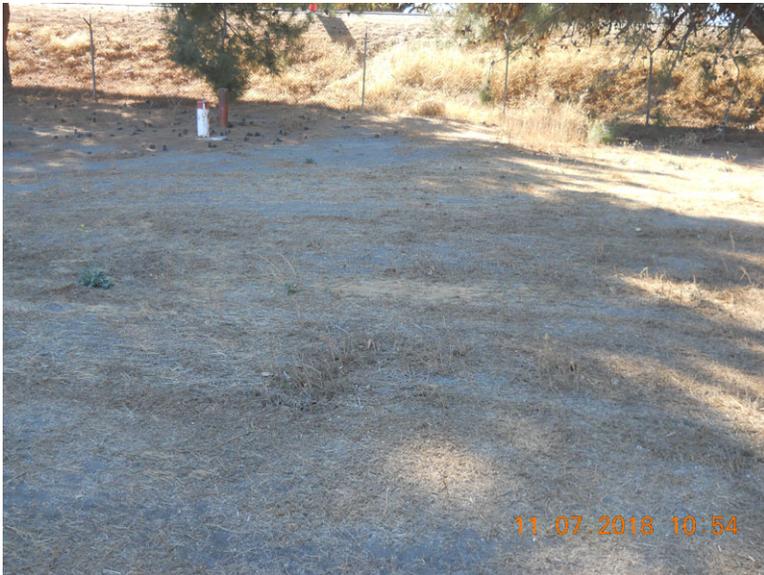
*View south from center of Southwest Trenches Area
(photo No. 3657).*

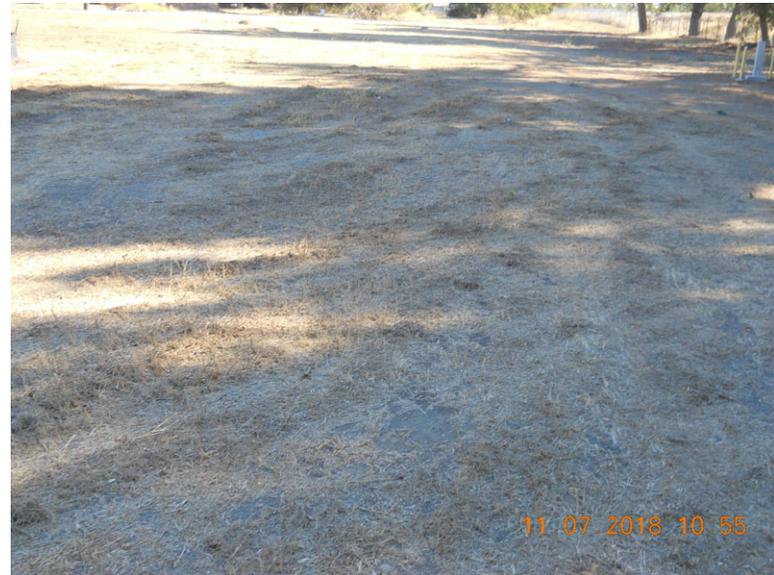
*View east from center of Southwest Trenches Area
(photo No. 3658).*

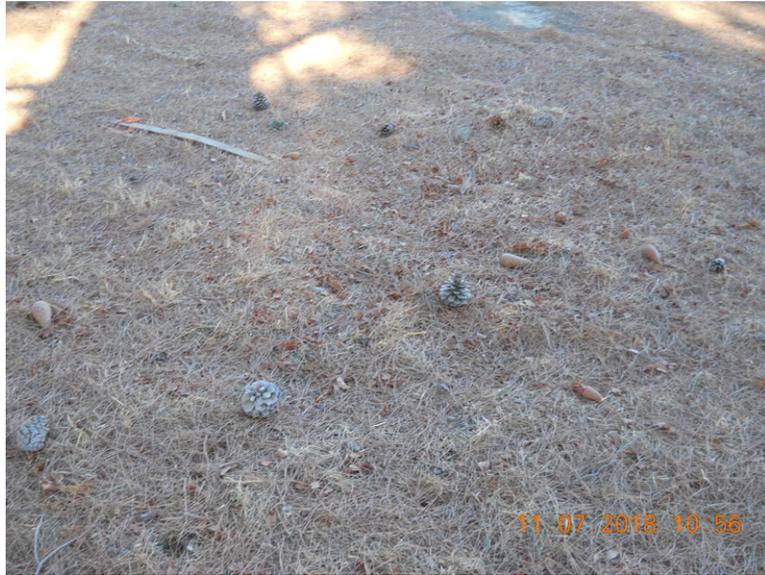
View of decommissioned soil gas well SWTSG-01 near southeast corner of Southwest Trenches Area (photo No. 3659).

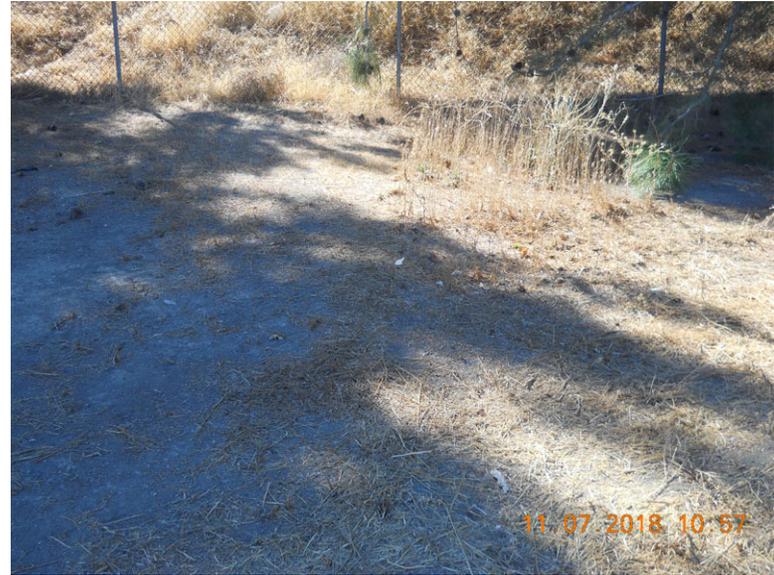
View of decommissioned soil gas wells SWTSG-02A and SWTSG-02B: South perimeter fence in background (photo No. 3660).

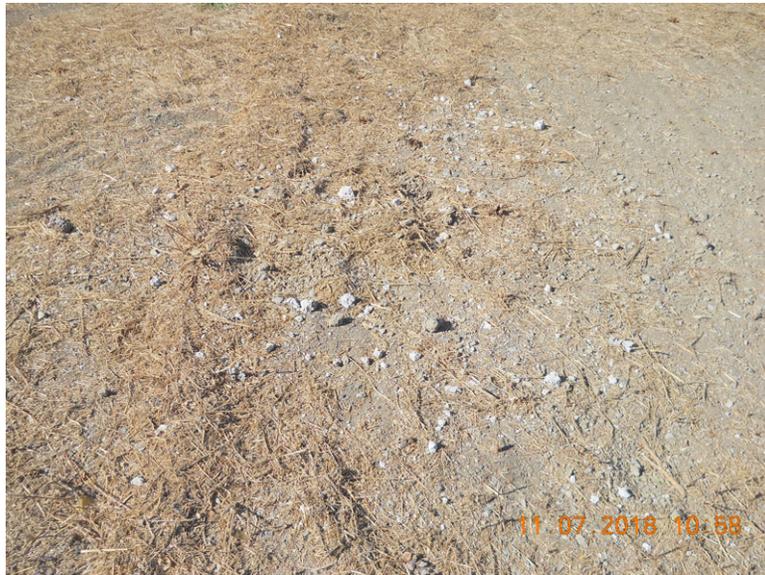
View of decommissioned soil gas well SWTSG-03 near center of Southwest Trenches Area (photo No. 3661).

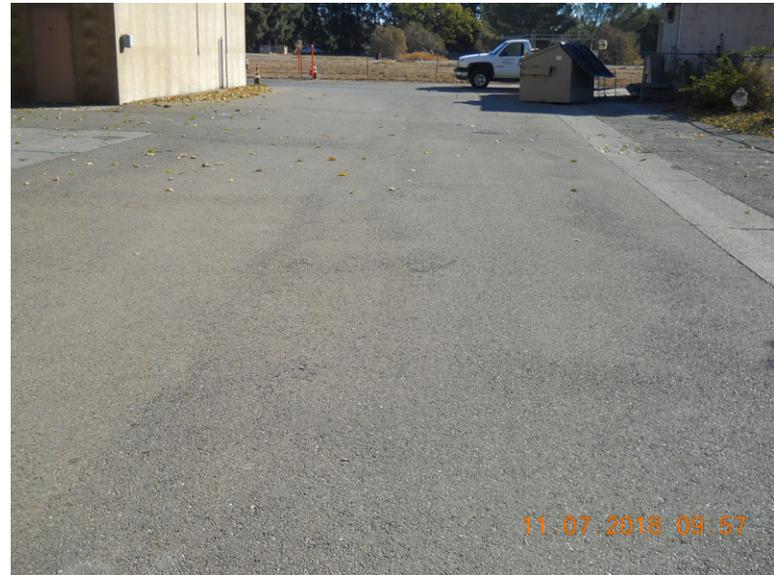
View east over former leach field part of Domestic Septic System 3 Area: Building H-216 to left; storage unit to right; Western Dog Pens Area in background (photo No. 3627).

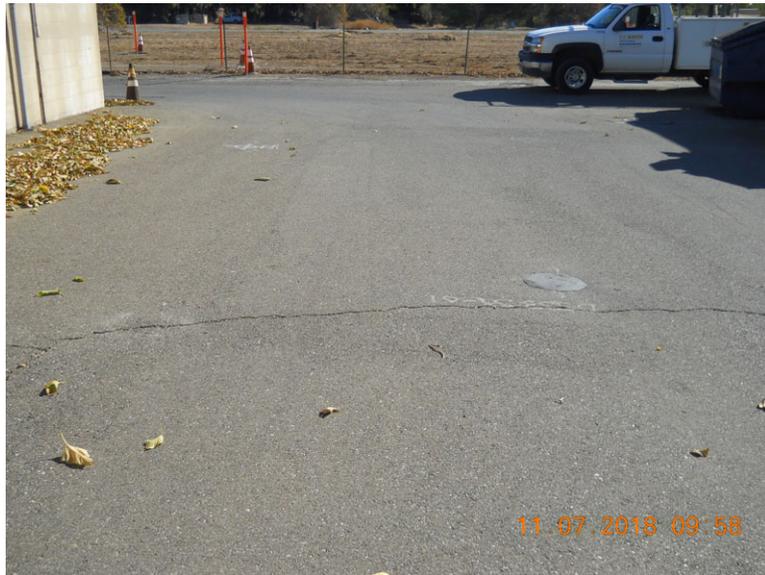
View east over eastern half of Domestic Septic System 3 Area (photo No. 3628).

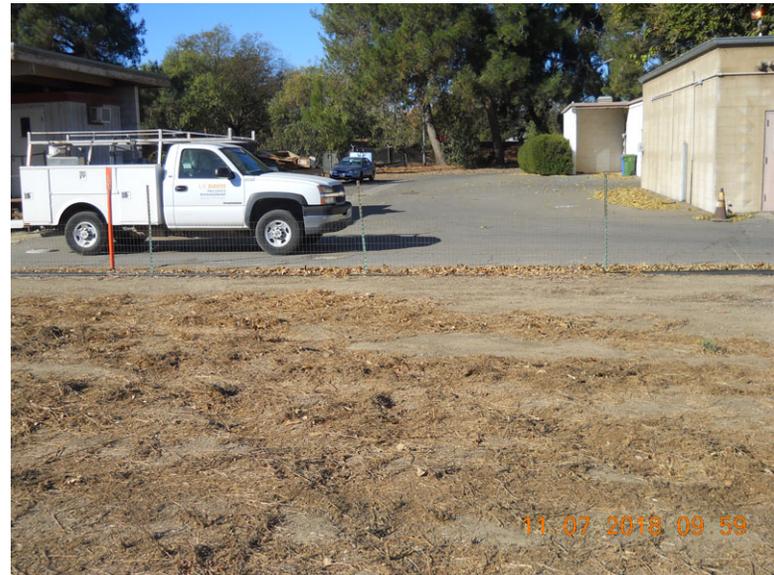
View west over former leach field part of Domestic Septic System 3 Area: Buildings H-215 and H-216 to right; shoulder of Old Davis Road in background (photo No. 3629).

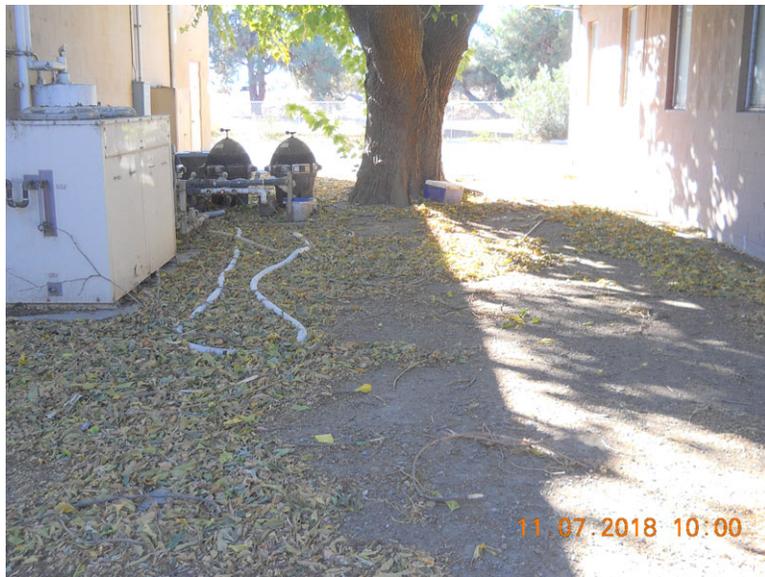
View south over septic tank part of Domestic Septic System 3 Area: Building H-216 to left; Building H-215 to right (photo No. 3630).

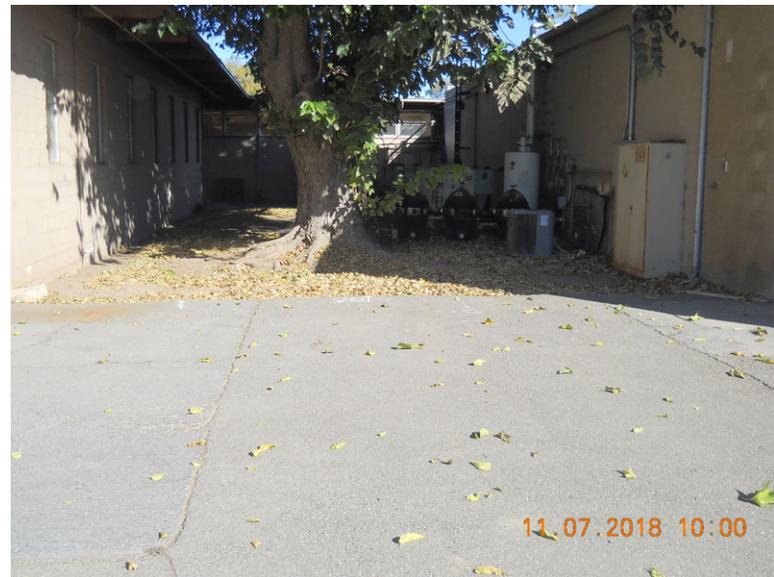
View north over septic tank part of Domestic Septic System 3 Area: Building H-215 to left; Building H-216 to right; Domestic Septic System 4 Area in background (photo No. 3631).

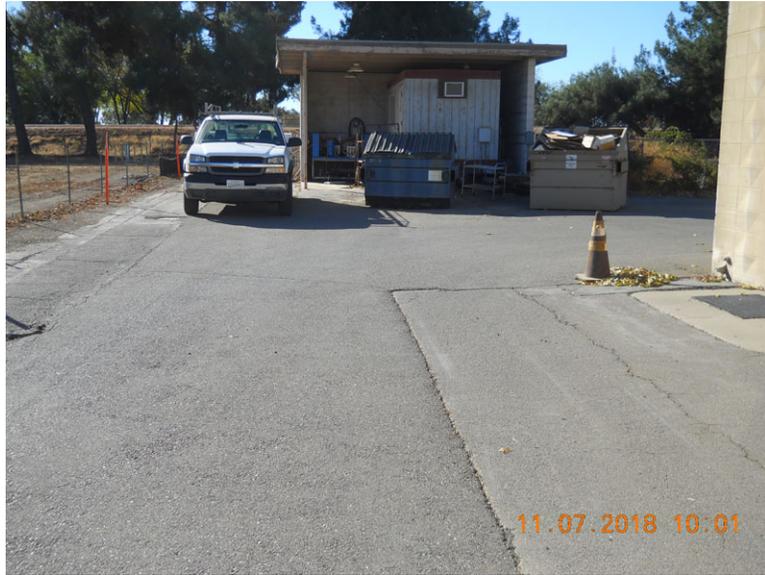
View south over east end of Domestic Septic System 3 Area leach field: Trailer storage unit in background (photo No. 3632).

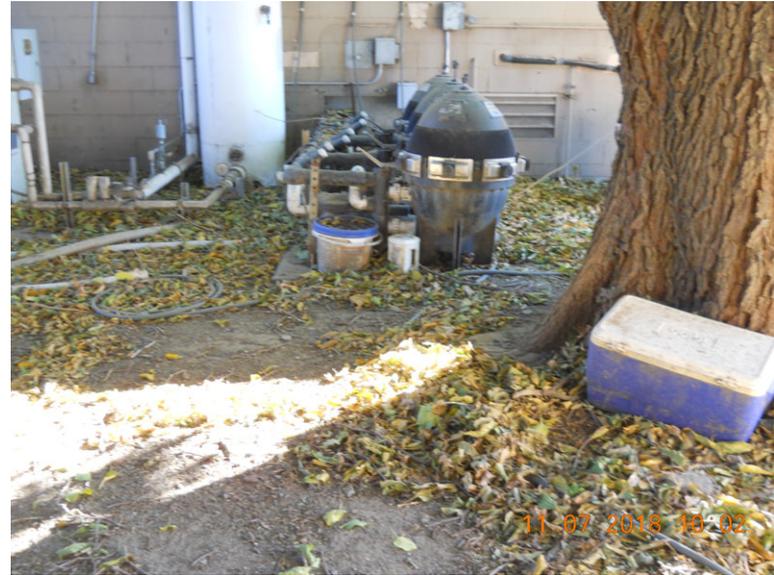
View east in Domestic Septic System 3 Area: Building H-216 in background, standing north/left of tree (photo No. 3633).

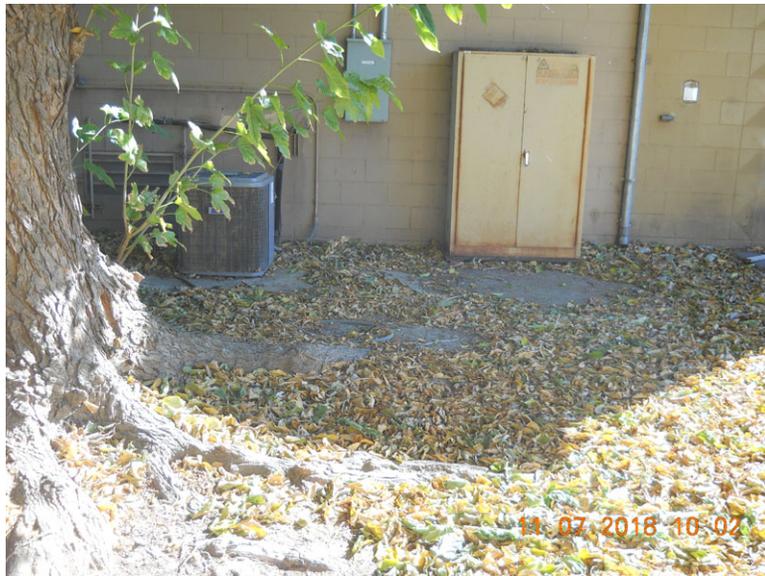
View east in Domestic Septic System 3 Area: Building H-216 in background, standing south/right of tree (photo No. 3634).

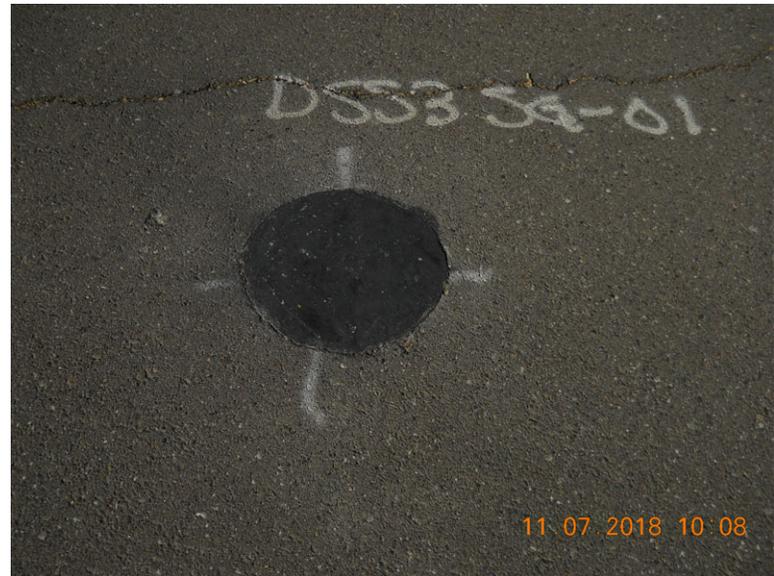
View of decommissioned soil gas well DSS3SG-01 near center of Domestic Septic System 3 Area leach field (photo No. 3635).

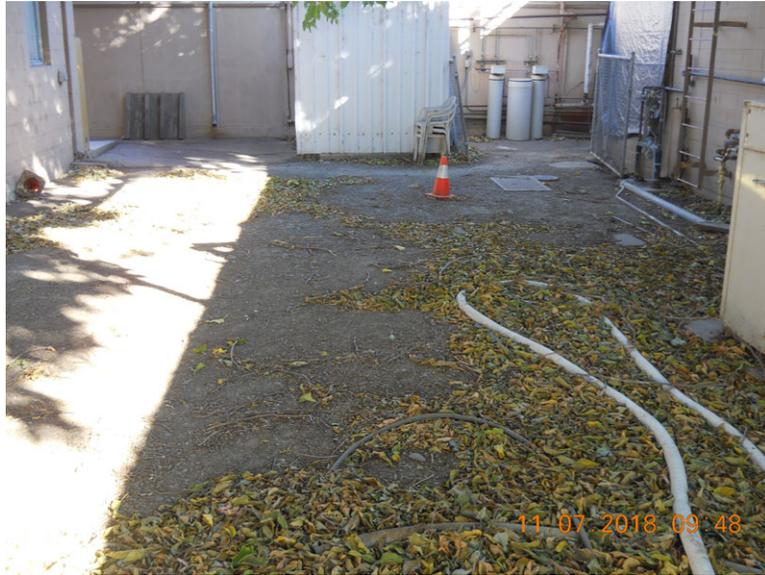
View north over Domestic Septic System 4 Area septic tank location and east end of leach field: Building H-215 to left; Building H-216 to right; Building H-217 in background (photo No. 3623).

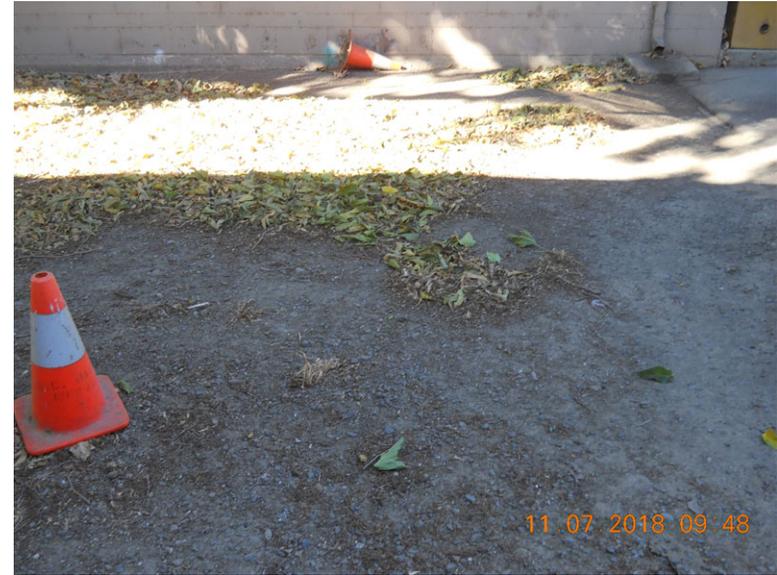
View west over east end of Domestic Septic System 4 Area leach field; decommissioned soil gas well DSS3SG-02 in upper left of photo: Building H-215 in background (photo No. 3624).

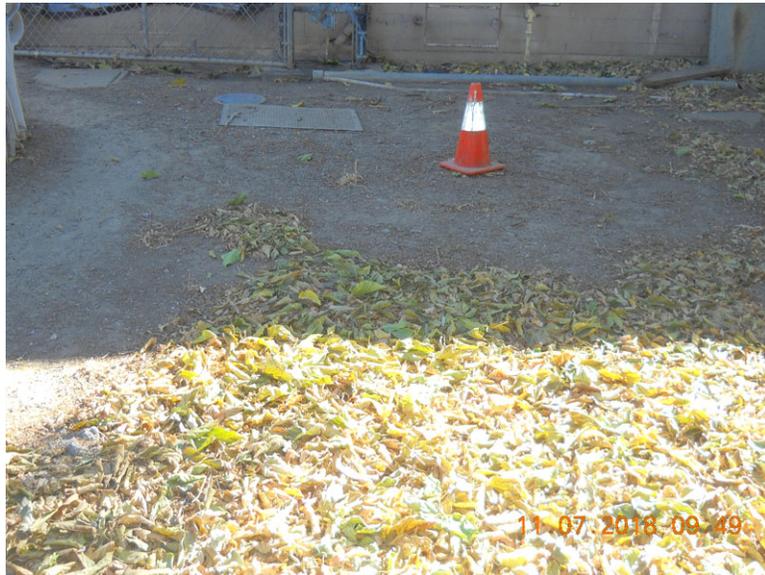
View east over Domestic Septic System 4 Area septic tank location: Building H-216 in background (photo No. 3625).

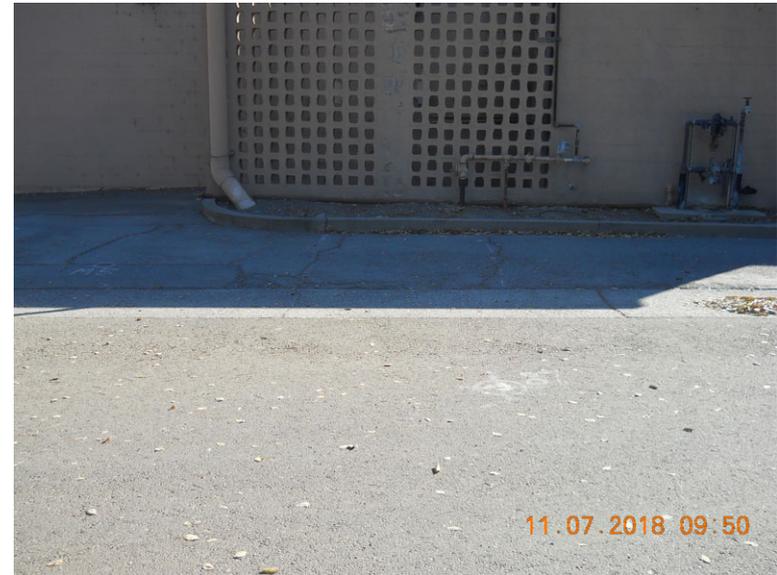
View east over western portion of Domestic Septic System 4 Area: Building H-215 in background (photo No. 3626).

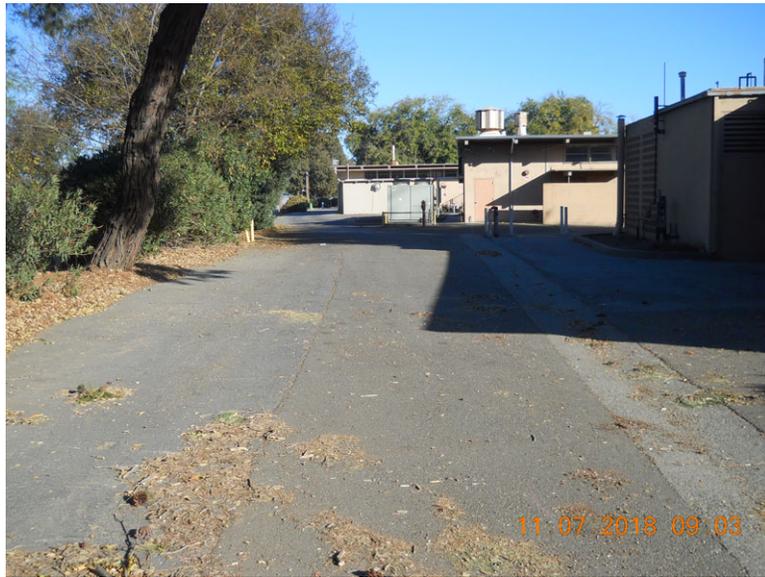
View north over southern portion of Radium/Strontium Treatment Systems Area: Building H-215 to right; Buildings H-218 and H-219 in background (photo No. 3600).

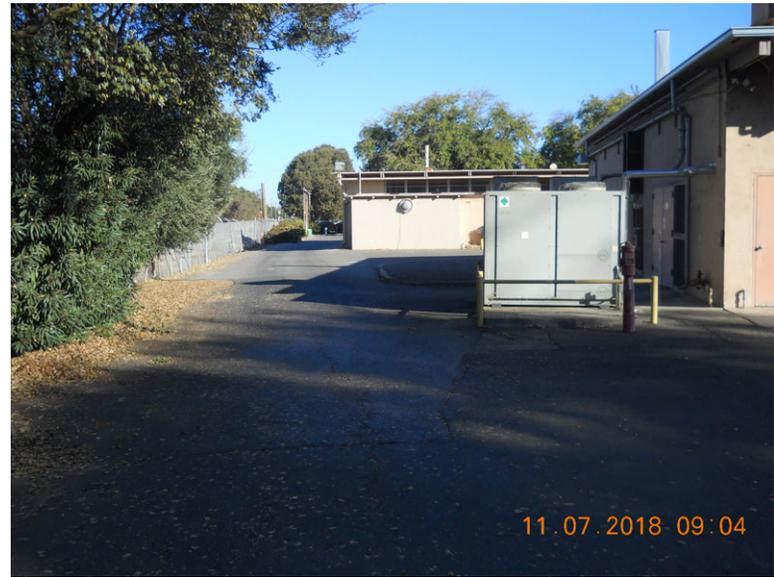
View north over middle portion of Radium/Strontium Treatment Systems Area: Building H-218 to right; Building H-219 in background (photo No. 3601).

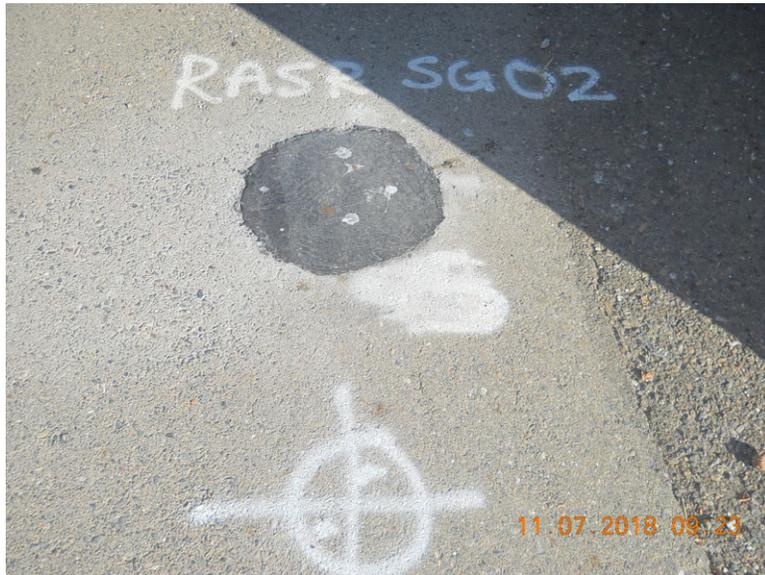
Radium/Strontium Treatment Systems Area: Decommissioned soil gas well RASRSG-01 (photo No. 3611).

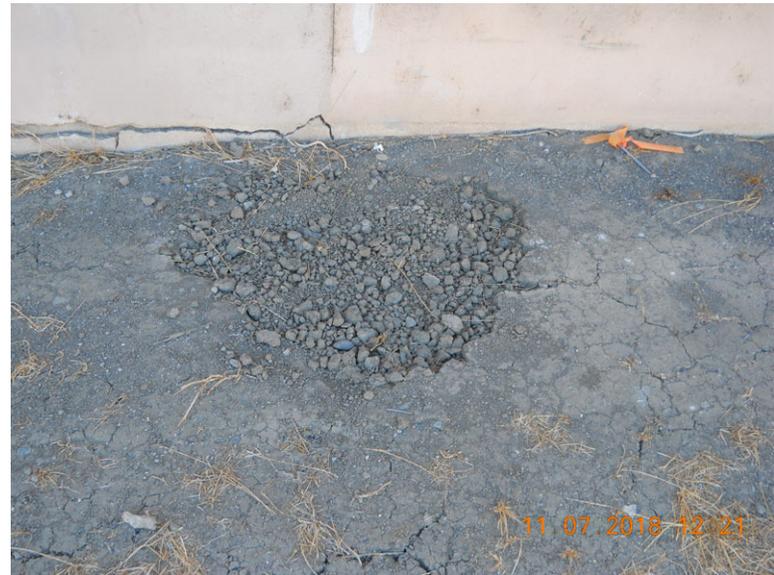
Radium/Strontium Treatment Systems Area: Decommissioned soil gas well RASRSG-02 (photo No. 3612).

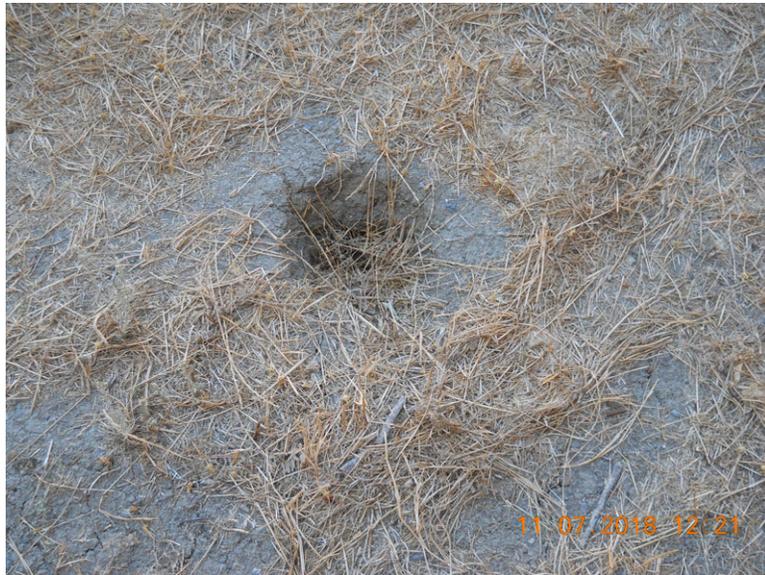
Radium/Strontium Treatment Systems Area: Decommissioned soil gas well RASRSG-03 center; Building H-218 above (photo No. 3692).

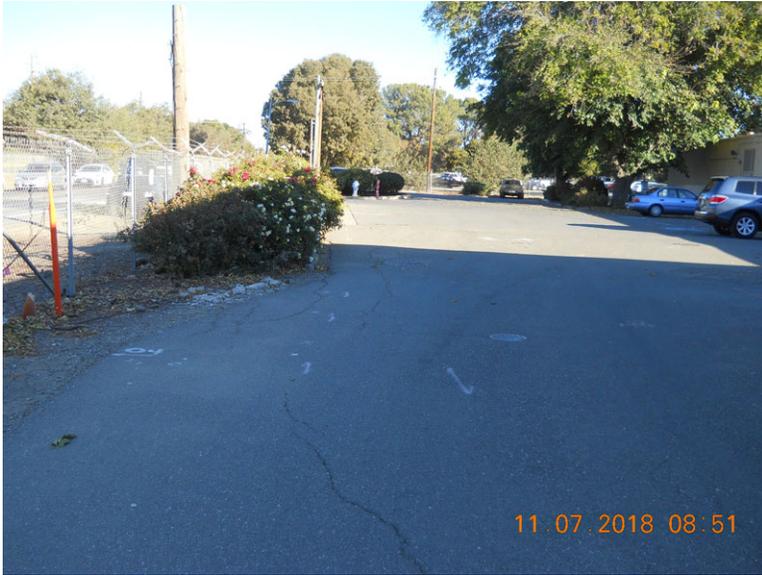
During the November 7, 2018, walkthrough inspection, Tim Utterback of Weiss observed and photographed one small animal burrow and one small area of soil subsidence in the Ra/Sr Treatment Systems Area (photographs 3693 and 3694 in Appendix C). The animal burrow was photographed in 2017. Comparison of 2017 and 2018 photographs indicates no change to the burrow and no soil disturbance between photographs. Animal burrows photographed in the EDPs area during the 2017 inspection were not found in the 2018 inspection. The area of soil subsidence in the Ra/Sr Treatment Systems Area does not indicate soil removal, but that a small area of ground surface has subsided slightly. A pile of asphalt not previously observed within the Eastern Dog pens was observed during the November 7, 2018, walkthrough inspection, but no soil disturbance due to the asphalt placement was observed. Thus, no soil disturbance was observed in 2018 other than the permitted activity described above.

Small subsidence adjacent to sidewalk at east end of unpaved courtyard of Radium/Strontium Treatment Systems Area (photo No. 3694).
