**2019 Annual Land-Use Covenant
Inspection Report
for DOE Areas at the Laboratory
for Energy-Related Health
Research/Old Campus Landfill
Superfund Site
University of California, Davis**

January 2020

**U.S. DEPARTMENT OF
ENERGY**

Legacy
Management

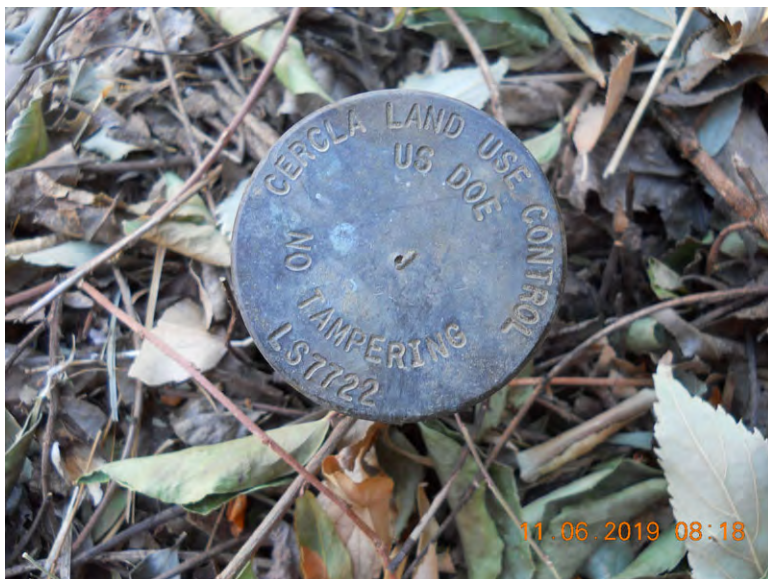
Survey Monument 1: Northwest corner of Dry Wells A–E Area
(Photo No. 3792).

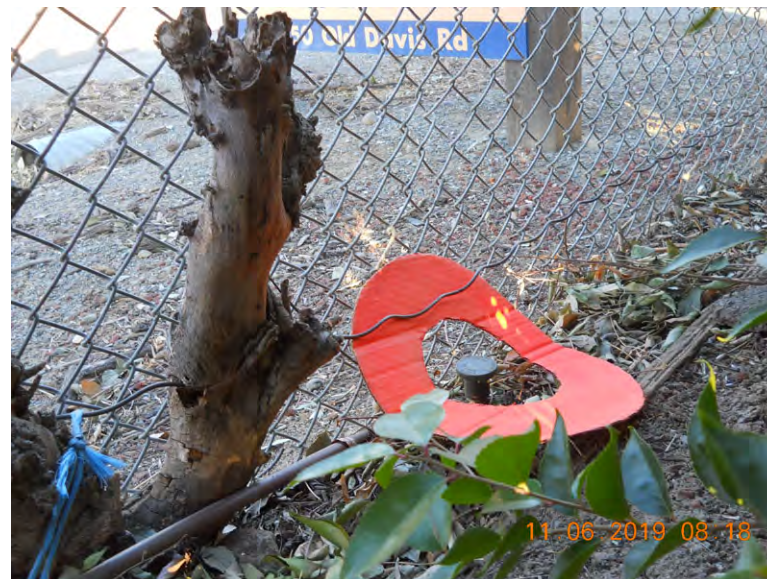
View northwest: Survey Monument 1, within orange ring (outside diameter is 14 inches); entrance sign in background (Photo No. 3793).

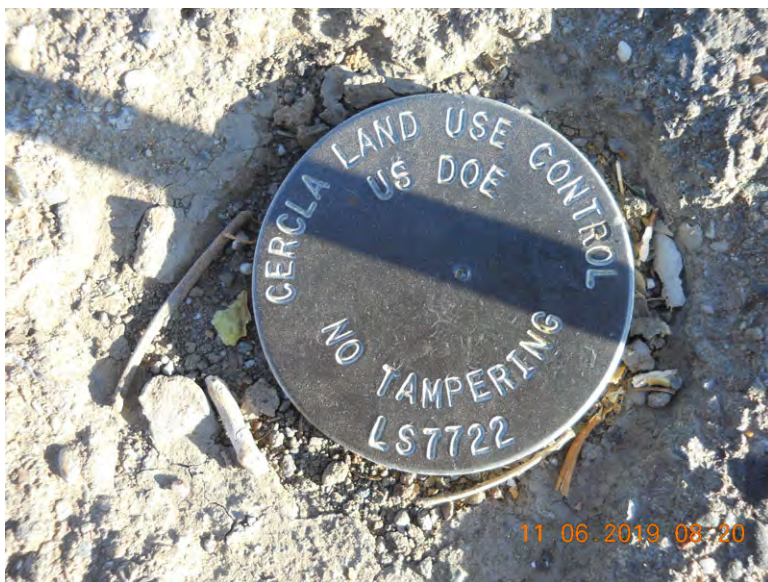
Survey Monument 2: Northeast corner of Dry Wells A–E Area
(Photo No. 3794).

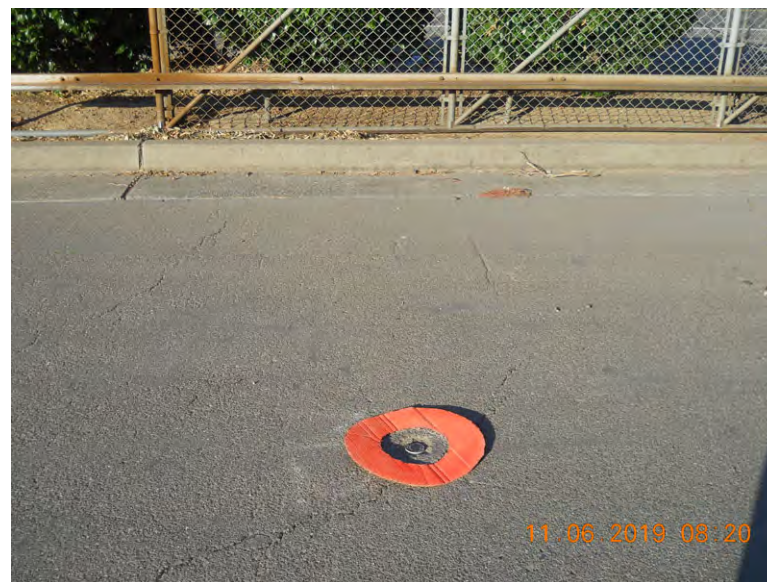
View west: Survey Monument 2, within orange ring; retracted entrance gate in background (Photo No. 3795).

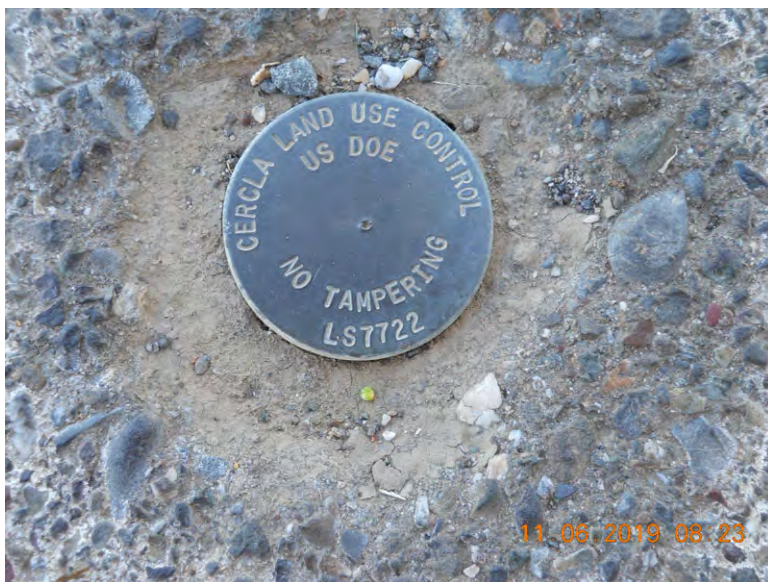
Survey Monument 4: Southeast corner of Dry Wells A–E Area
(Photo No. 3798).

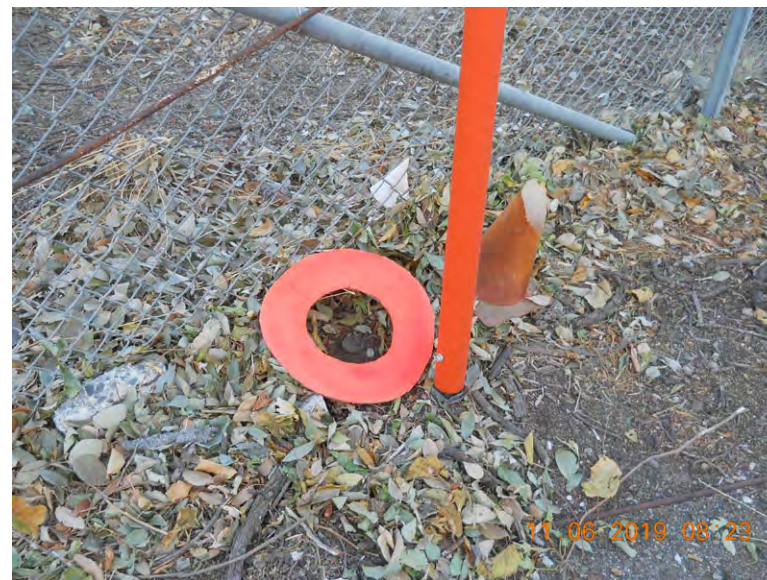
View northwest: Survey Monument 3, within orange ring; west
perimeter fence behind survey monument; orange delineator right of
survey monument (Photo No. 3797).

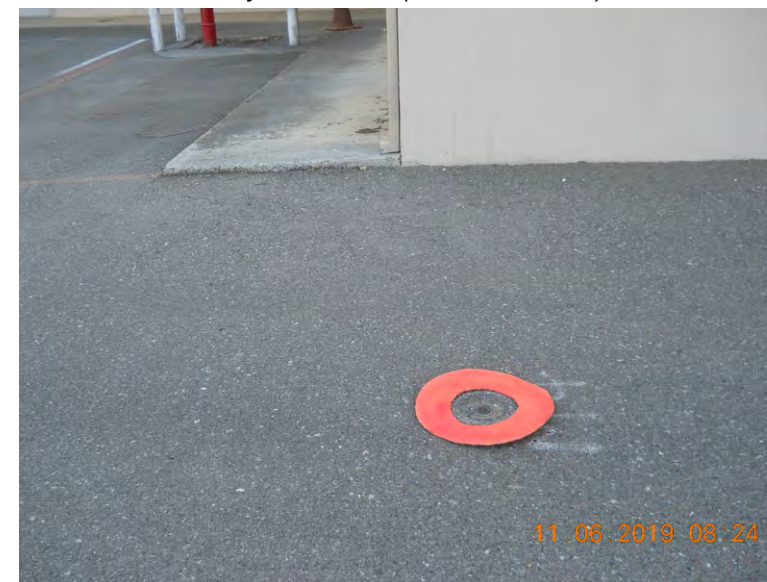
View east: Survey Monument 4, within orange ring; Building H-219
in background (Photo No. 3799).

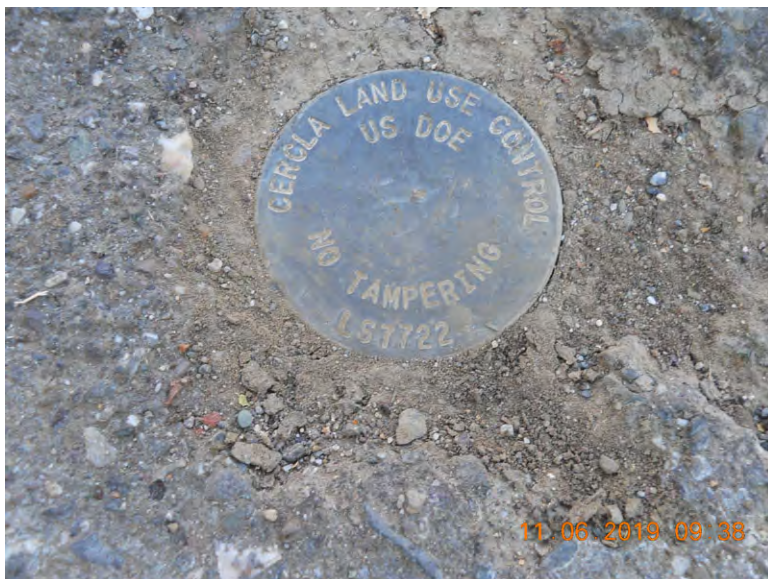
Survey Monument 5: Northwest corner of Domestic Septic System 4 Area (Photo No. 3818).

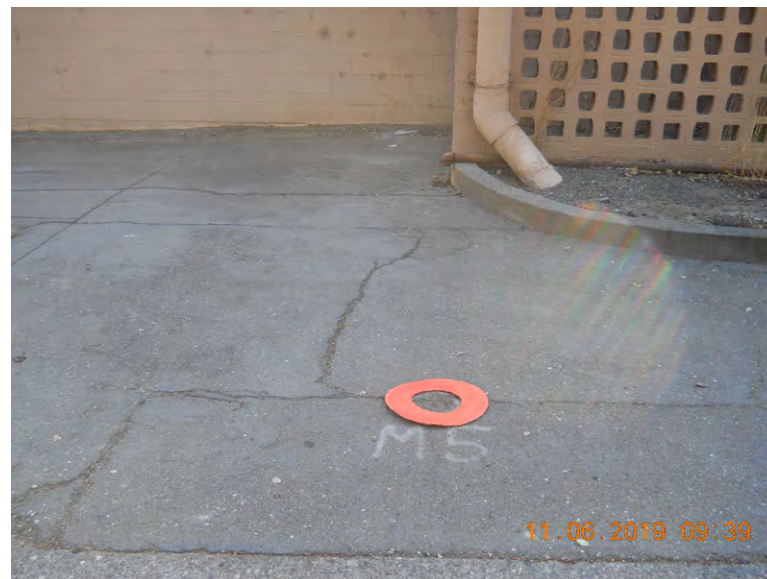
View east: Survey Monument 5, within orange ring; Building H-215 in background (Photo No. 3819).

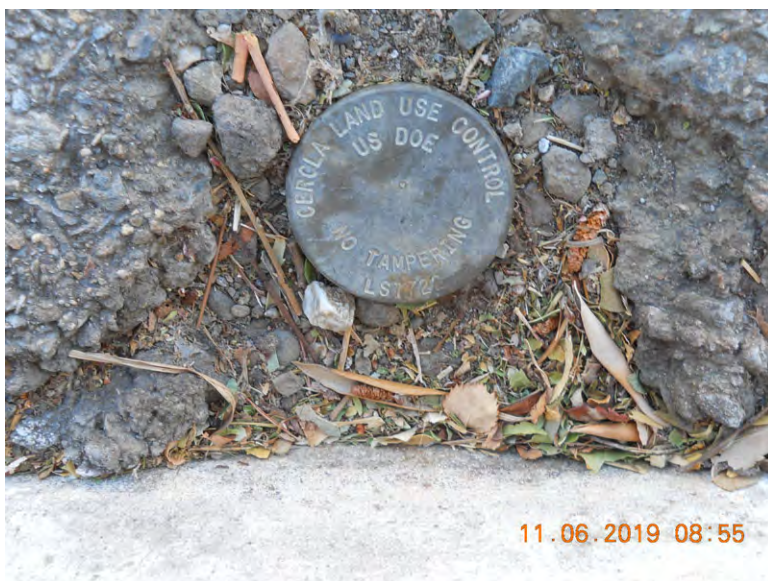
Survey Monument 6: Adjacent to northwest corner of Building H-218; Radium/Strontium Treatment Systems Area (Photo No. 3807).

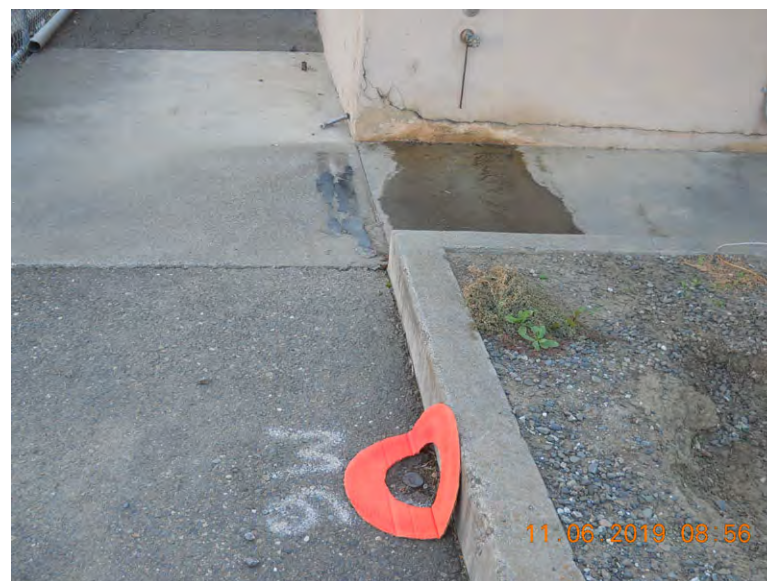
View east: Survey Monument 6, within orange ring; corner of Building H-218 in background (Photo No. 3808).

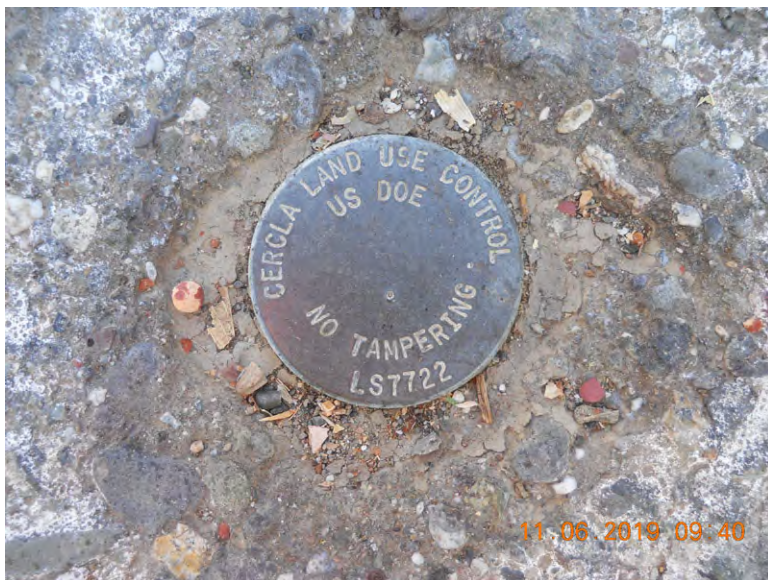
Survey Monument 7: Southwest corner of Domestic Septic System 4 Area (Photo No. 3820).

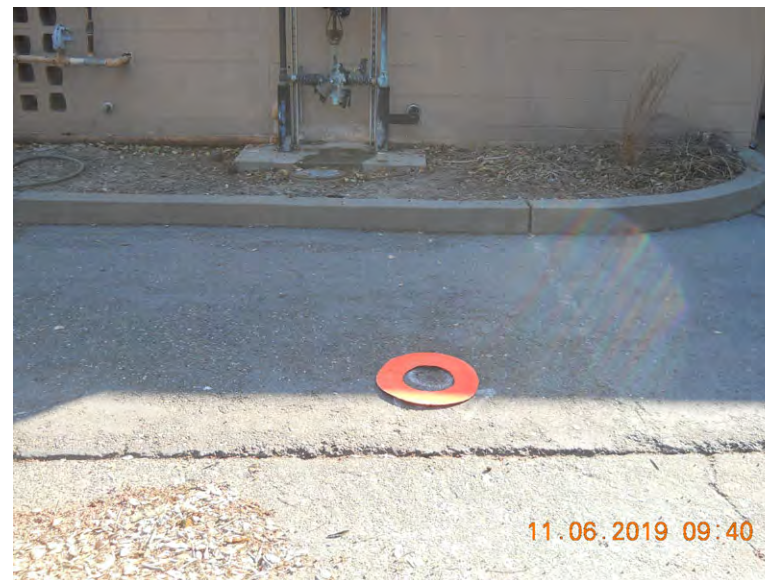
View east: Survey Monument 7, within orange ring; Building H-215 in background (Photo No. 3821).

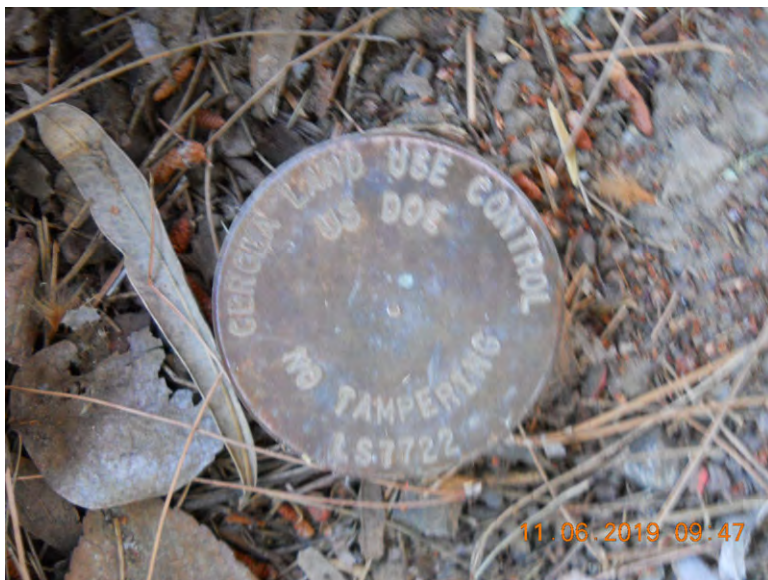
Survey Monument 8: Southwest corner of radium-226 leach trench; Radium/Strontium Treatment Systems Area (Photo No. 3824).

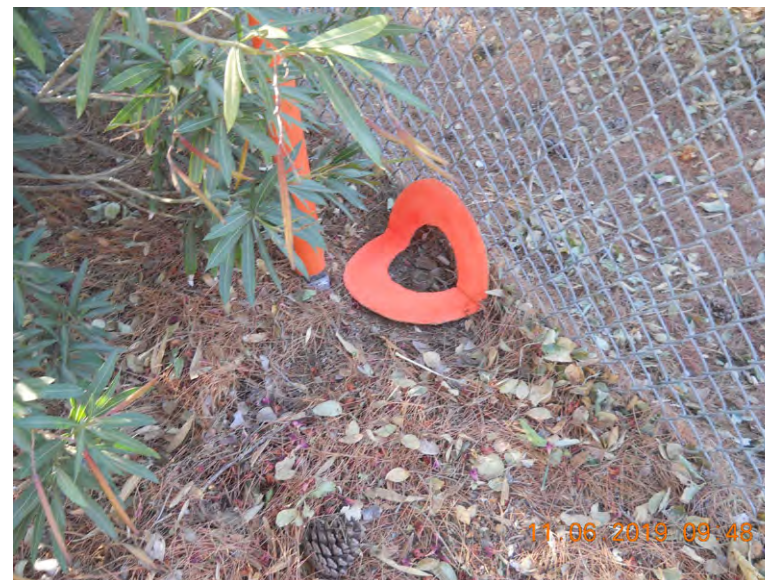
View southwest: Survey Monument 8, within orange ring; west perimeter fence right of survey monument; orange delineator left of survey monument (Photo No. 3825).

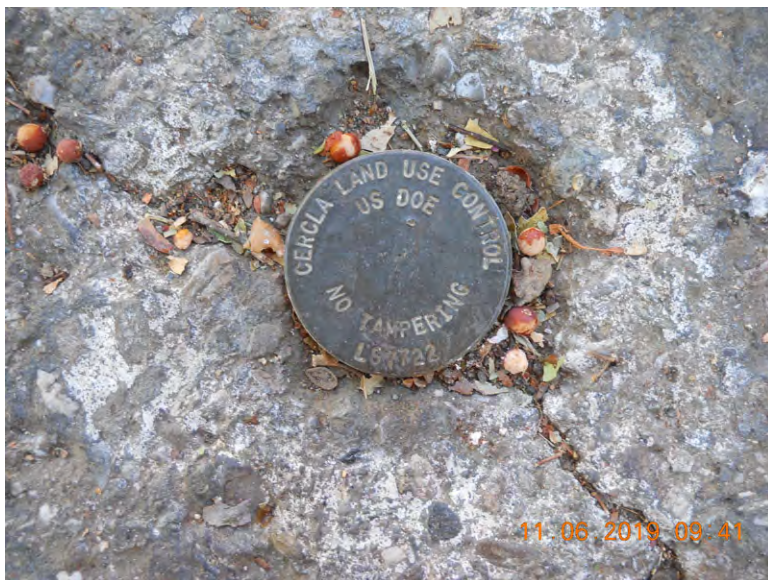
Survey Monument 9: Southeast corner of radium-226 leach trench; Radium/Strontium Treatment Systems Area (Photo No. 3822).

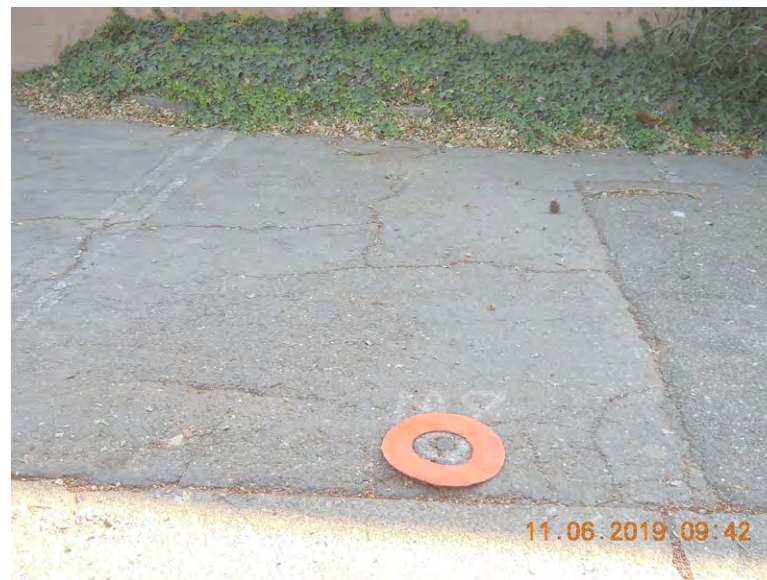
View east: Survey Monument 9, within orange ring; planter and foot of Building H-215 in background (Photo No. 3823).

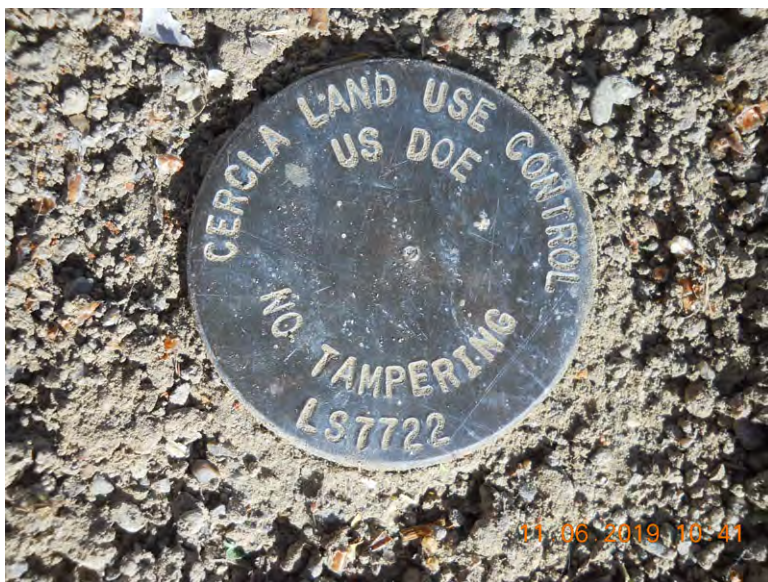
Survey Monument 10: Northeast corner of former leach field in Domestic Septic System 3 Area (Photo No. 3841).

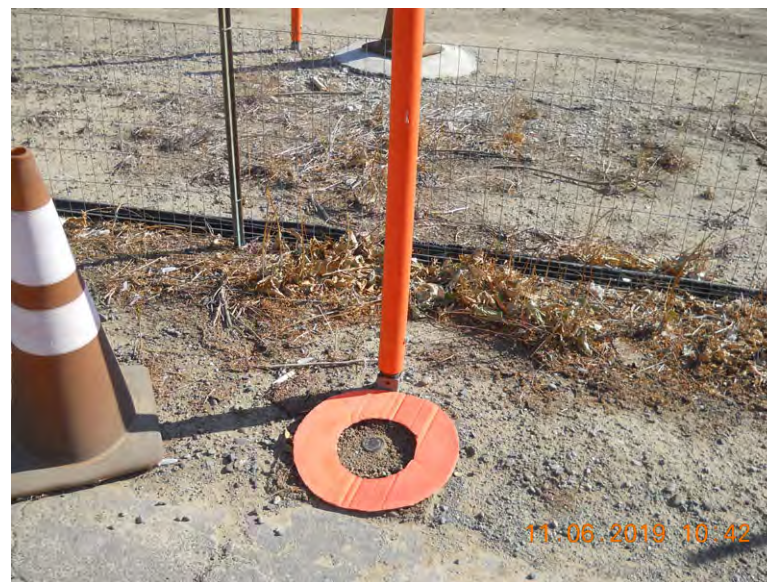
View east: Survey Monument 10, within orange ring in foreground; delineator behind survey monument; well UCD1-069 in background (Photo No. 3842).

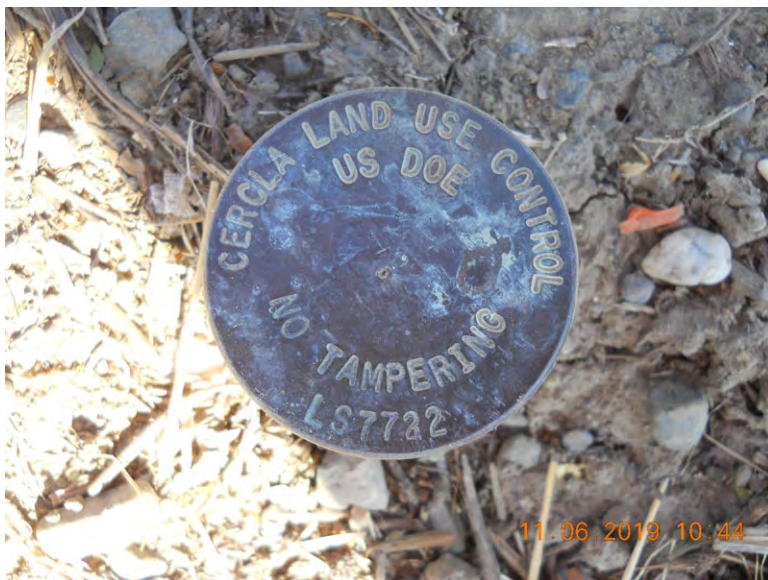
Survey Monument 11: Northeast corner of Eastern Remediation Support Area (Photo No. 3843).

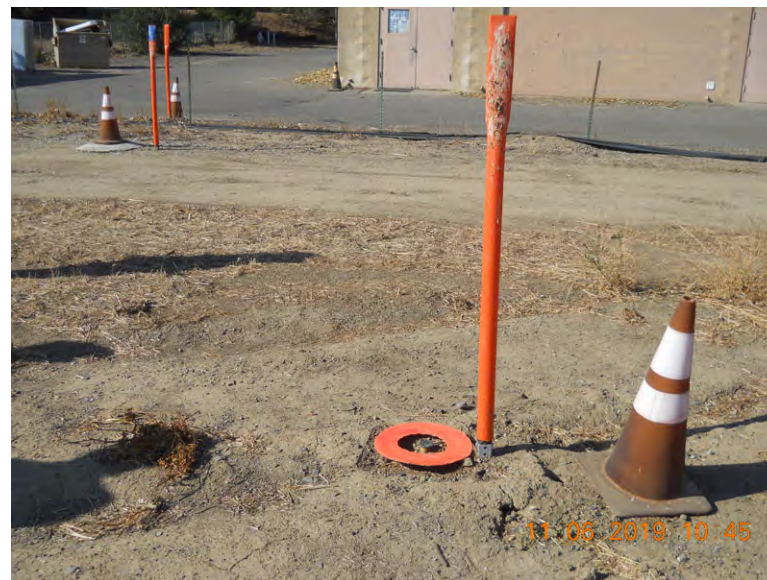
View west: Survey Monument 11, within orange ring; delineator right of survey monument; Building H-216 in background (Photo No. 3844).

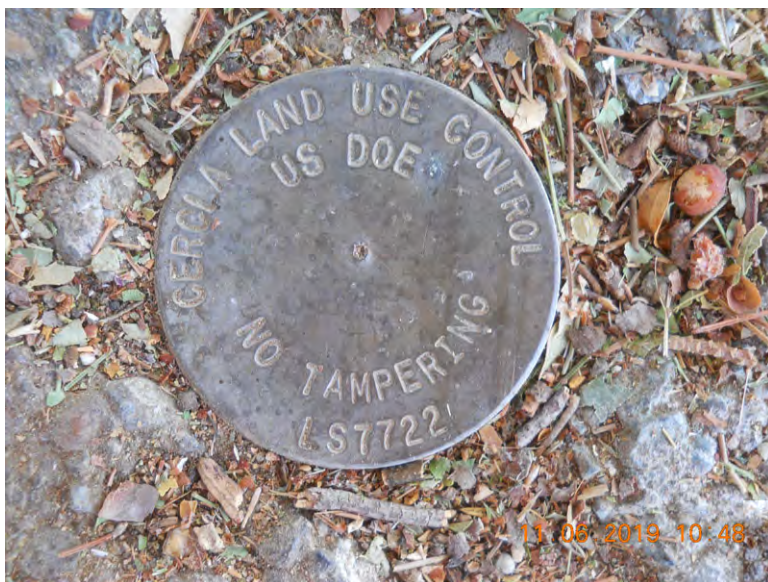
Survey Monument 12: Northwest corner of Southwest Trenches Area (Photo No. 3845).

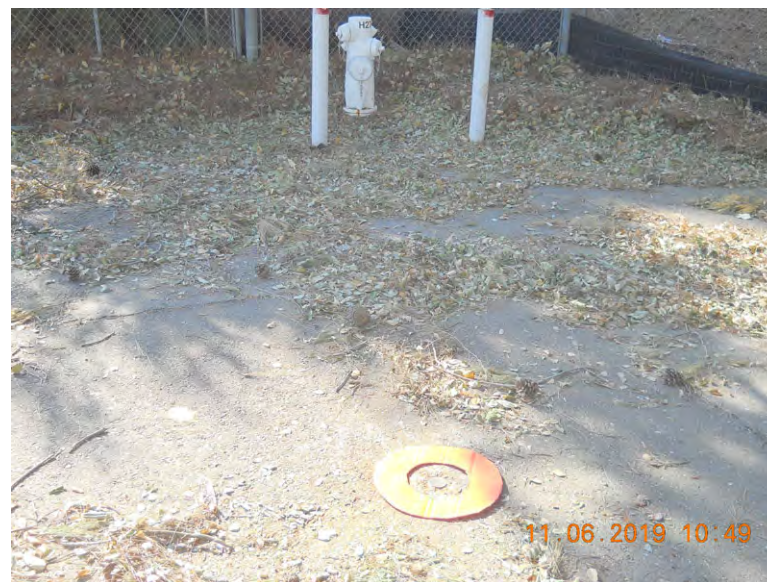
View south: Survey Monument 12, within orange ring in foreground; water hydrant in background (Photo No. 3846).

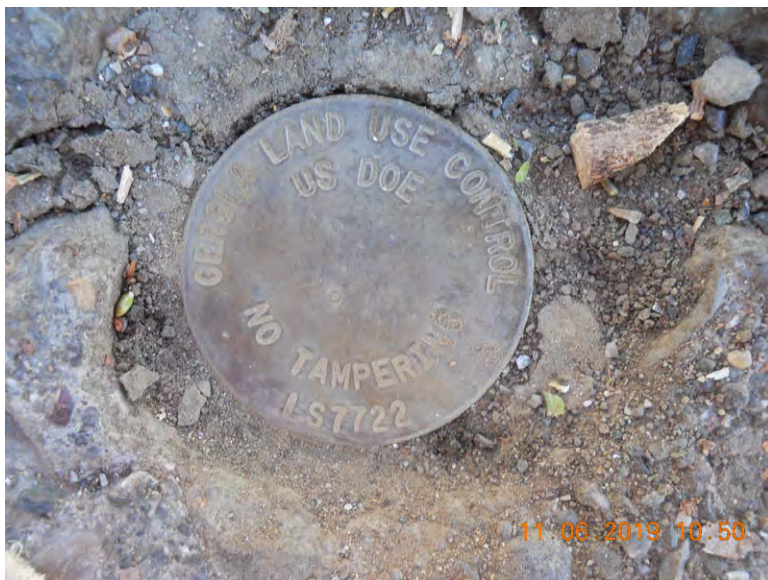
Survey Monument 13: Southwest corner of Domestic Septic System 3 Area, at northern perimeter of Southwest Trenches Area (Photo No. 3847).

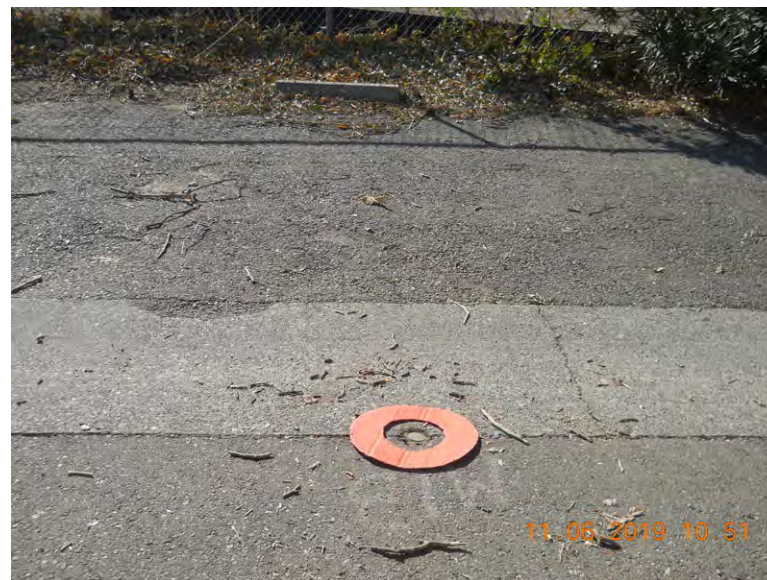
View south: Survey Monument 13, within orange ring at edge of concrete swale (Photo No. 3848).

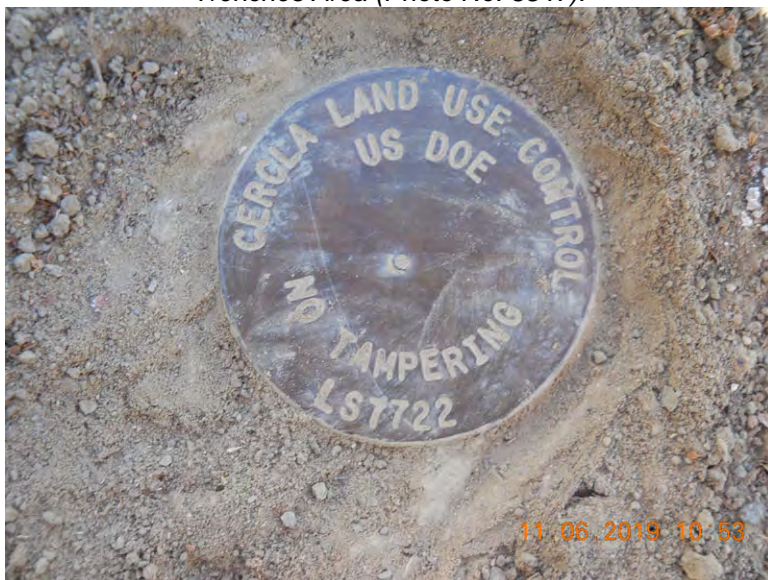
Survey Monument 14: Southeast corner of Domestic Septic System 3 Area (Photo No. 3849).

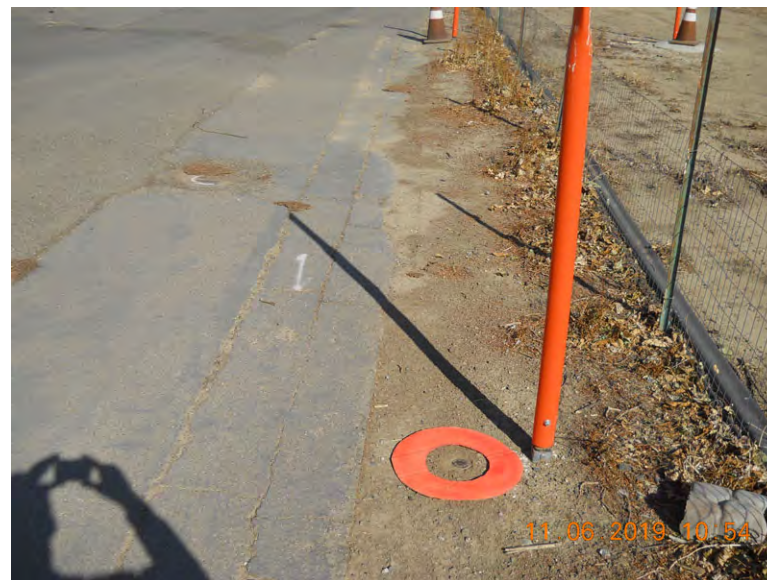
View north: Survey Monument 14, within orange ring; delineator right of survey monument (Photo No. 3850).

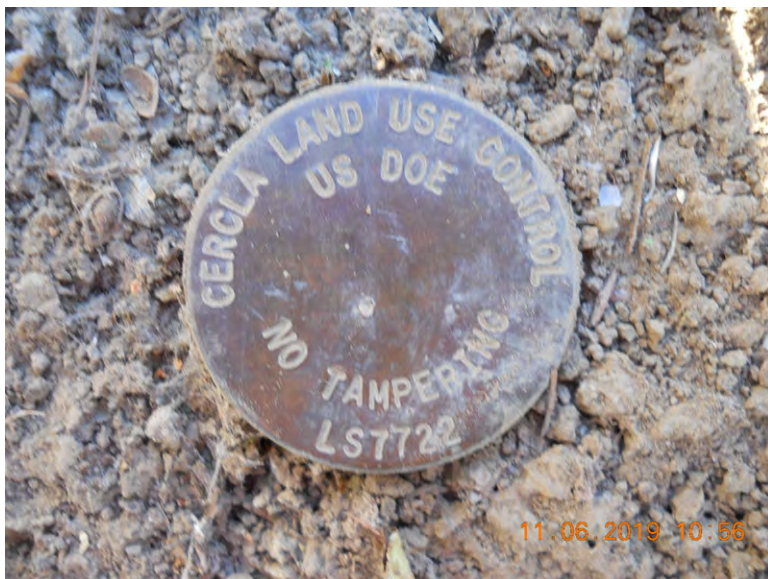
Survey Monument 15: Eastern corner of Southwest Trenches Area
(Photo No. 3851).

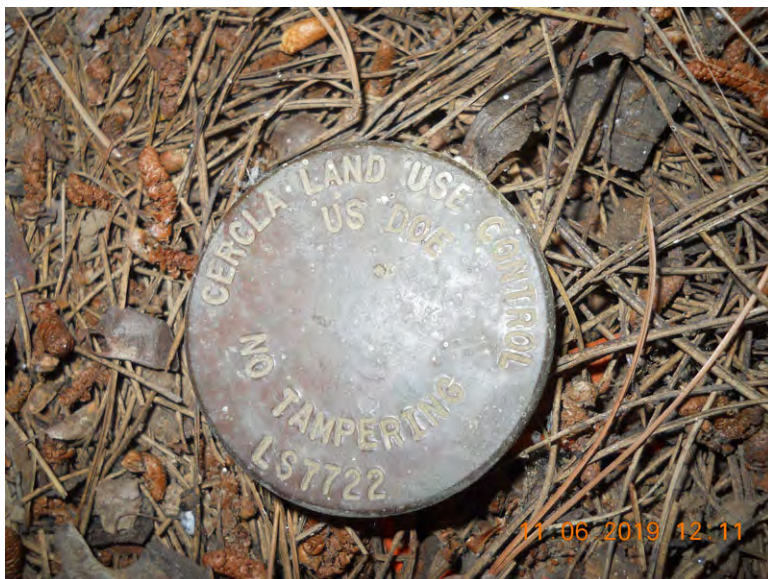
Survey Monument 16: Southwest corner of Southwest Trenches Area
(Photo No. 3874).

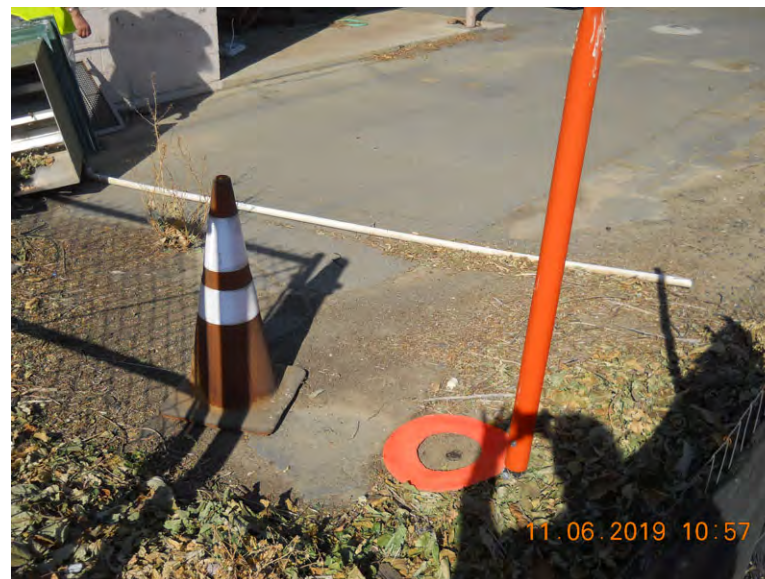
View northwest: Survey Monument 15, within orange ring; delineator
right of survey monument, trailer storage unit in background
(Photo No. 3852).

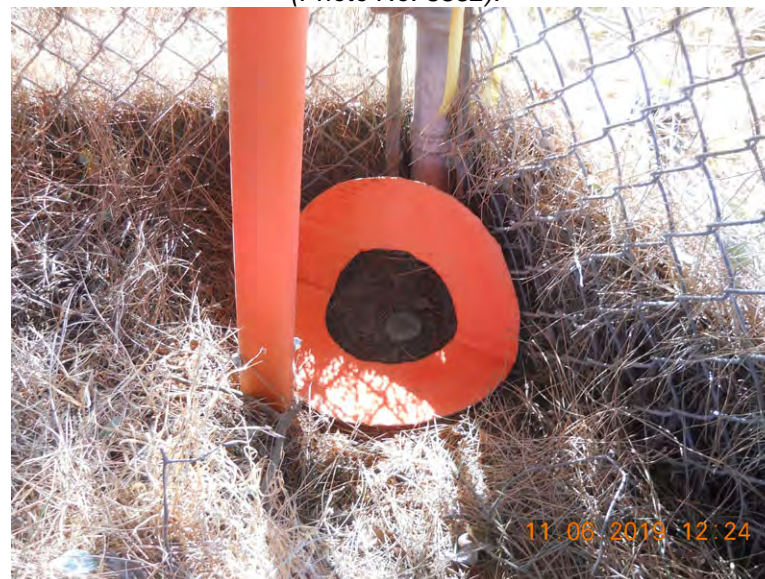
View southwest: Survey Monument 16, within orange ring; delineator
left of survey monument; southwest corner post of perimeter fence
behind survey monument (Photo No. 3878).

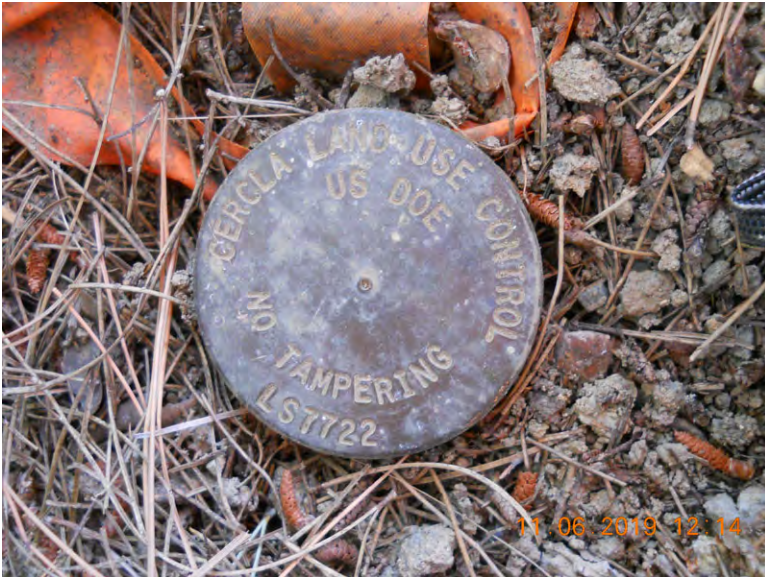
Survey Monument 17: Southeast corner of Southwest Trenches Area (Photo No. 3875).

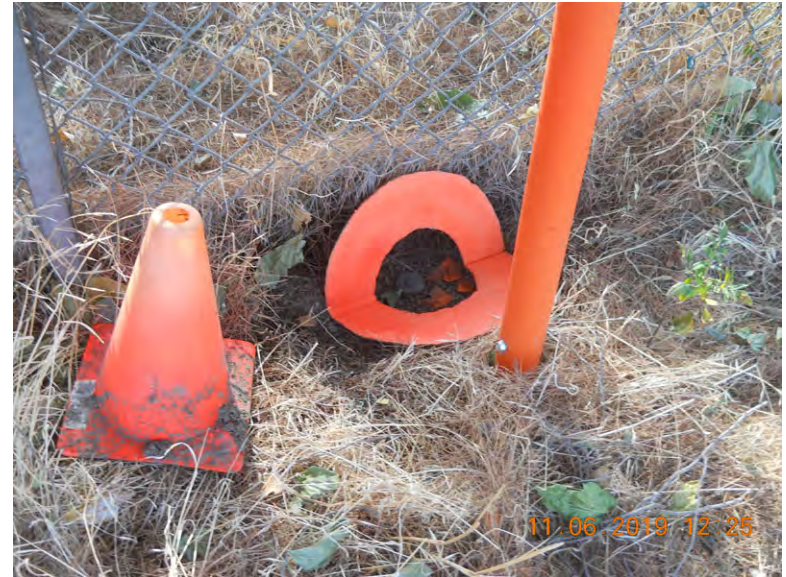
View southwest: Survey Monument 17, within orange ring; delineator right of survey monument; south perimeter fence behind survey monument; foot of North Levee in background (Photo No. 3879).

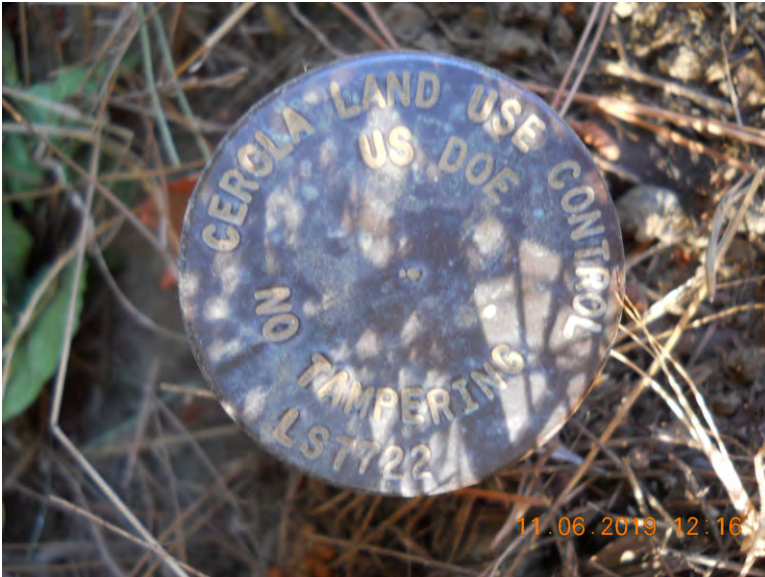
Survey Monument 18: Southeast corner of Eastern Remediation Support Area (Photo No. 3876).

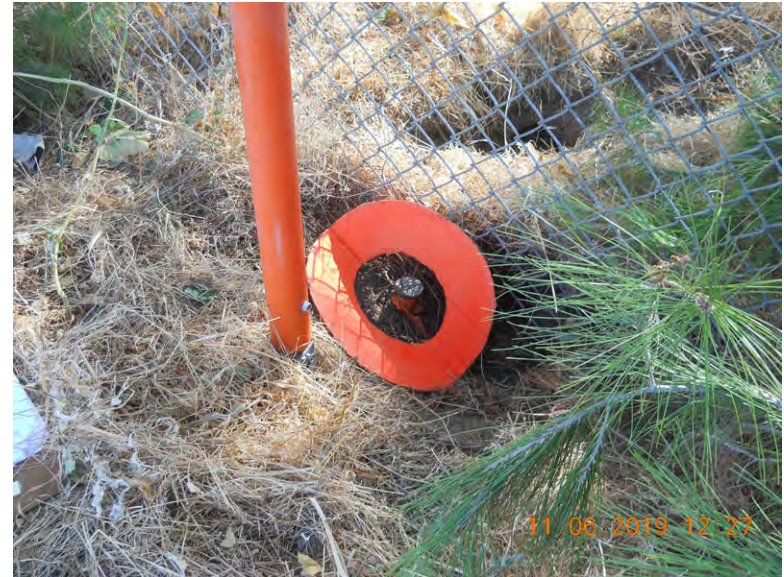
View southeast: Survey Monument 18, within orange ring; delineator left of survey monument; south perimeter fence behind survey monument; foot of North Levee in background (Photo No. 3880).

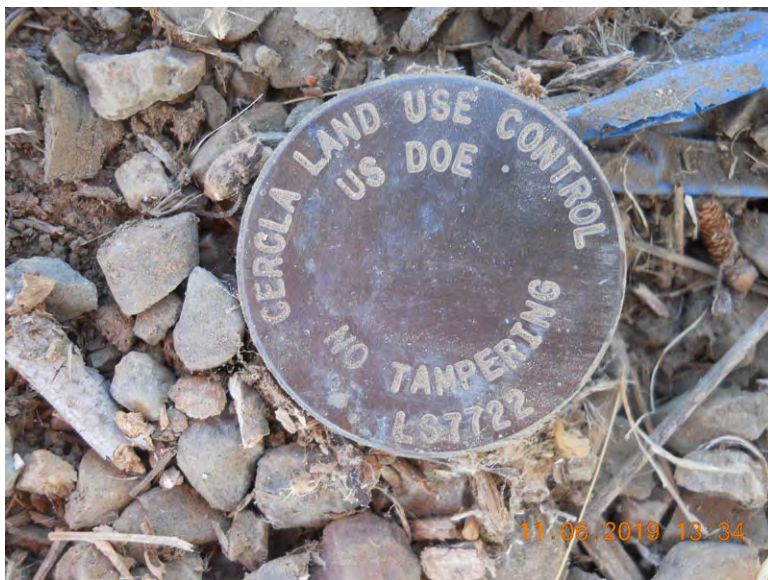
Survey Monument 19: Northwest corner of Eastern Dog Pens Area
(Photo No. 3887).

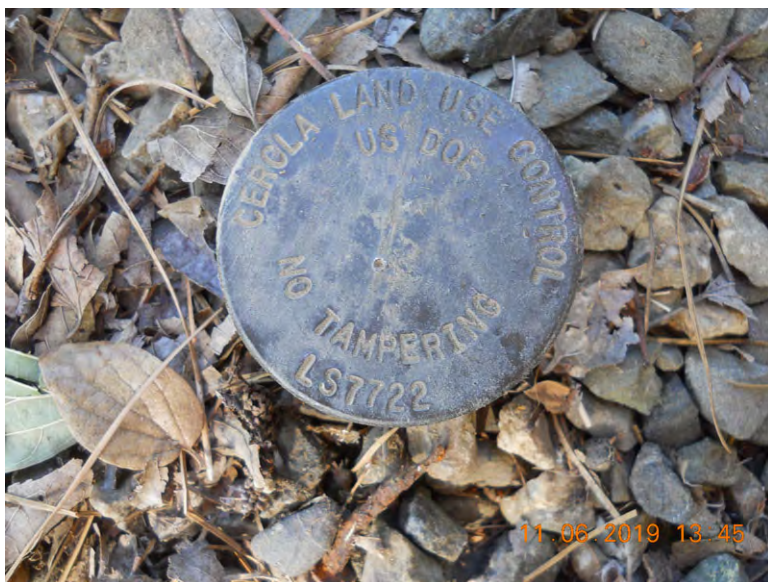
Survey Monument 20: Northeast corner of Eastern Dog Pens Area
(Photo No. 3892).

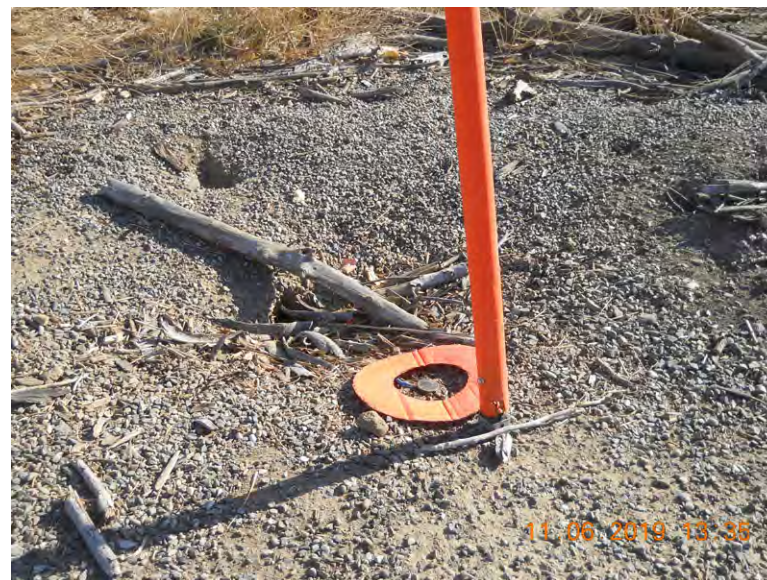
View southeast: Survey Monument 19, within orange ring;
delineator right of survey monument; Eastern Dog Pens Area
in background (Photo No. 3888).

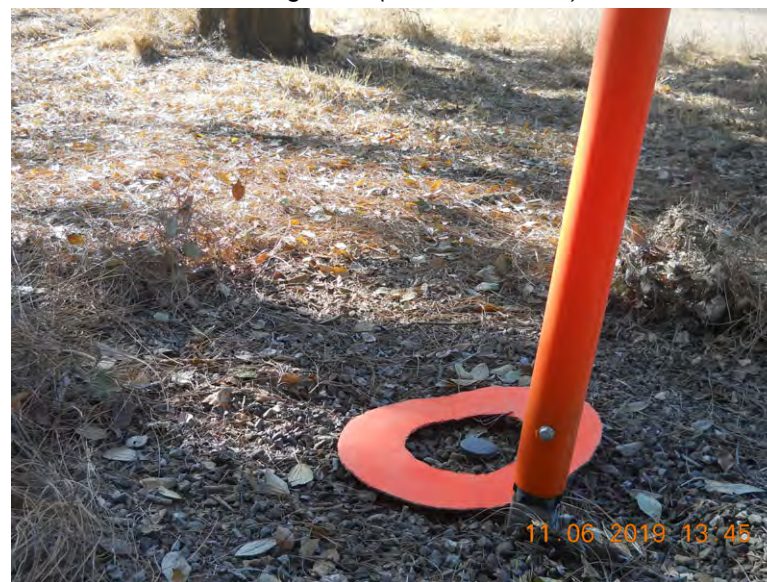
View southwest: Survey Monument 20, within orange ring;
delineator right of survey monument; Eastern Dog Pens Area in background
(Photo No. 3893).

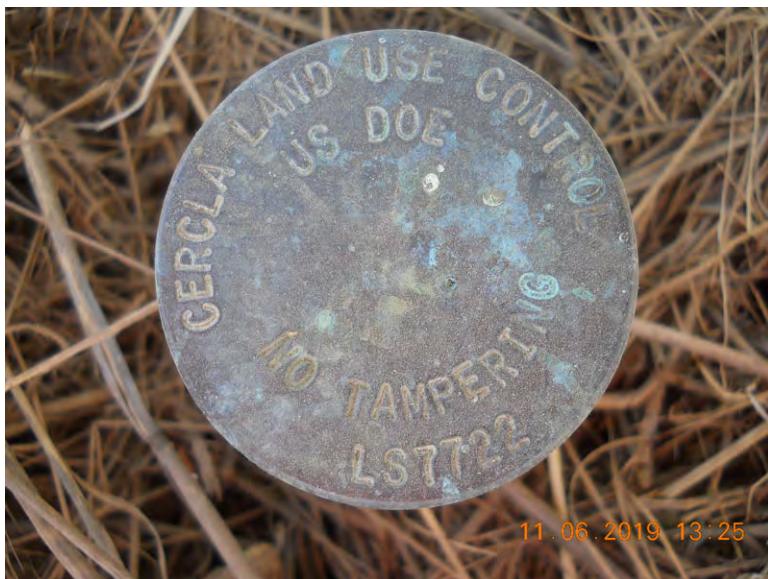
Survey Monument 21: Southwest corner of Eastern Dog Pens Area
(Photo No. 3882).

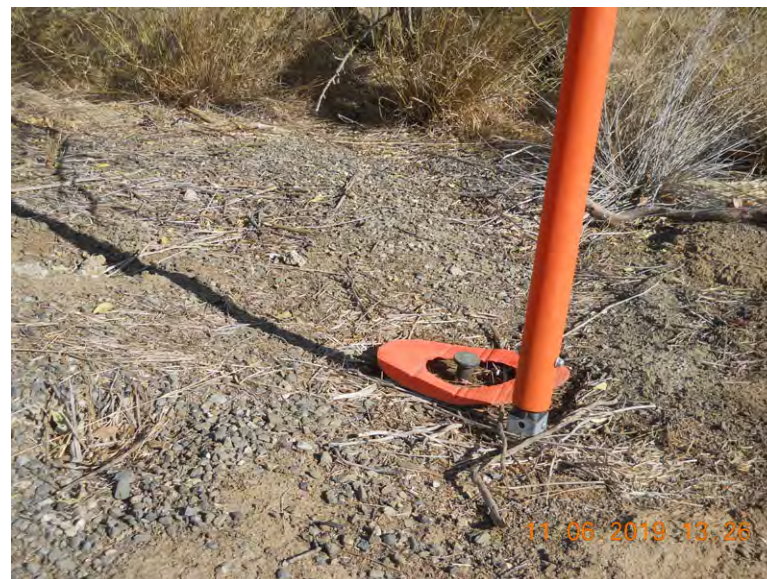
View northeast: Survey Monument 21, within orange ring; delineator
right of survey monument; Eastern Dog Pens Area in background
(Photo No. 3883).

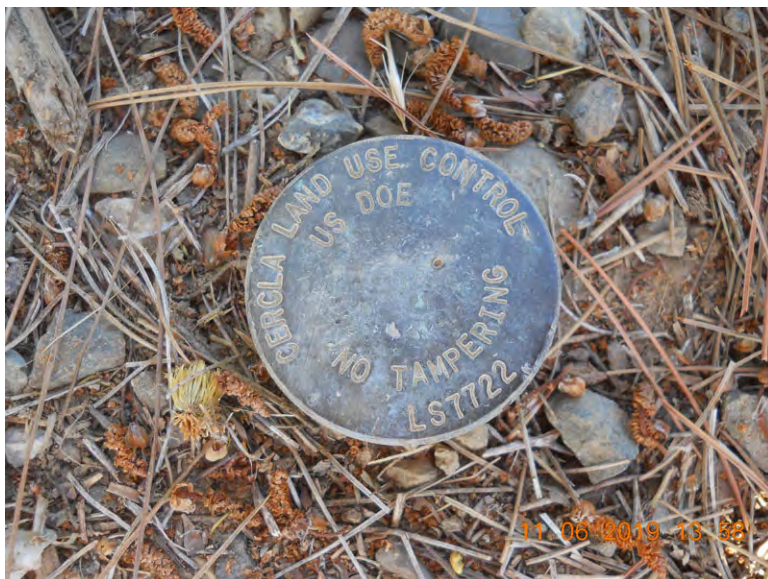
Survey Monument 22: Southeast corner of Eastern Dog Pens Area
(Photo No. 3900).

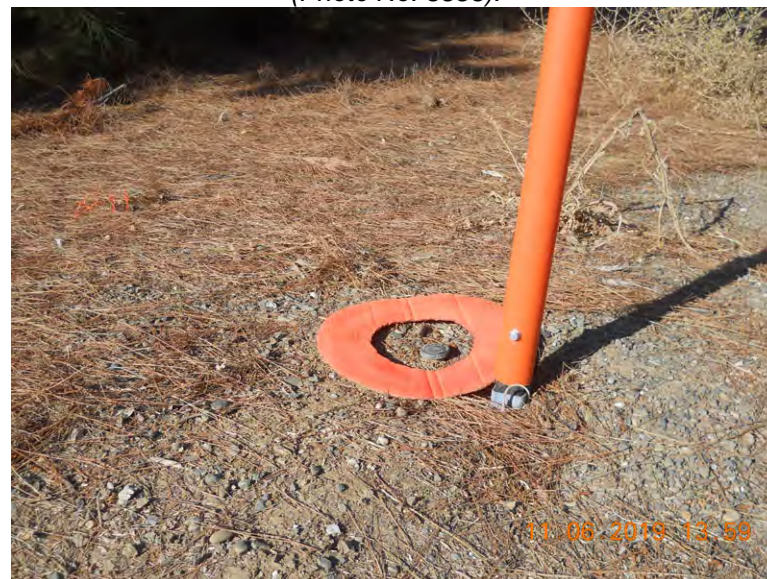
View northwest: Survey Monument 22, within orange ring; delineator
right of survey monument; Eastern Dog Pens Area in background
(Photo No. 3901).

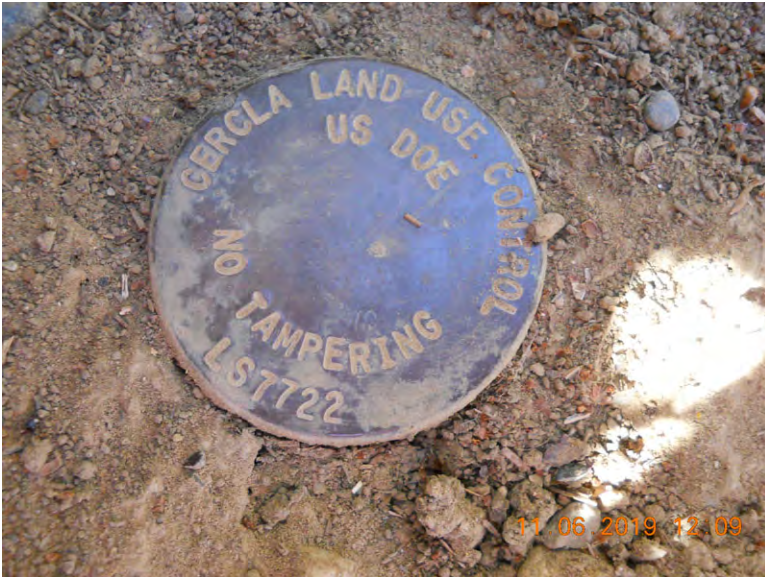
Survey Monument 23: Western perimeter point of Southwest Trenches Area (Photo No. 3873).

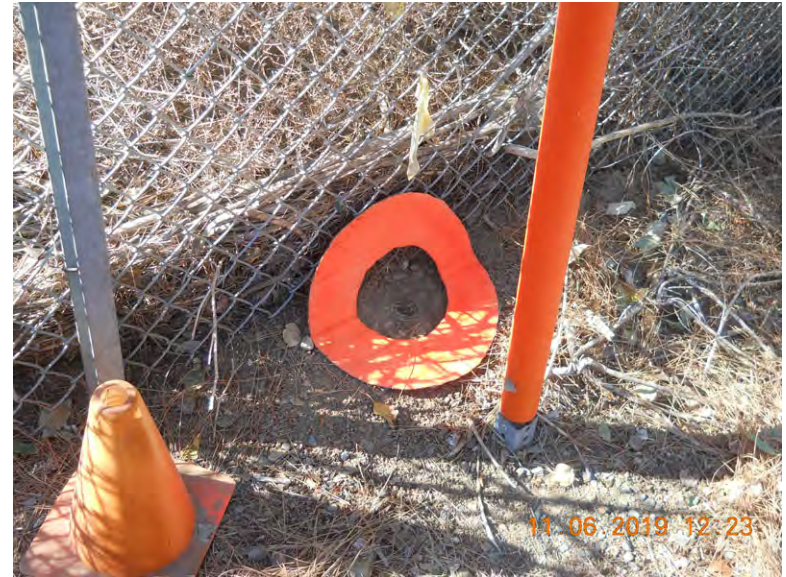
View northwest: Survey Monument 23, within orange ring; delineator right of survey monument; west perimeter fence behind and left of survey monument (Photo No. 3877).

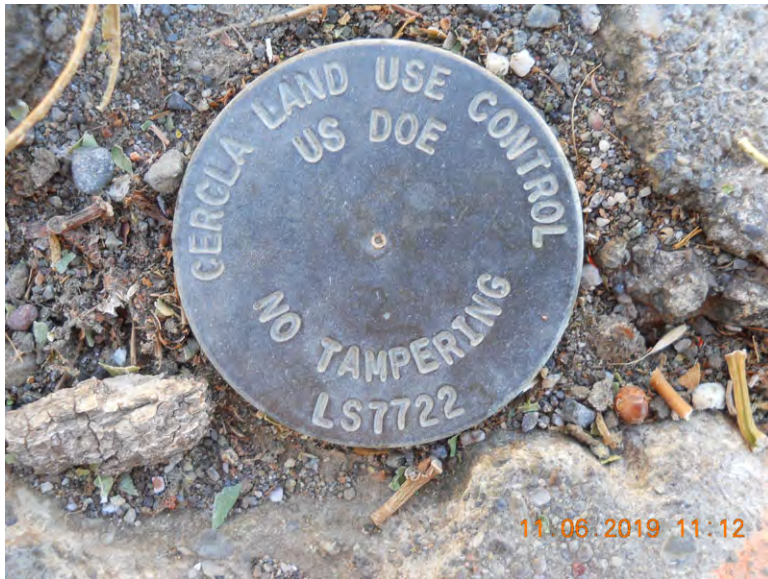
Survey Monument 24: Northeast corner of Southwest Trenches Area, at southern perimeter of Domestic Septic System 3 Area (Photo No. 3853).

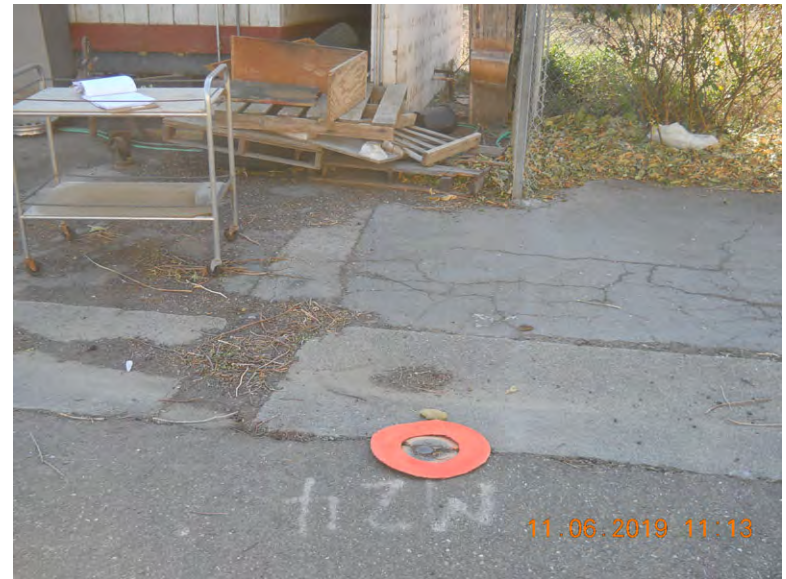
View south: Survey Monument 24, within orange ring on edge of concrete swale; trailer storage unit behind survey monument (Photo No. 3854).

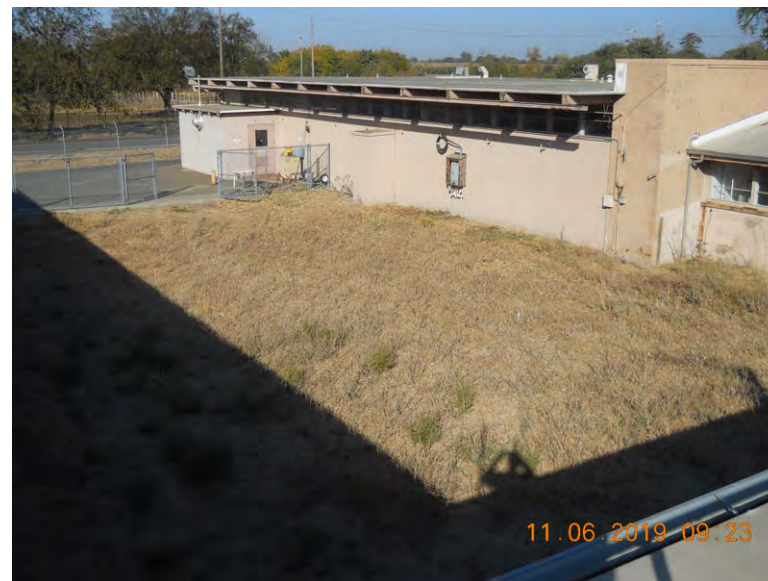
Roof-level view northwest of central portion of Radium/Strontium Treatment Systems Area: Building H-219 in background (Photo No. 3817).
