**2019 Annual Land-Use Covenant
Inspection Report
for DOE Areas at the Laboratory
for Energy-Related Health
Research/Old Campus Landfill
Superfund Site
University of California, Davis**

January 2020

**U.S. DEPARTMENT OF
ENERGY**

Legacy
Management

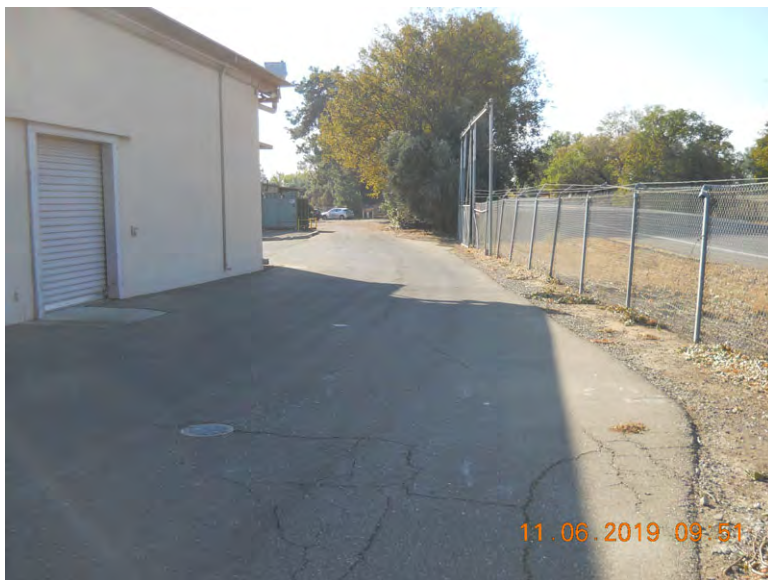
View south over northern portion of Radium/Strontium Treatment Systems Area: Building H-219 to left; west perimeter fence and Old Davis Road to right (photo No. 3826).

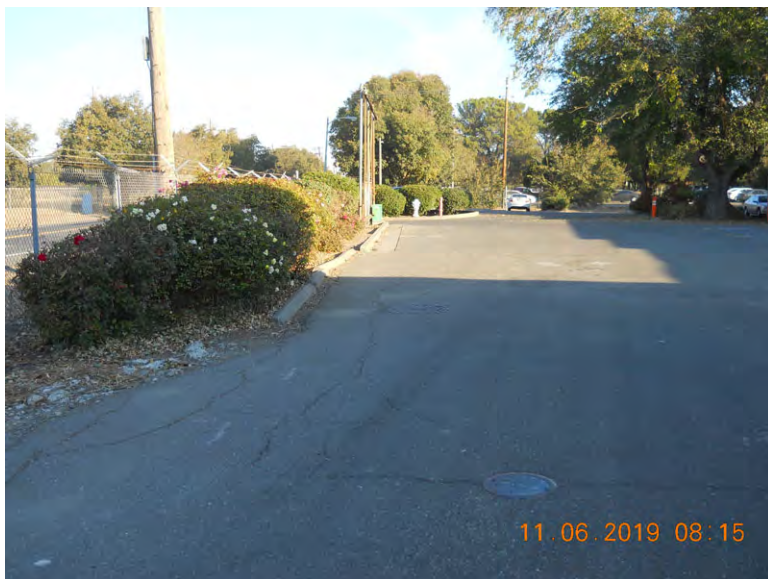
*View north of Dry Wells A-E Area: Old Davis Road to left
(Photo No. 3791).*

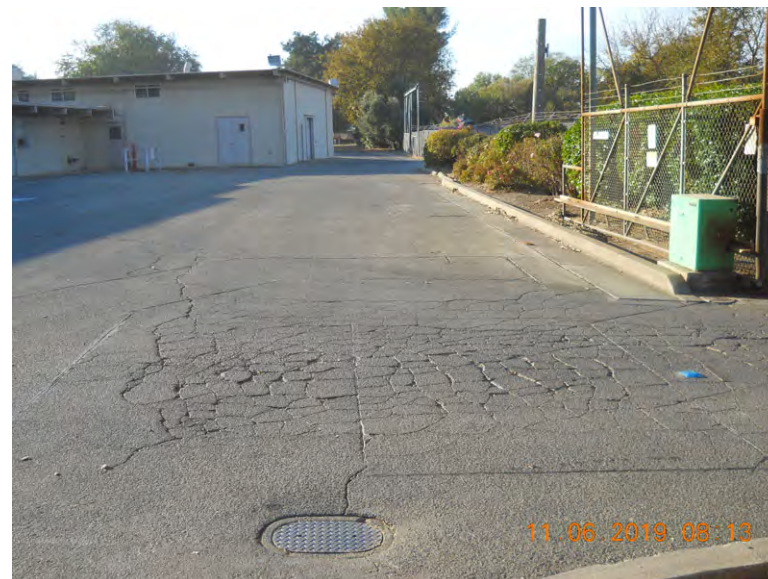
*View south of Dry Wells A-E Area: Building H-219 in
background/left (Photo No. 3788).*

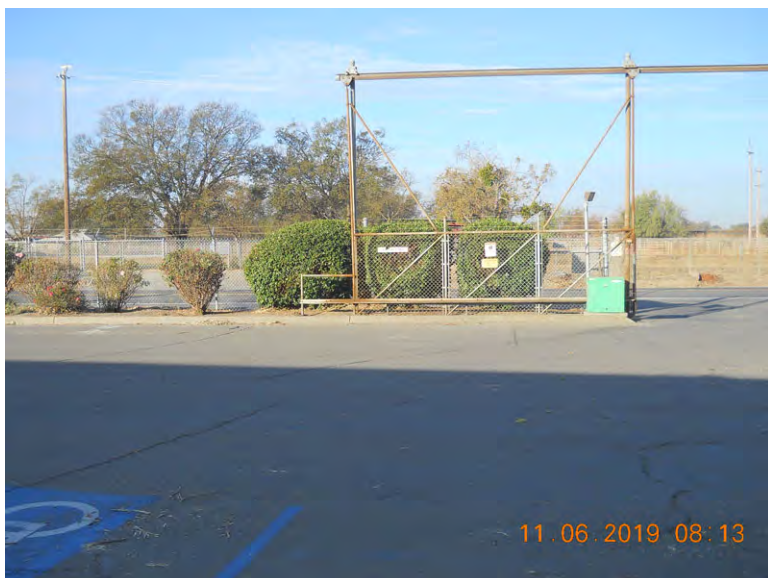
*View west of Dry Wells A-E Area and main gate; Old Davis Road
in background (Photo No. 3789).*

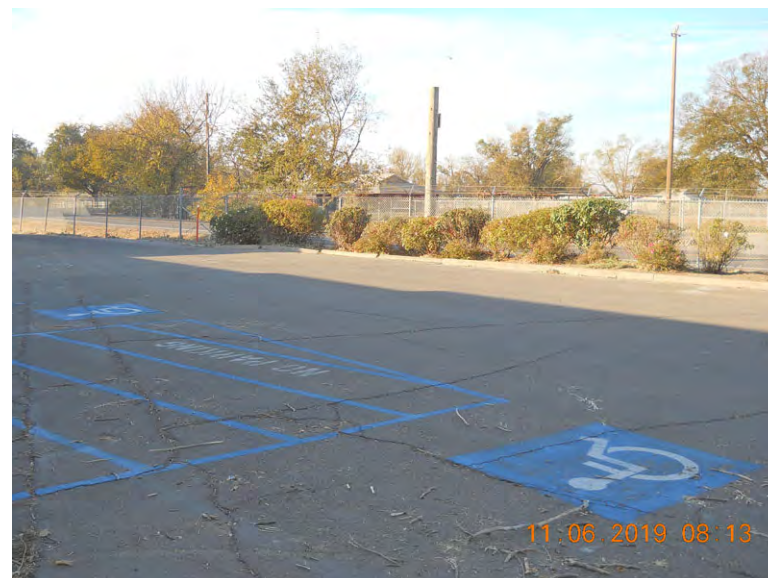
*View southwest of Dry Wells A-E Area
(Photo No. 3790).*

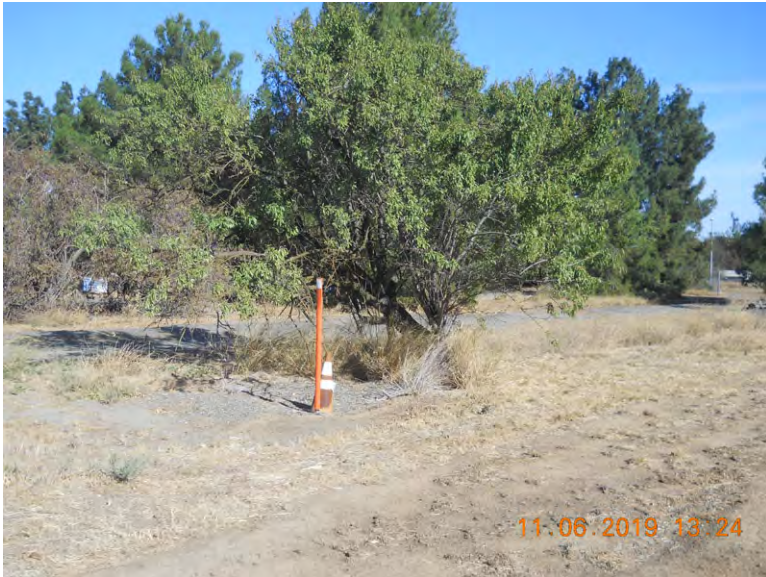
View northeast of Eastern Dog Pens Area from southwest corner showing southwest corner monument location (Photo No. 3881).

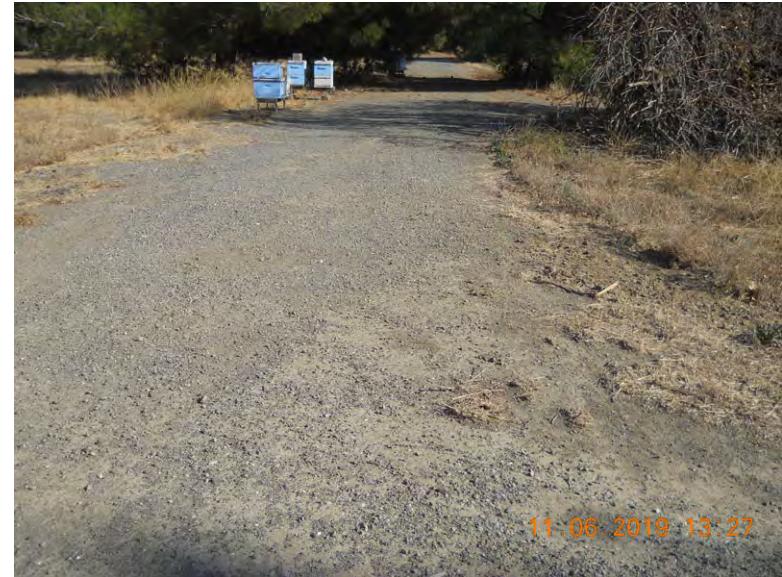
View east of Eastern Dog Pens Area; beehives in background (Photo No. 3884).

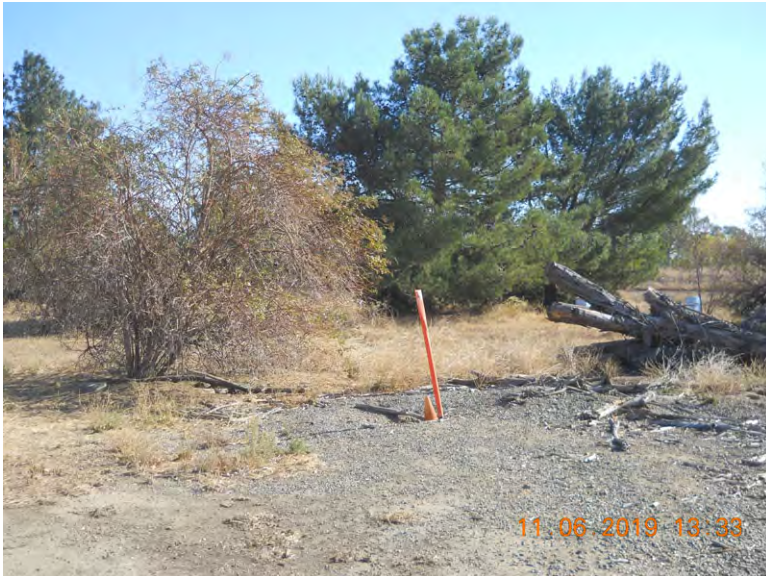
View southeast of Eastern Dog Pens Area from northwest corner showing northwest corner monument location; downed tree on right side was originally located outside the Eastern Dog Pens Area (Photo No. 3886).

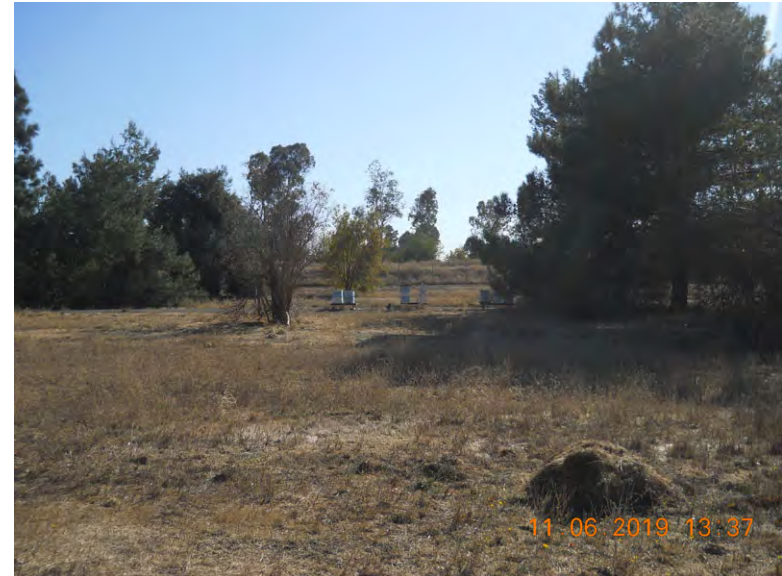
View south of Eastern Dog Pens Area; beehives in background (Photo No. 3889).

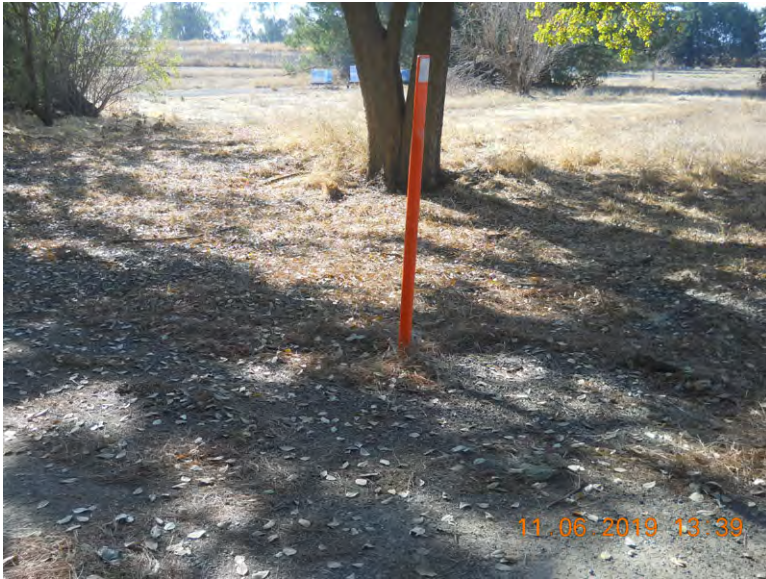
View southwest of Eastern Dog Pens Area from northeast corner showing location of northeast corner monument (Photo No. 3890).

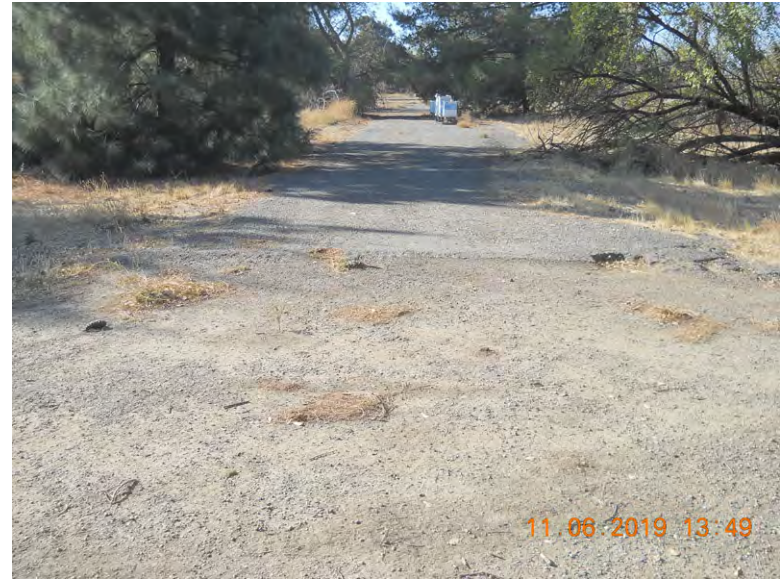
View west of Eastern Dog Pens Area; beehives in background (Photo No. 3894).

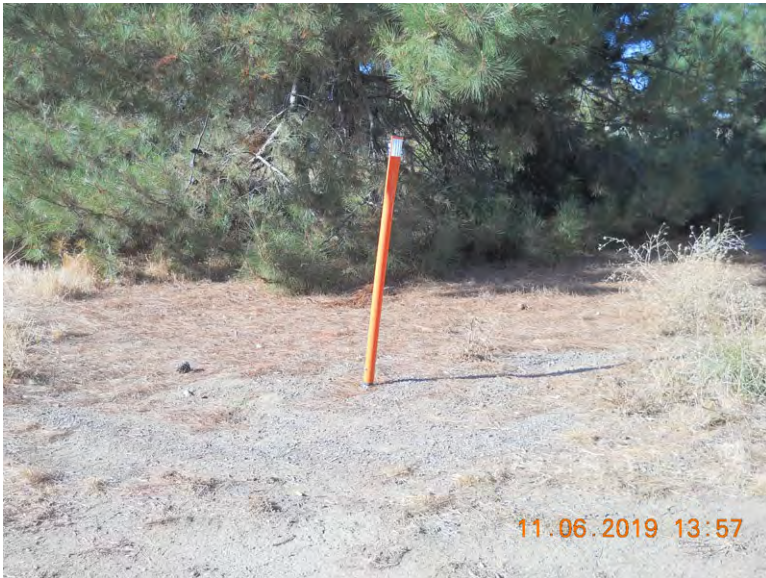
View northwest into Eastern Dog Pens Area from southeast corner showing location of southeast corner monument (Photo No. 3898).

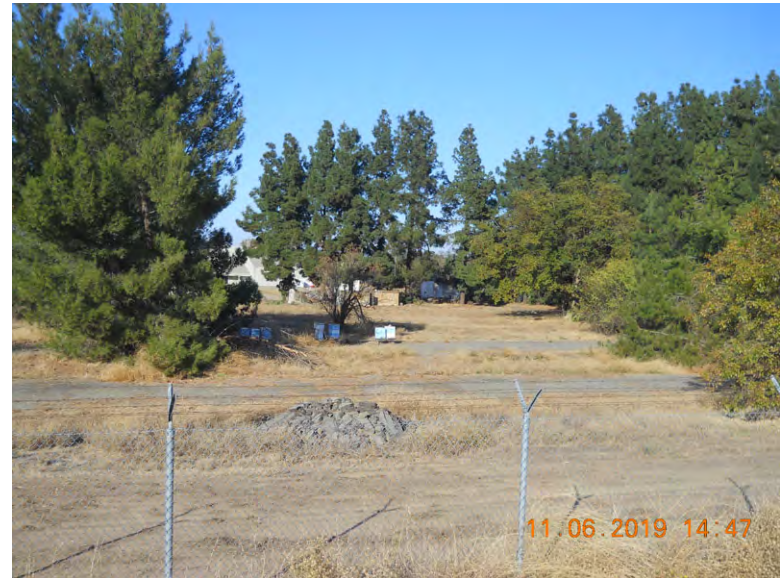
View north over Eastern Dog Pens Area from North Levee of the South Fork of Putah Creek; beehives in middle ground (Photo No. 3910).

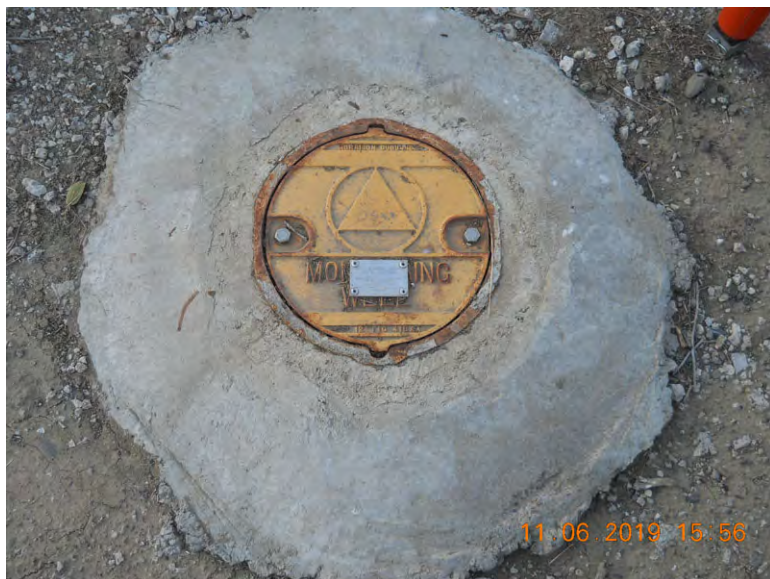
UCD1-069 Wellhead (Photo No. 3921).

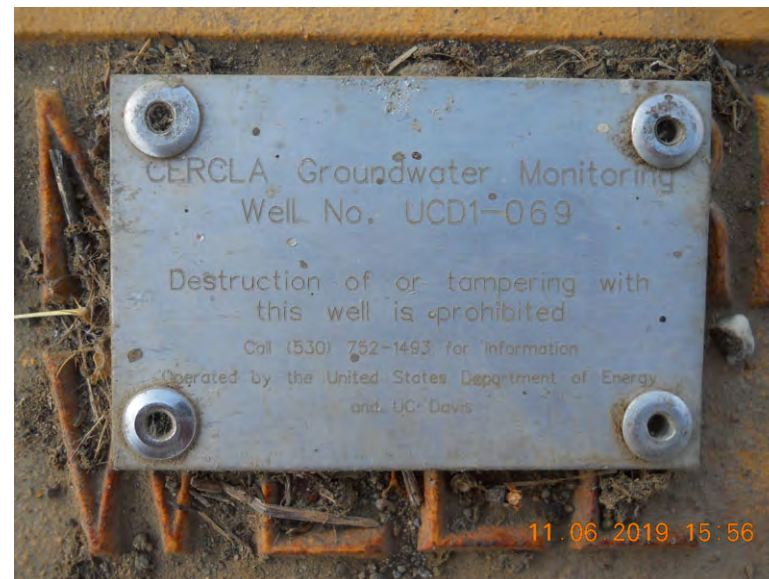
UCD1-069 Wellhead plaque (Photo No. 3922).

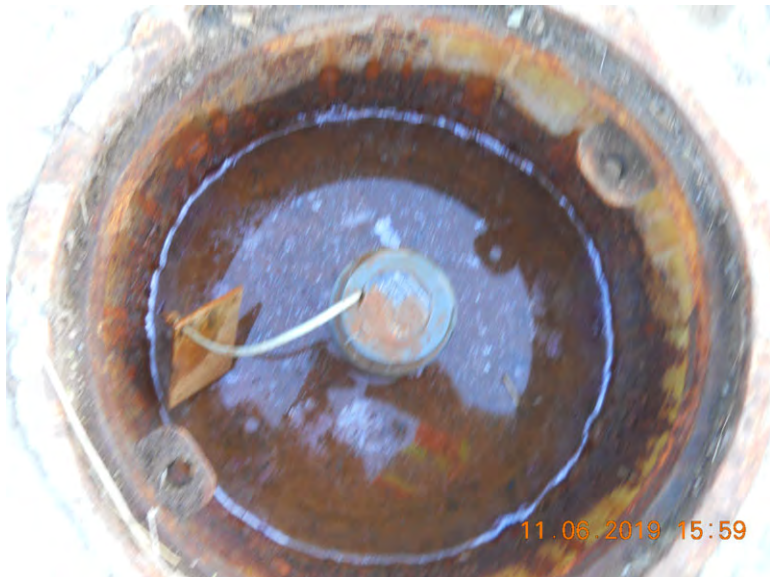
UCD1-069 Interior (Photo No. 3923).

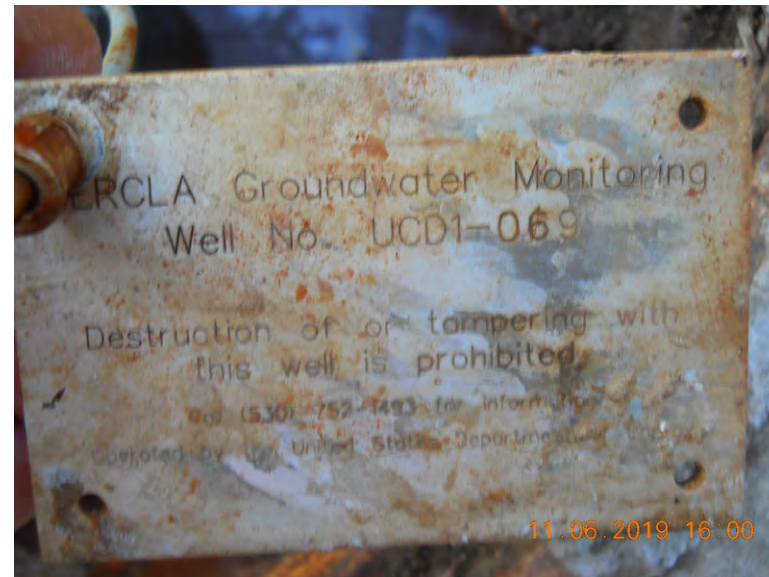
UCD1-069 Interior plaque (Photo No. 3924).

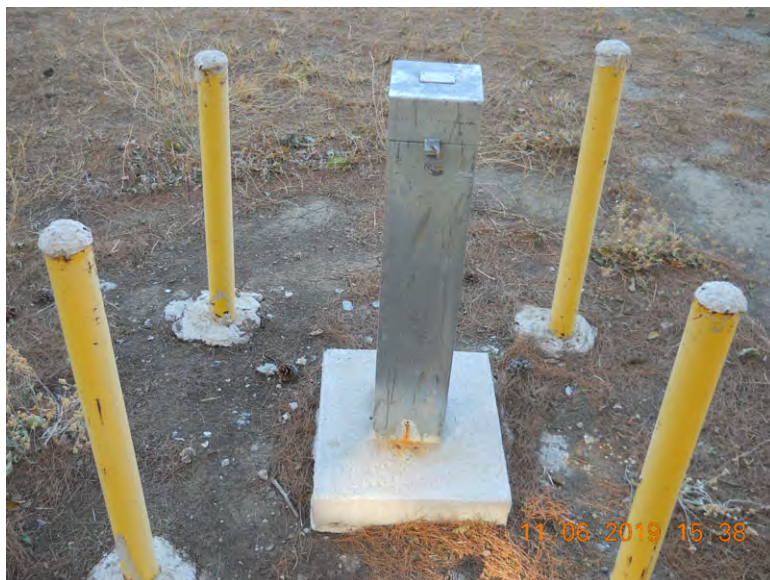
UCD1-070 Wellhead (Photo No. 3917).

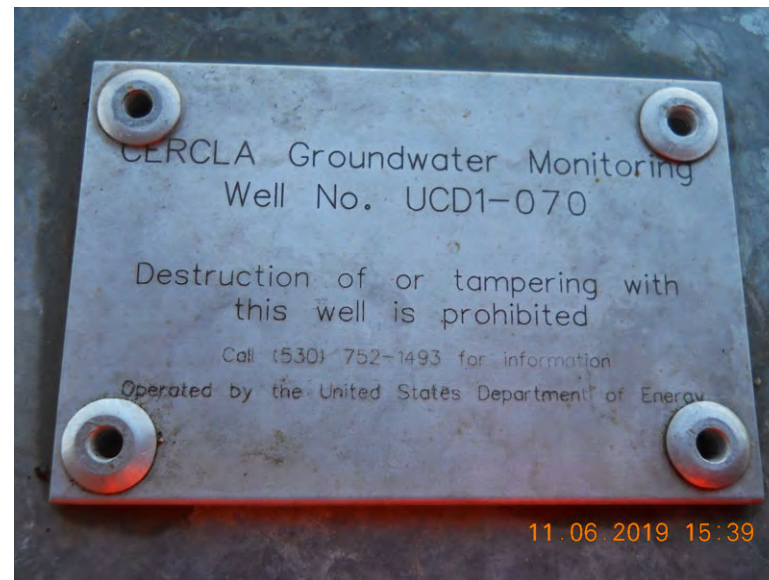
UCD1-070 Wellhead plaque (Photo No. 3918).

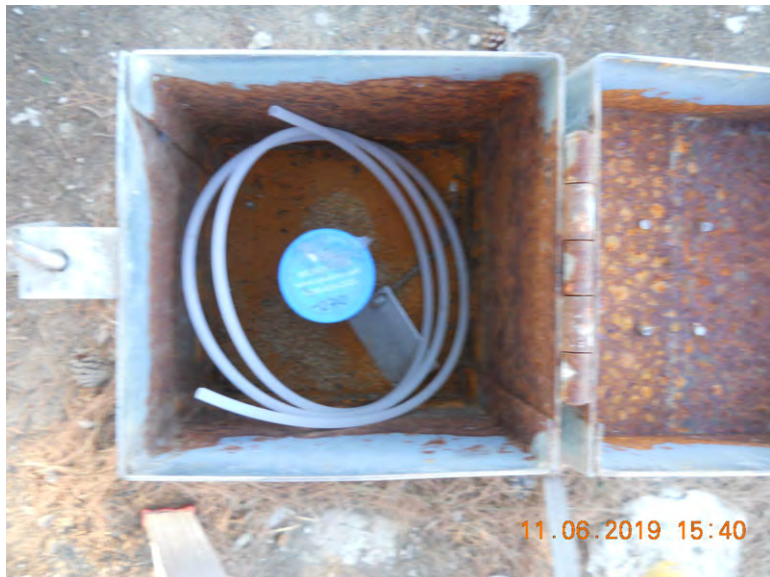
UCD1-070 Interior (Photo No. 3919).

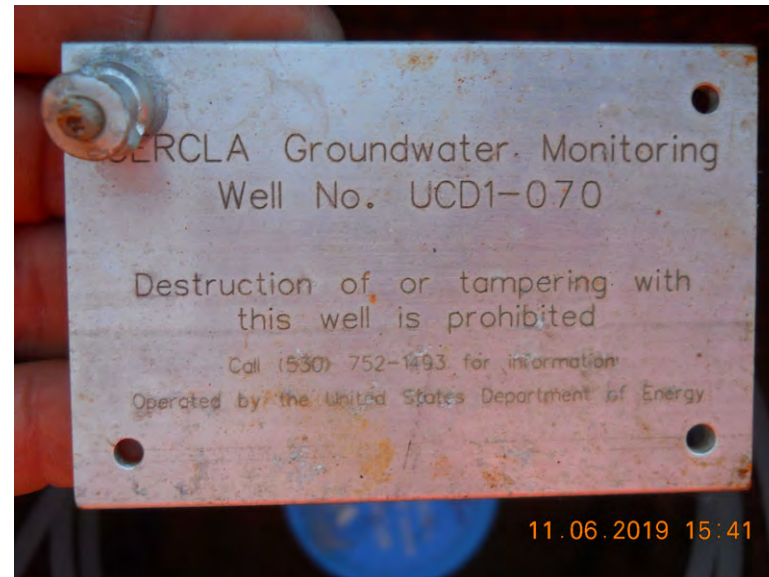
UCD1-070 Interior plaque (Photo No. 3920).

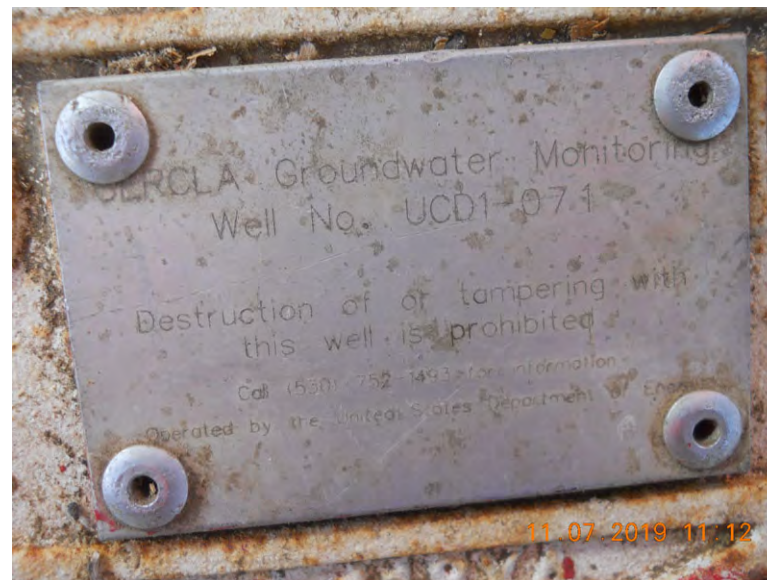
UCD1-071 Wellhead plaque (Photo No. 3948).

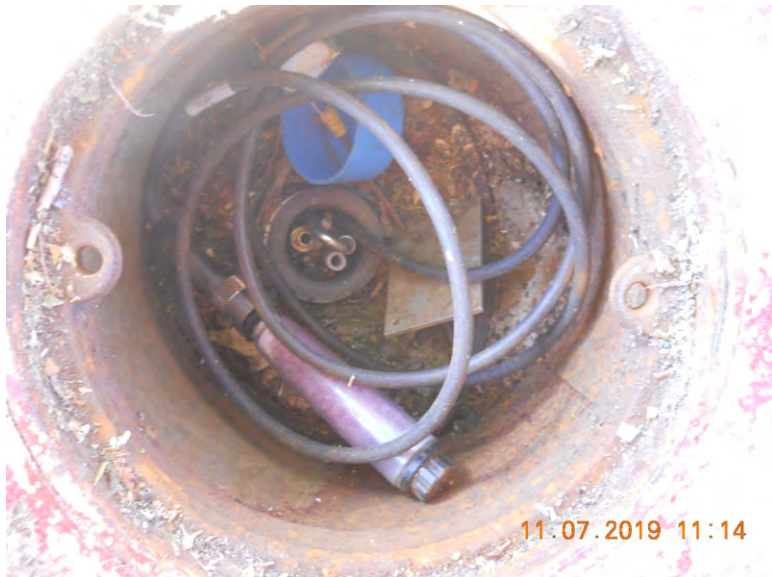
UCD1-071 Interior (Photo No. 3949).

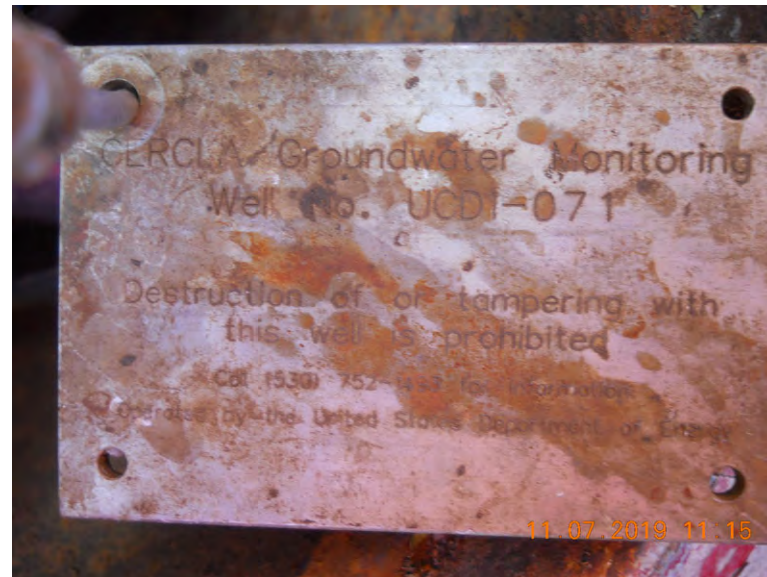
UCD1-071 Interior plaque (Photo No. 3951).

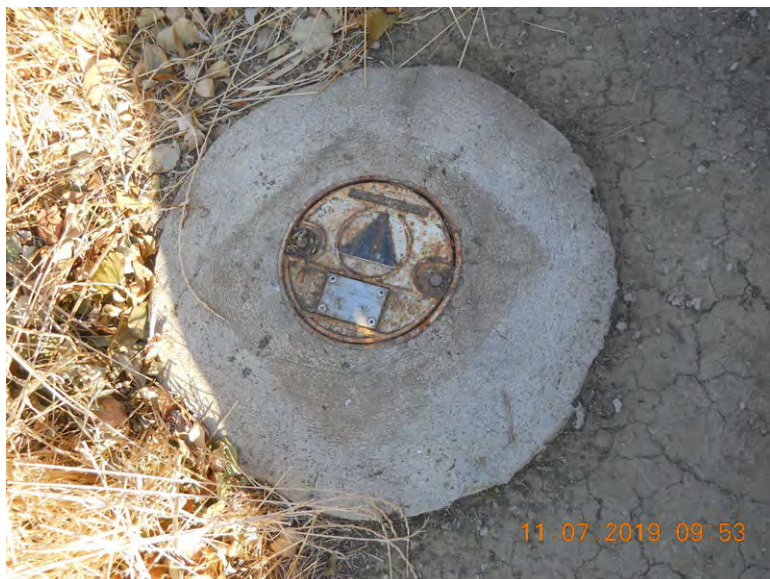
UCD1-072 Wellhead (Photo No. 3932).

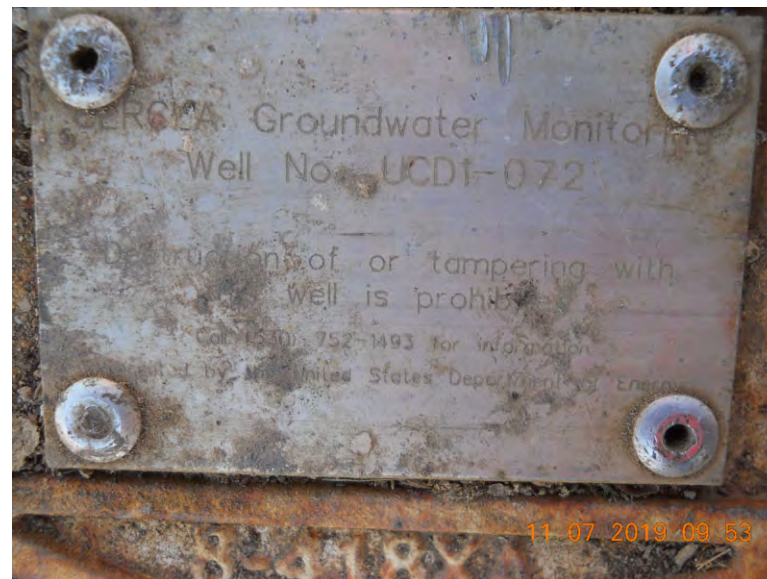
UCD1-072 Wellhead plaque (Photo No. 3933).

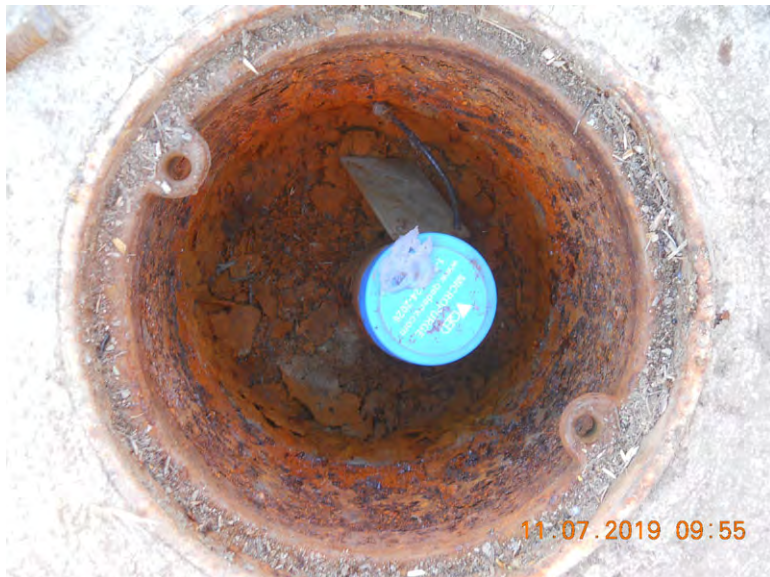
UCD1-072 Interior (Photo No. 3934).

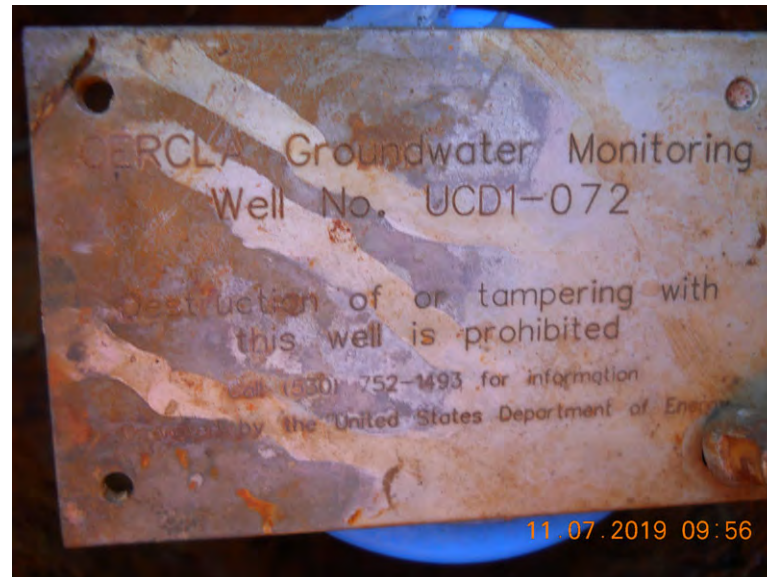
UCD1-072 Interior plaque (Photo No. 3935).

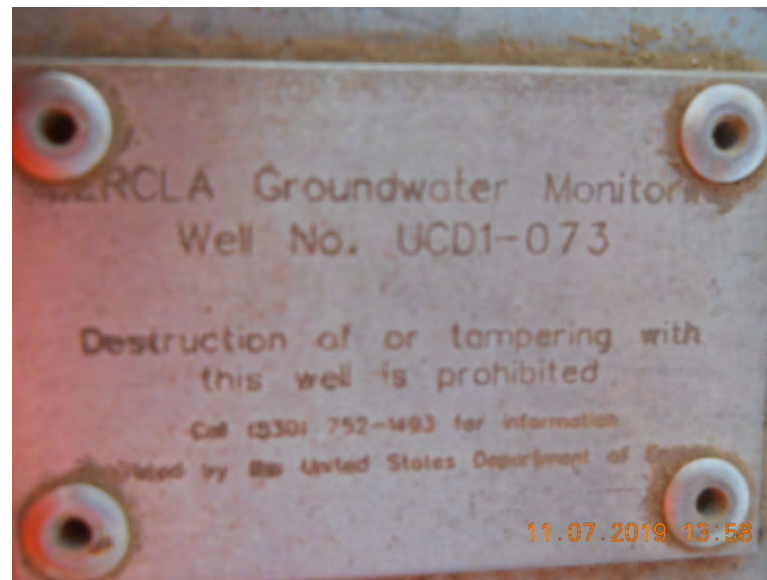
UCD1-073 Wellhead plaque (Photo No. 3965).

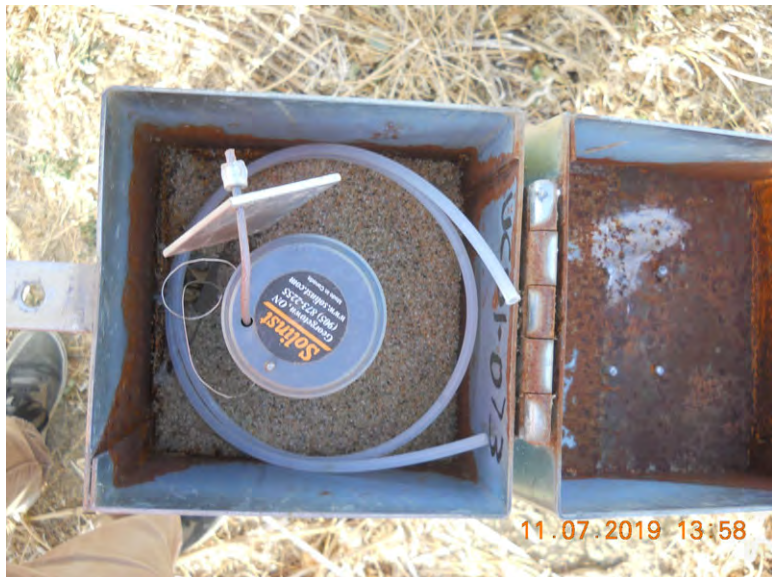
UCD1-073 Interior (Photo No. 3966).

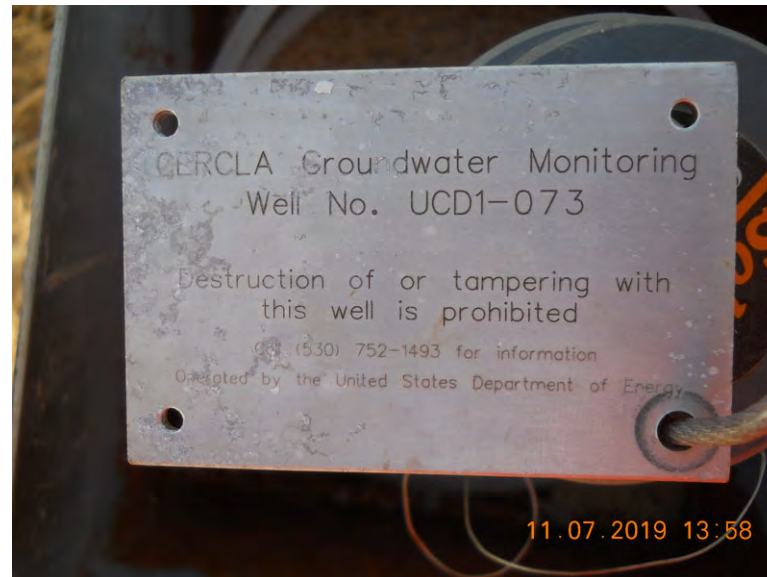
UCD1-073 Interior plaque (Photo No. 3968).
