יווי 2020 Annual Land-Use Covenant **Inspection Report** for DOE Areas at the Laboratory for Energy-Related Health **Research/Old Campus Landfill Superfund Site University of California, Davis** January 2021 ENERGY Legacy Management

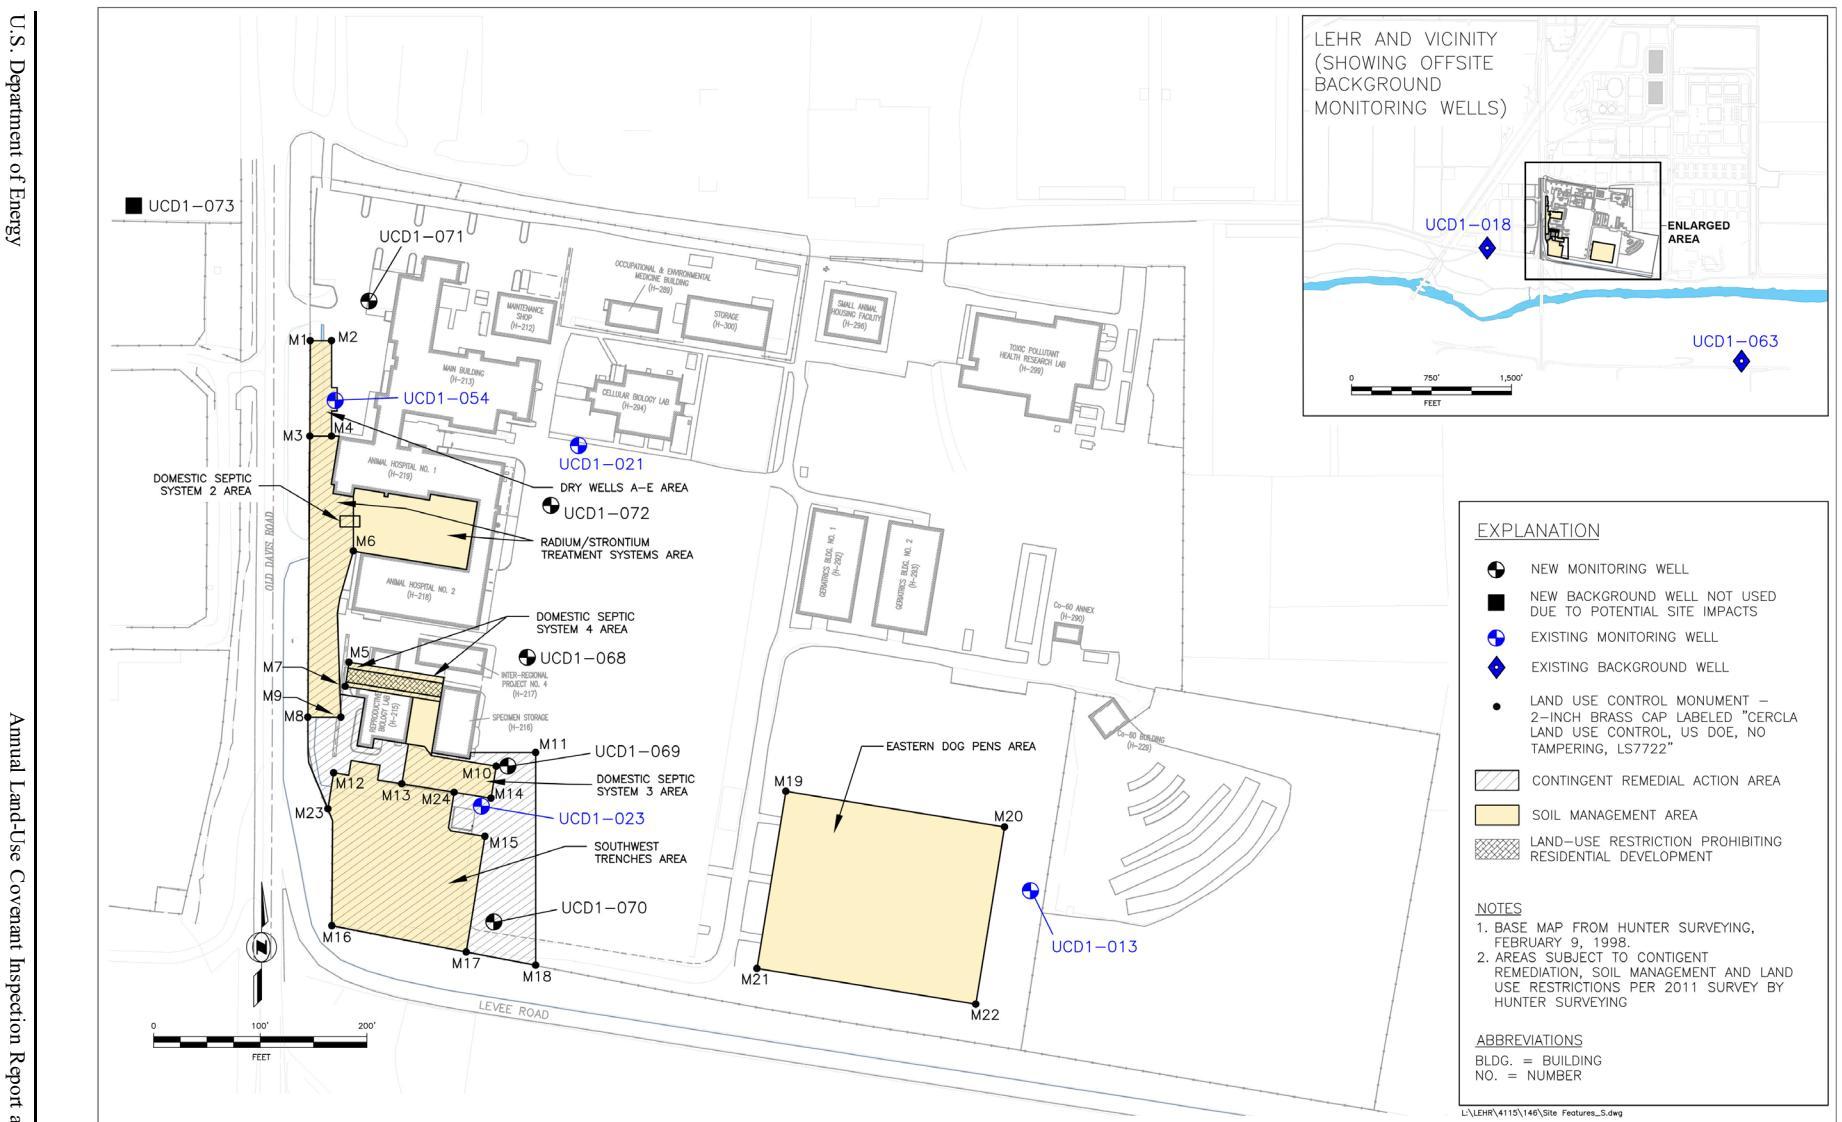
Figure 2. DOE Areas of the LEHR Federal Facility Subject to Land-Use Controls and Locations of DOE Groundwater Monitoring Wells and Survey Monuments

All 24 survey monuments (Figure 2) were found in good condition during the November 4, 2020, inspection as documented in the checklists and photographs in Appendixes A and B, respectively.

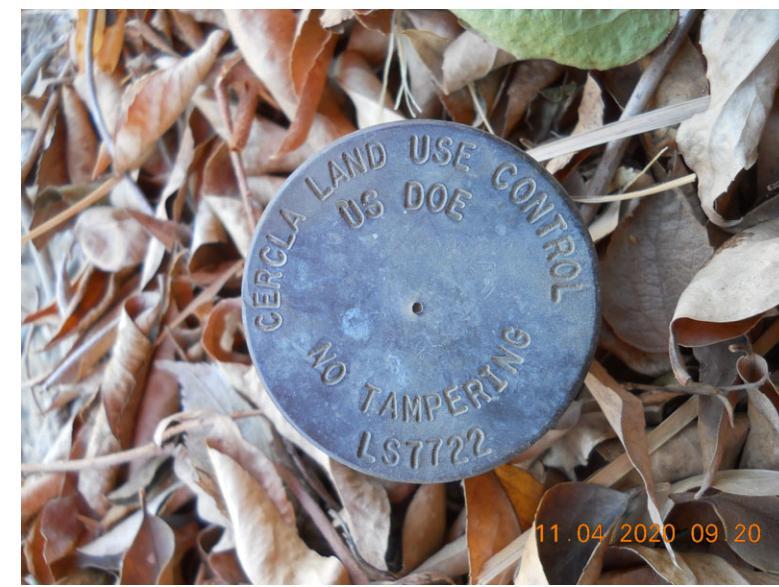
Survey Monument 1: Northwest corner of Dry Wells A–E Area (Photo No. 4088).

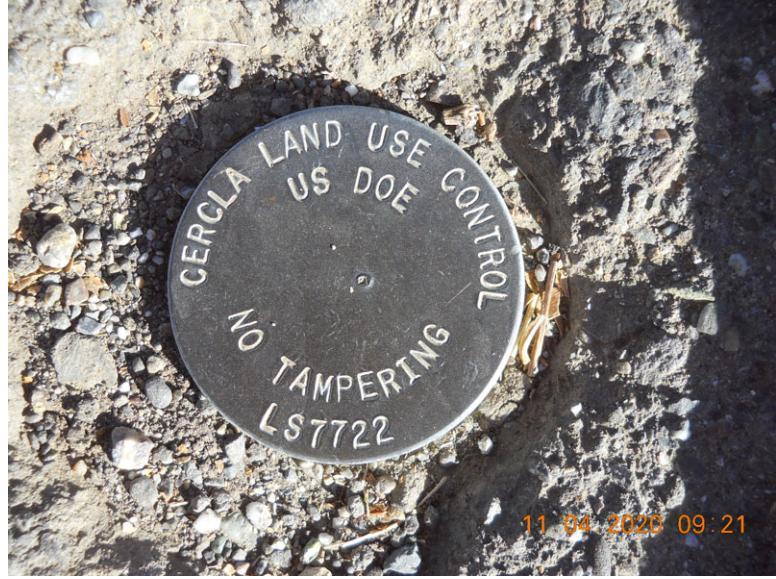
Survey Monument 2: Northeast corner of Dry Wells A–E Area (Photo No. 4090).

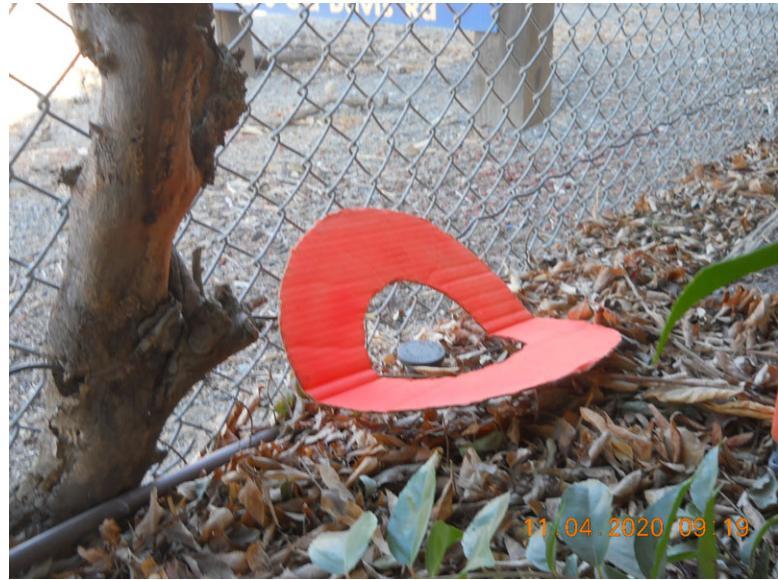
View northwest: Survey Monument 1, within orange ring (outside diameter is 14 inches); lower portion of entrance sign in background (Photo No. 4087).

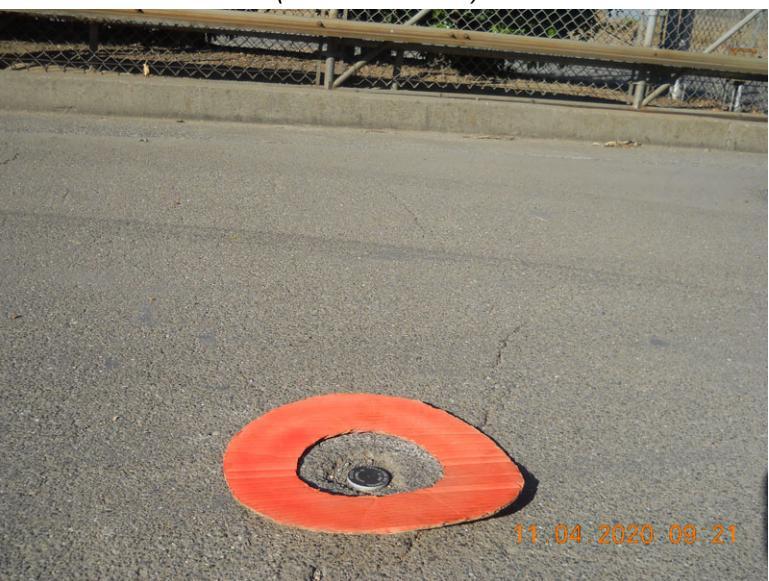
View west: Survey Monument 2, within orange ring; retracted entrance gate in background (Photo No. 4089).

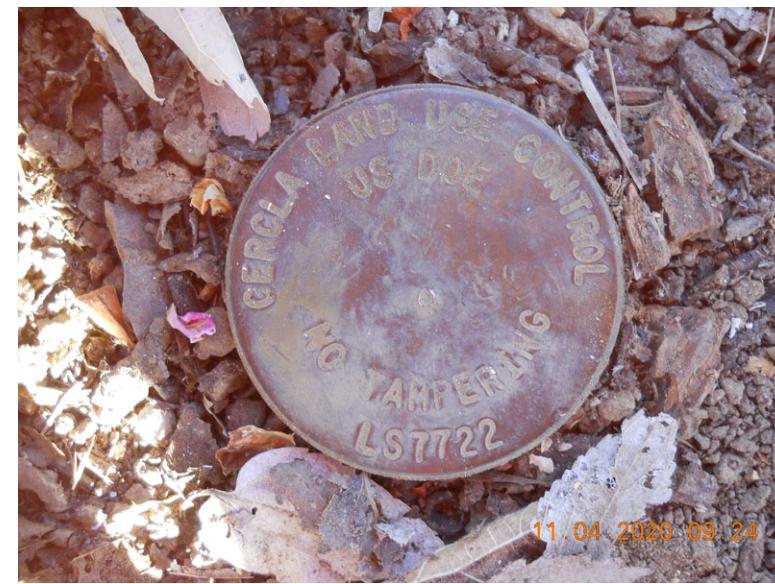
Survey Monument 3: Southwest corner of Dry Wells A–E Area (Photo No. 4092).

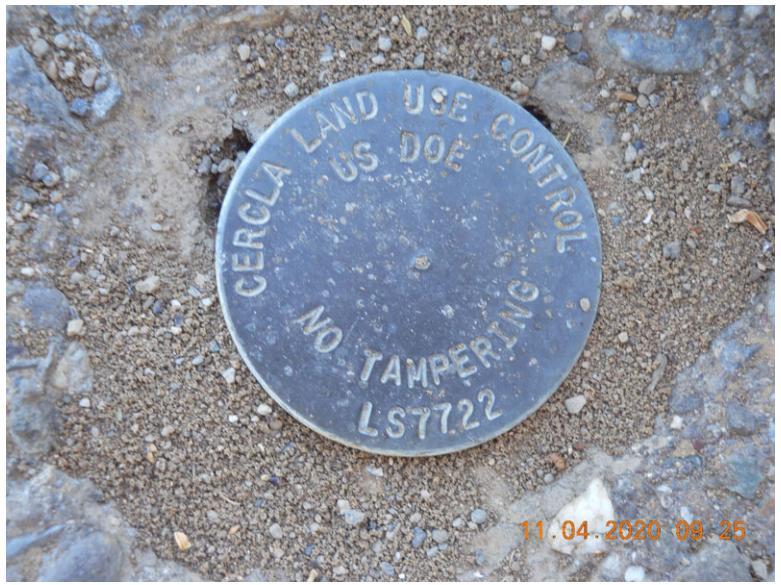
Survey Monument 4: Southeast corner of Dry Wells A–E Area (Photo No. 4094).

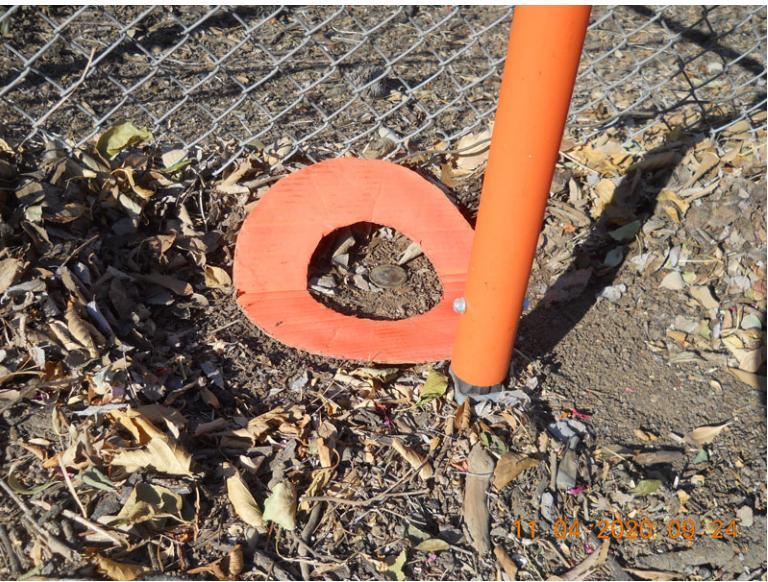
View west: Survey Monument 3, within orange ring; west perimeter fence behind survey monument; orange delineator right of survey monument (Photo No. 4091).

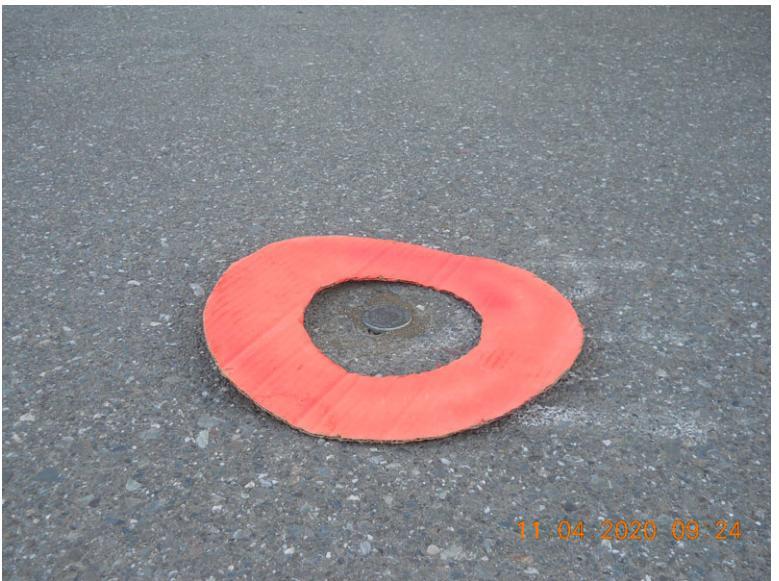
View east: Survey Monument 4, within orange ring (Photo No. 4093).

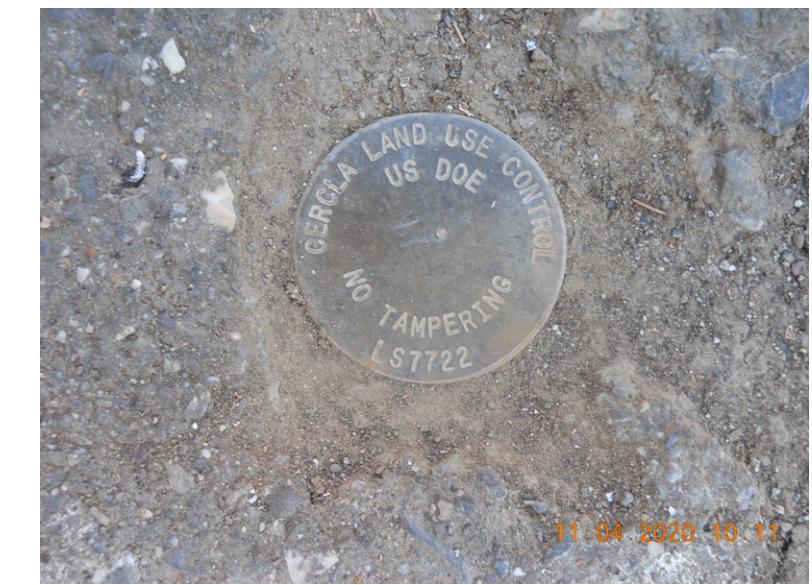
Survey Monument 5: Northwest corner of Domestic Septic System 4 Area (Photo No. 4109).

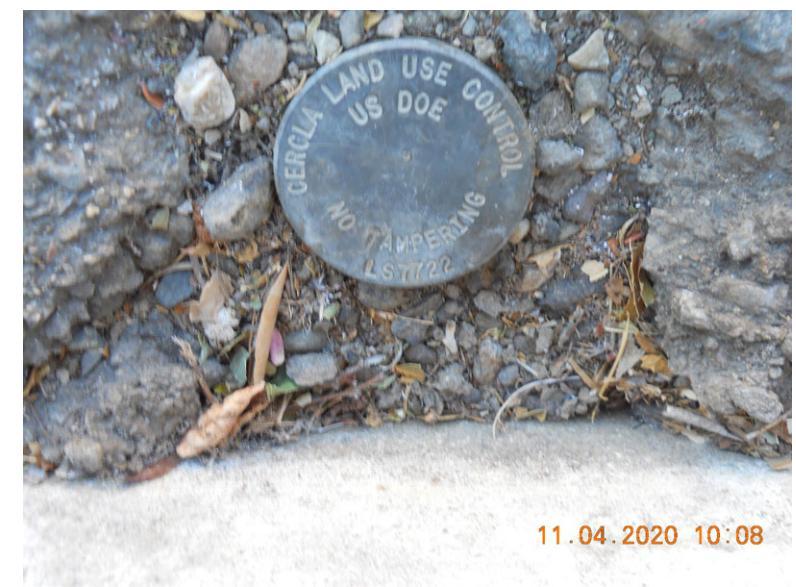
Survey Monument 6: Adjacent to northwest corner of Building H-218; Radium/Strontium Treatment Systems Area (Photo No. 4107).

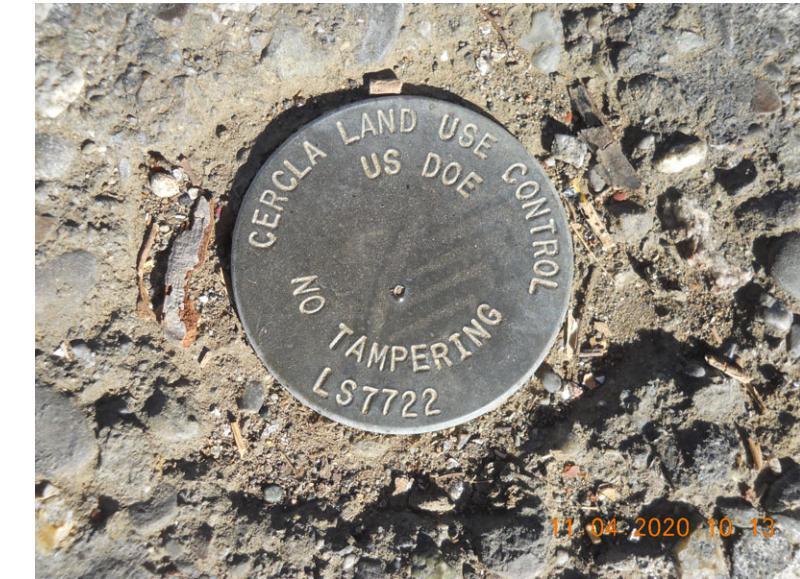
Survey Monument 7: Southwest corner of Domestic Septic System 4 Area (Photo No. 4111).

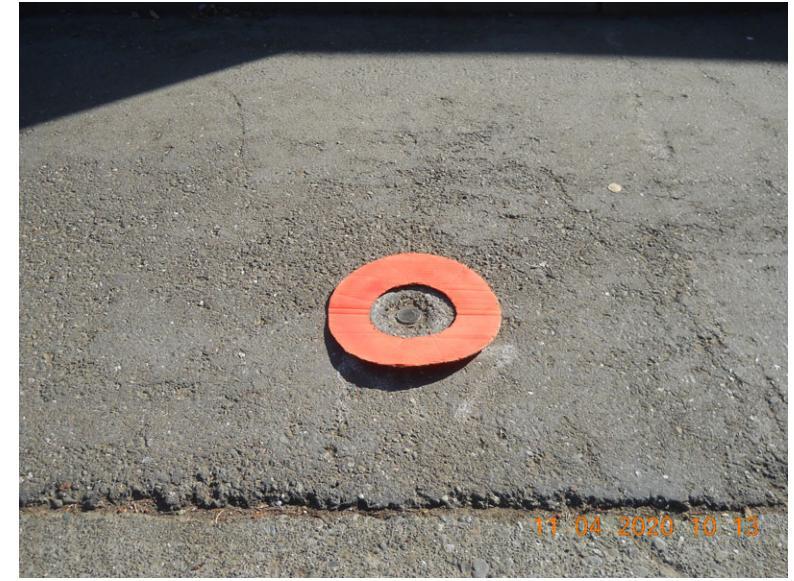
View east: Survey Monument 7, within orange ring (Photo No. 4112).

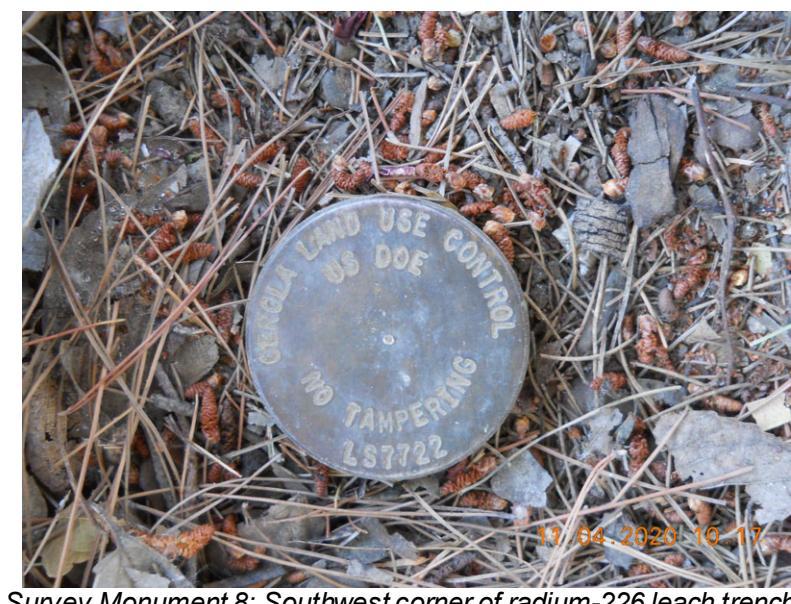
Survey Monument 8: Southwest corner of radium-226 leach trench; Radium/Strontium Treatment Systems Area (Photo No. 4114).

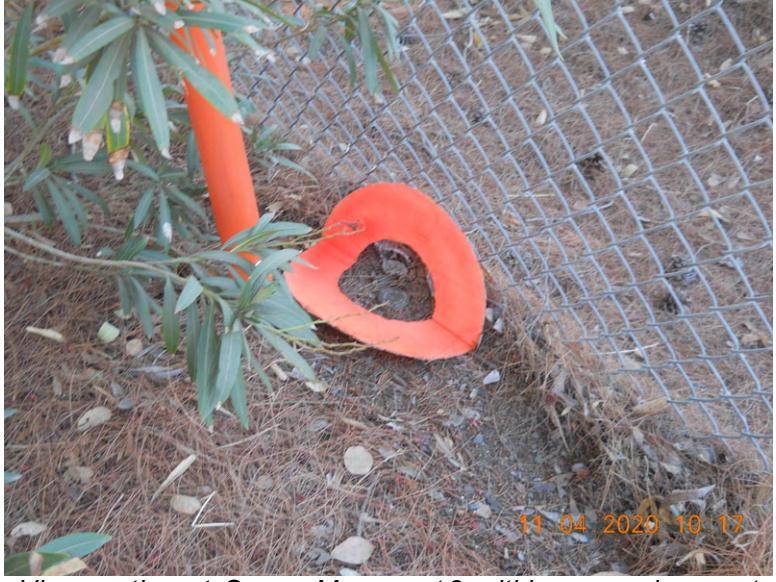
View southwest: Survey Monument 8, within orange ring; west perimeter fence right of survey monument; orange delineator left of survey monument (Photo No. 4116).

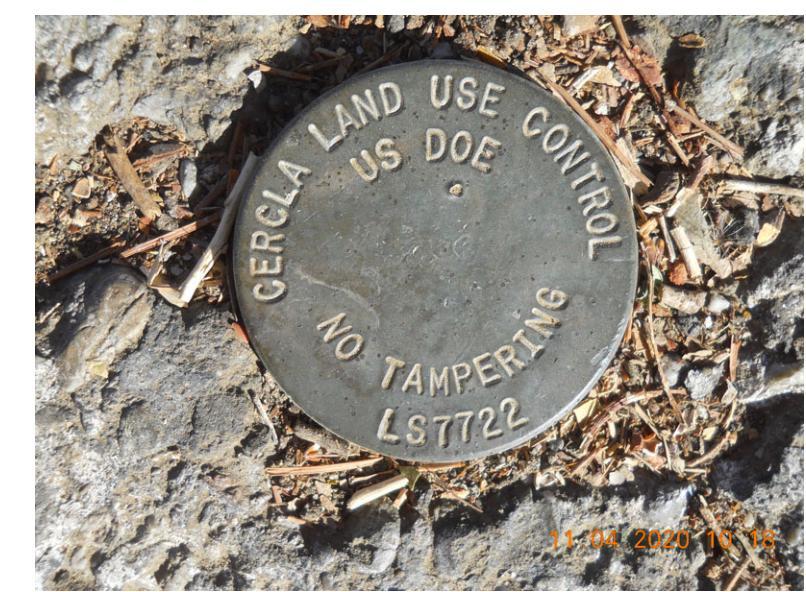
Survey Monument 9: Southeast corner of radium-226 leach trench; Radium/Strontium Treatment Systems Area (Photo No. 4117).

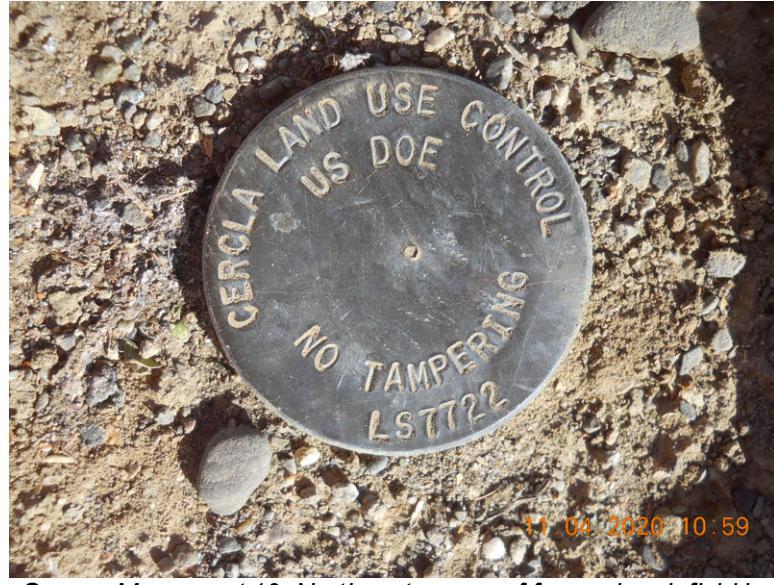
Survey Monument 10: Northeast corner of former leach field in Domestic Septic System 3 Area (Photo No. 4132).

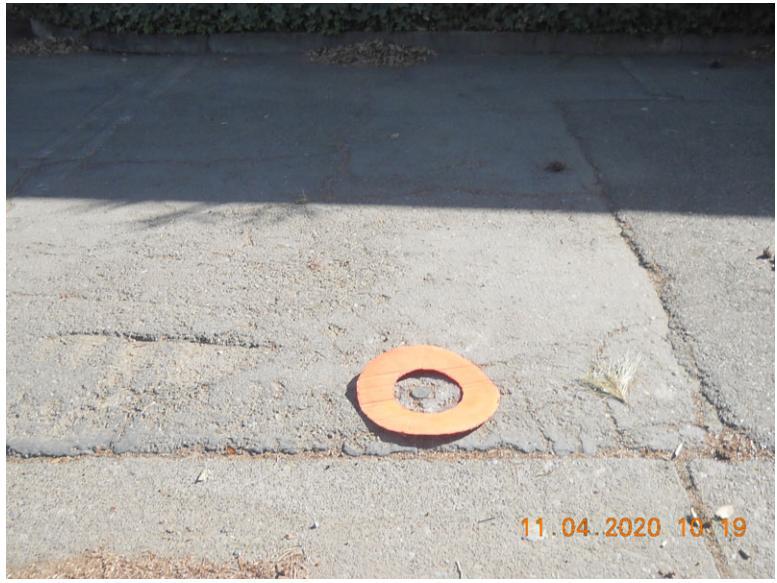
View east: Survey Monument 9, within orange ring; planter at foot of Building H-215 in background (Photo No. 4118).

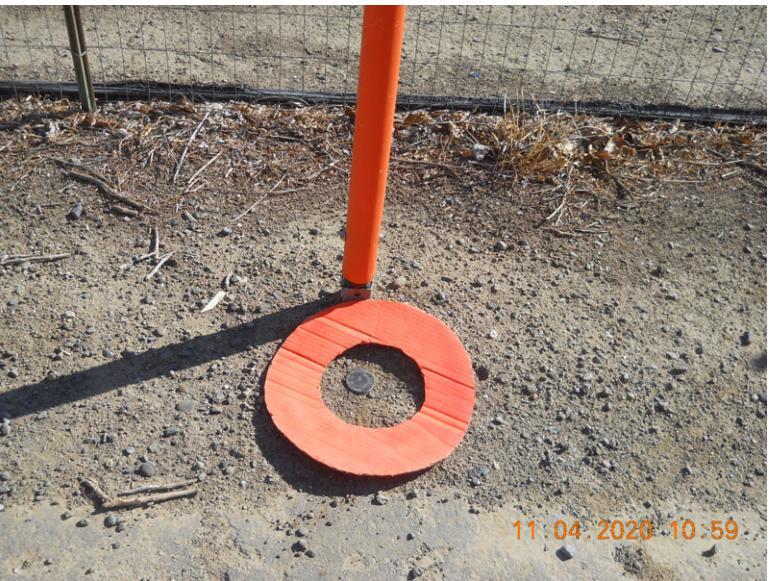
View east: Survey Monument 10, within orange ring in foreground; delineator behind survey monument (Photo No. 4133).

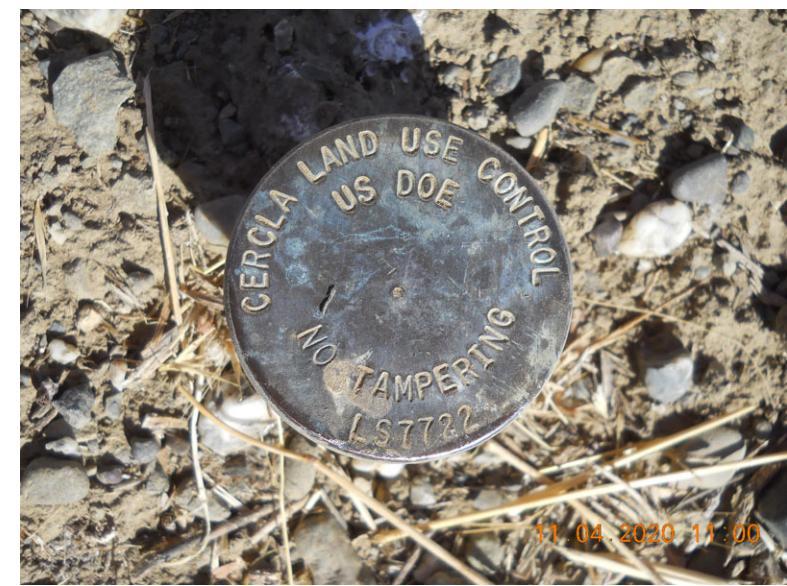
Survey Monument 11: Northeast corner of Eastern Remediation Support Area (Photo No. 4134).

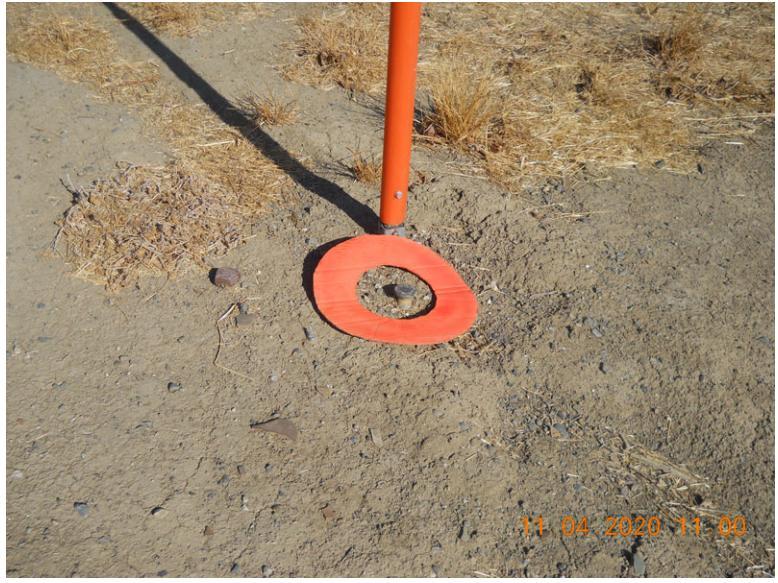
View north: Survey Monument 11, within orange ring; delineator behind survey monument (Photo No. 4135).

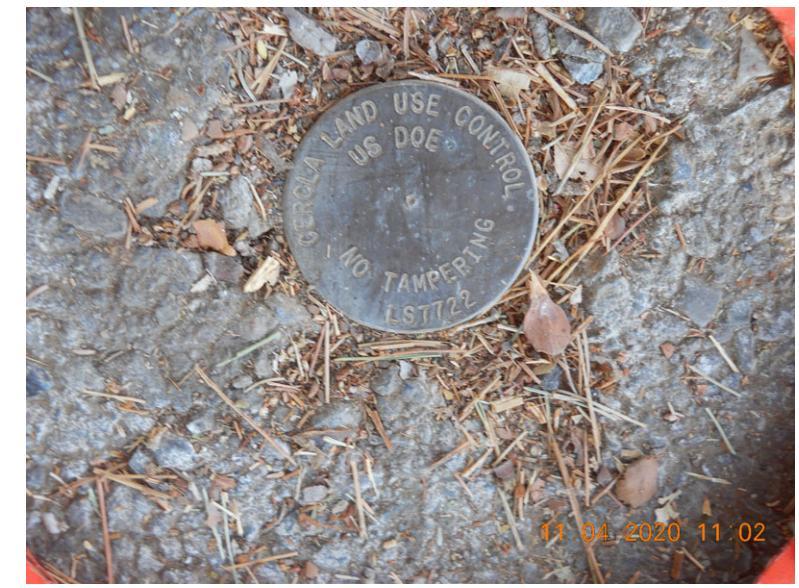
Survey Monument 12: Northwest corner of Southwest Trenches Area (Photo No. 4136).

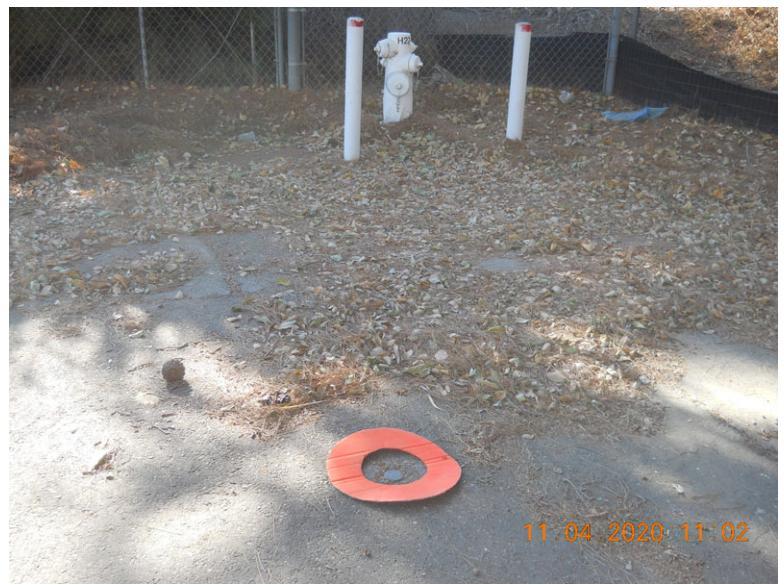
View south: Survey Monument 12, within orange ring in foreground; water hydrant in background (Photo No. 4137).

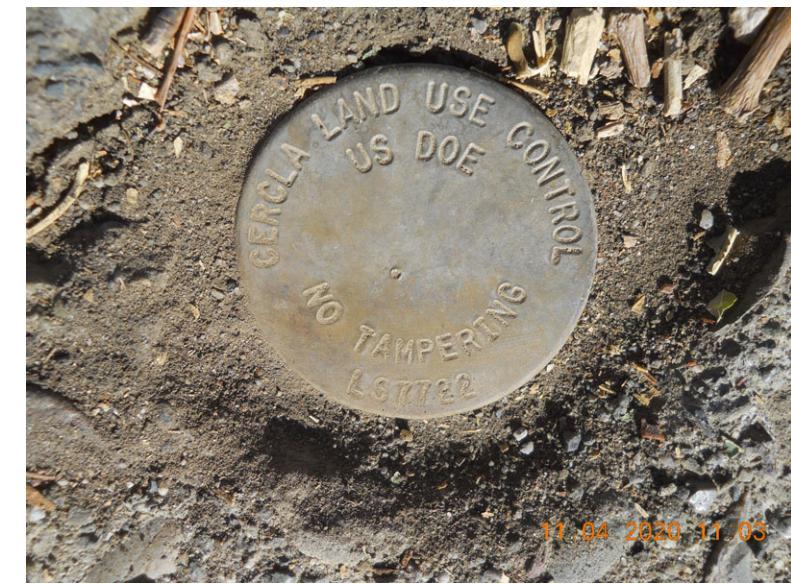
Survey Monument 13: Southwest corner of Domestic Septic System 3 Area, at northern perimeter of Southwest Trenches Area (Photo No. 4138).

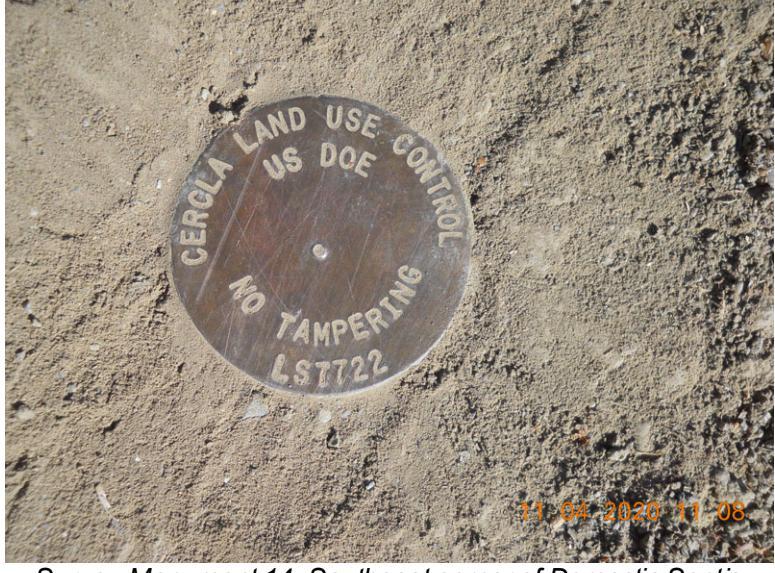
Survey Monument 14: Southeast corner of Domestic Septic System 3 Area (Photo No. 4142).

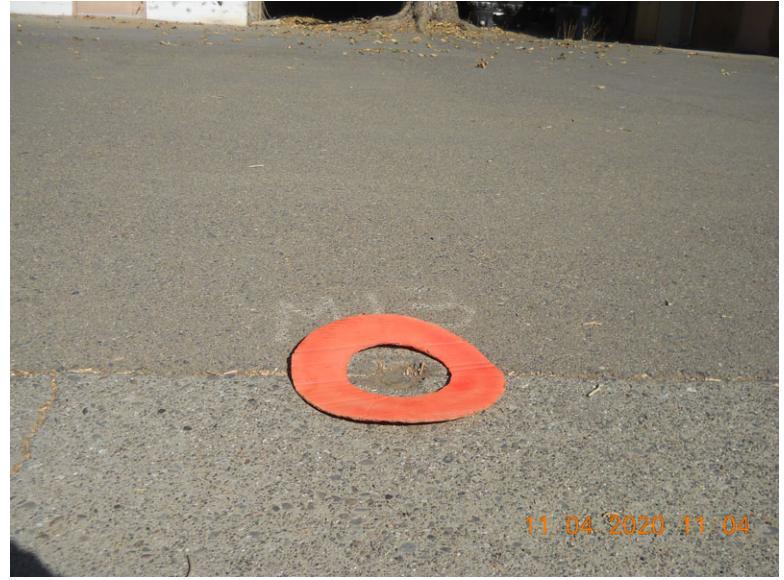
View north: Survey Monument 13, within orange ring at edge of concrete swale (Photo No. 4139).

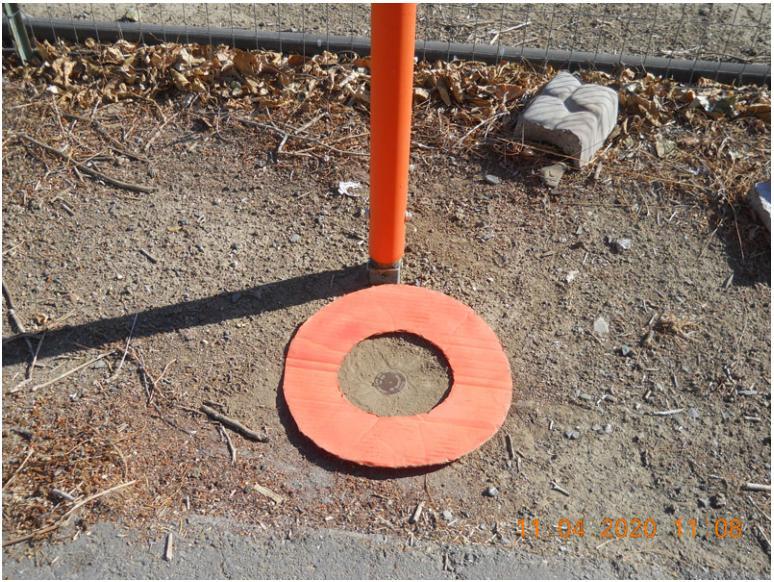
View north: Survey Monument 14, within orange ring; delineator behind survey monument (Photo No. 4143).

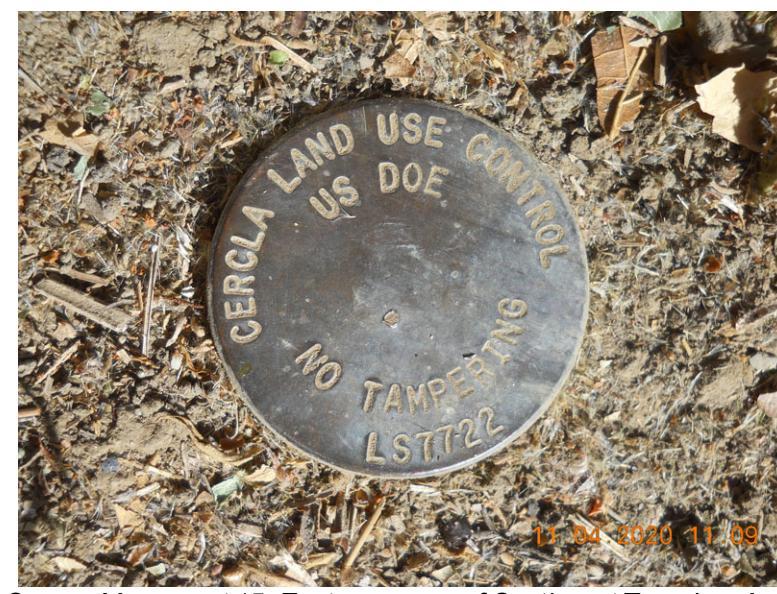
Survey Monument 15: Eastern corner of Southwest Trenches Area (Photo No. 4144).

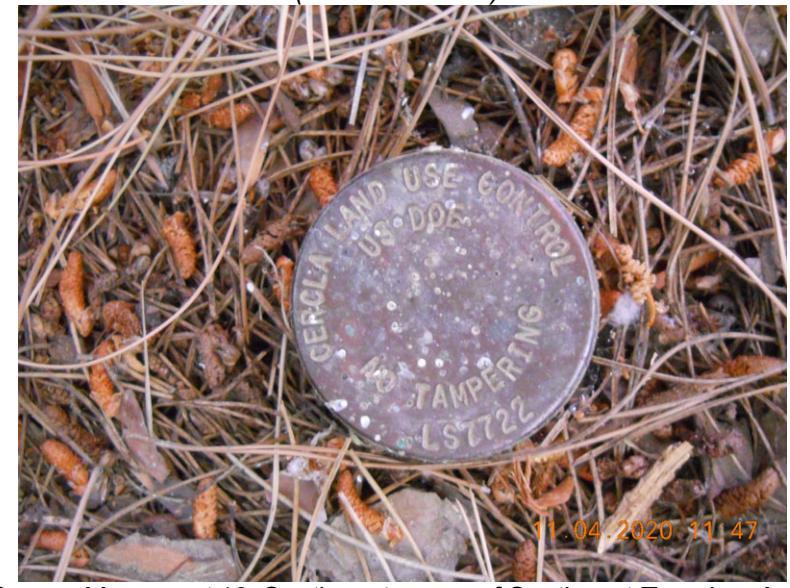
Survey Monument 16: Southwest corner of Southwest Trenches Area (Photo No. 4163).

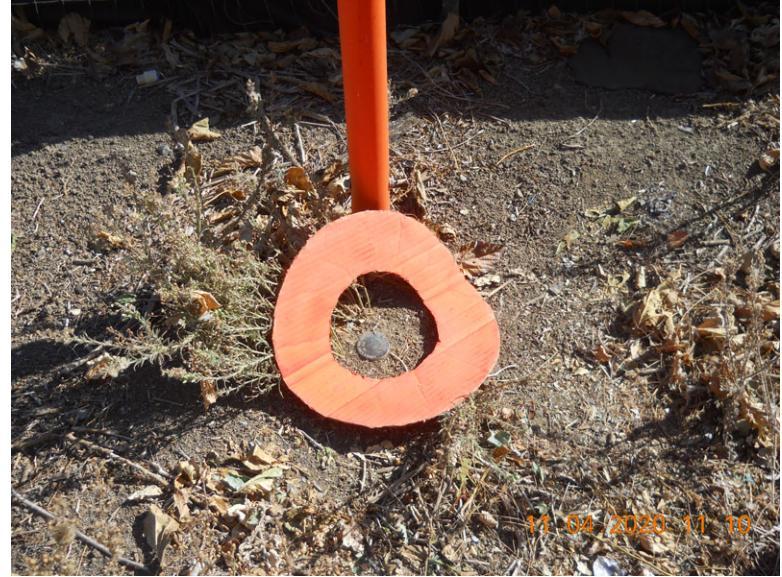
View east: Survey Monument 15, within orange ring; delineator behind survey monument (Photo No. 4145).

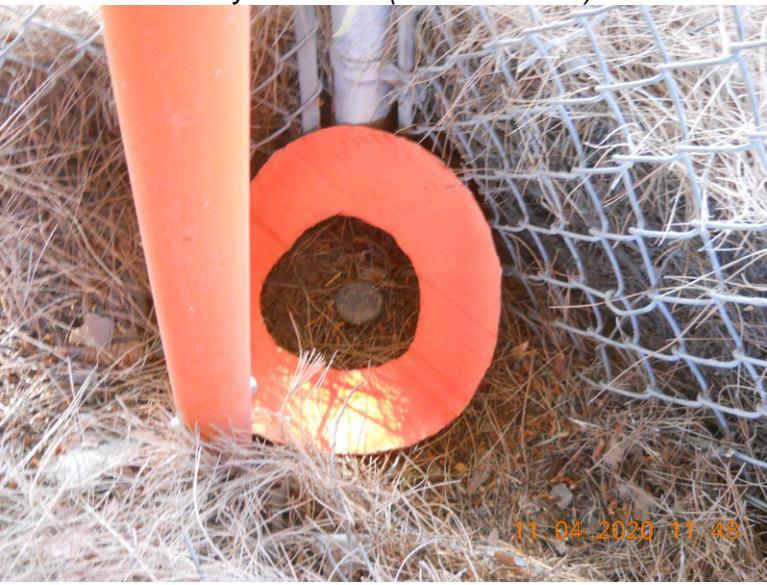
View southwest: Survey Monument 16, within orange ring; delineator left of survey monument; southwest corner post of perimeter fence behind survey monument (Photo No. 4164).

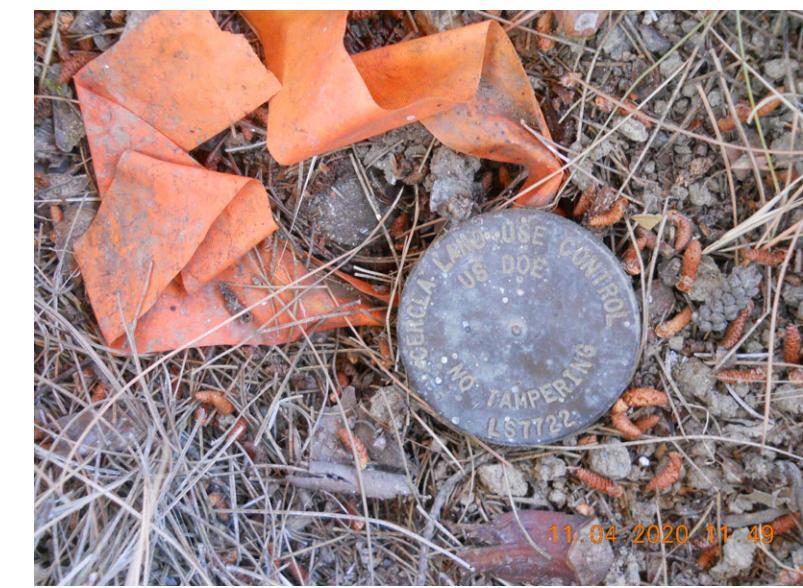
Survey Monument 17: Southeast corner of Southwest Trenches Area (Photo No. 4165).

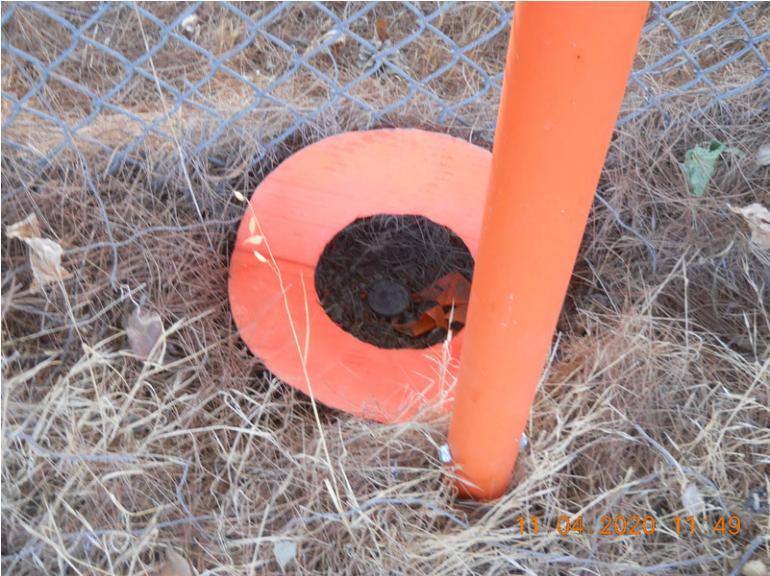
View southwest: Survey Monument 17, within orange ring; delineator right of survey monument; south perimeter fence behind survey monument; foot of North Levee in background (Photo No. 4166).

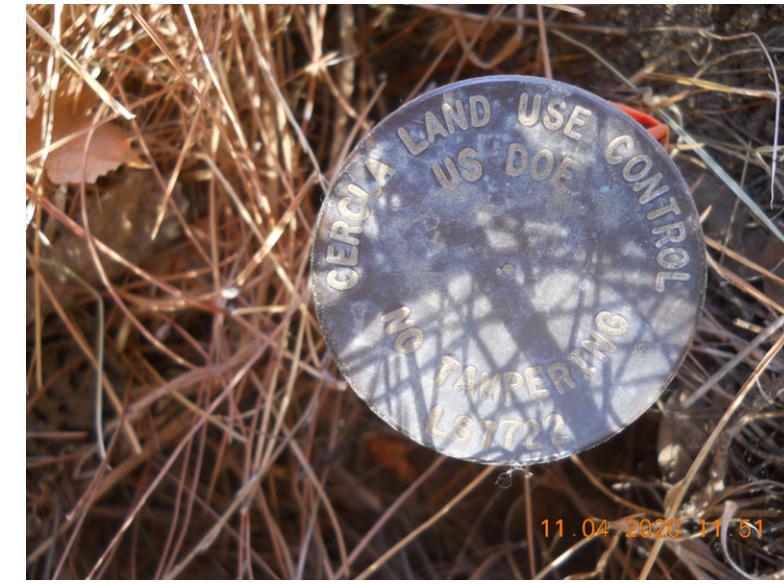
Survey Monument 18: Southeast corner of Eastern Remediation Support Area (Photo No. 4167).

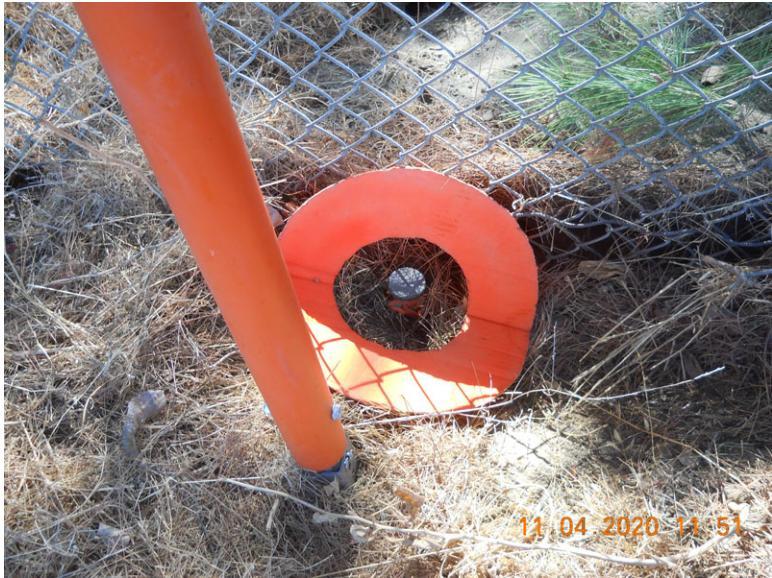
View south: Survey Monument 18, within orange ring; delineator left of survey monument; south perimeter fence behind survey monument; foot of North Levee in background (Photo No. 4168).

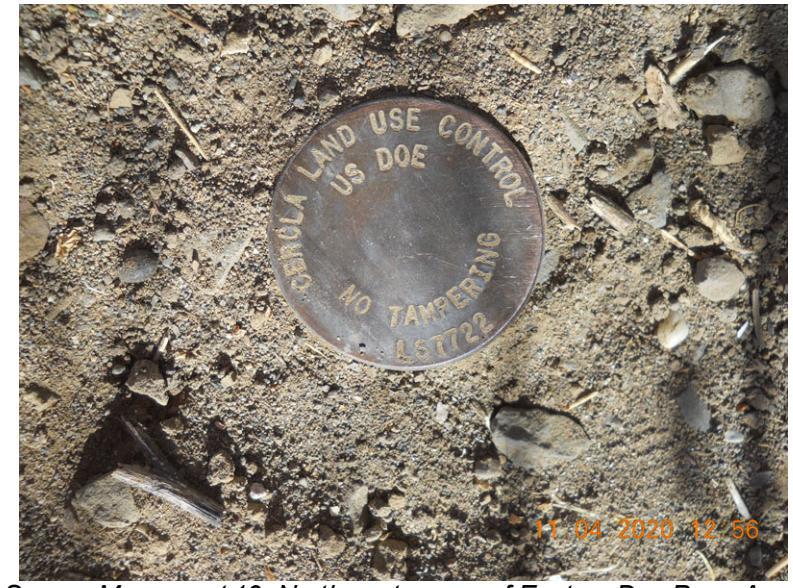
Survey Monument 19: Northwest corner of Eastern Dog Pens Area (Photo No. 4175).

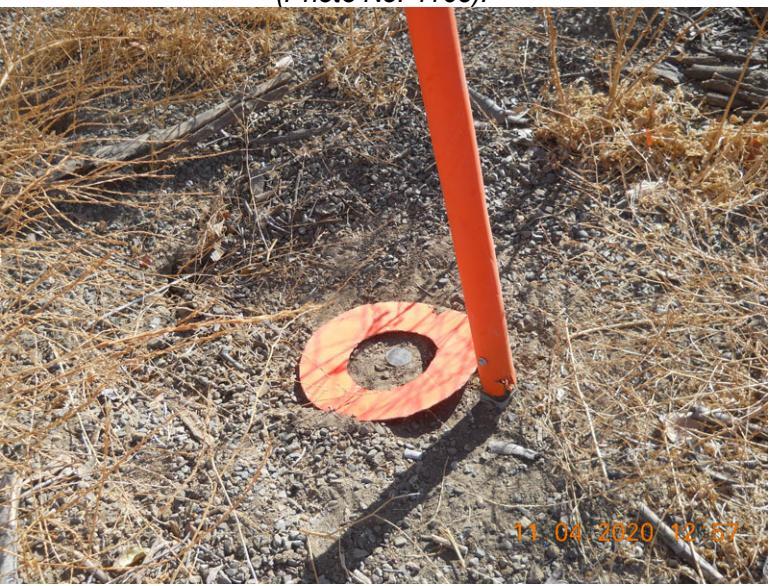
View southeast: Survey Monument 19, within orange ring; delineator right of survey monument (Photo No. 4176).

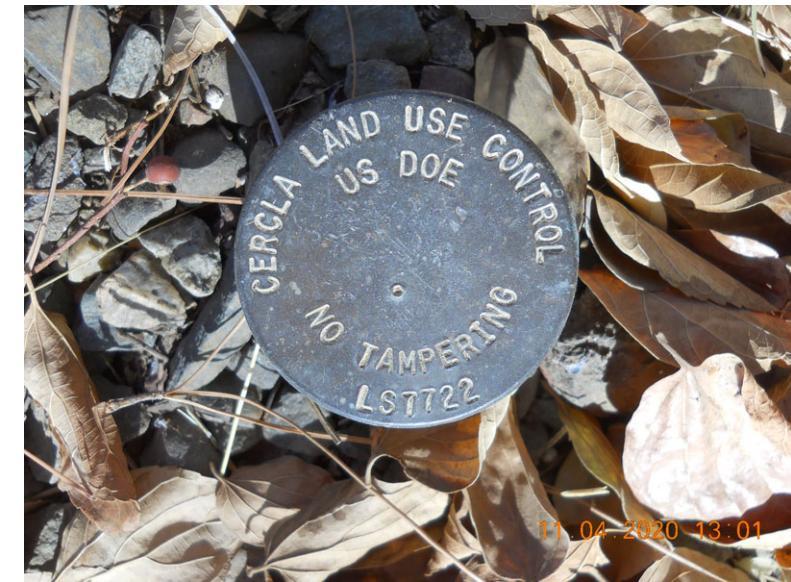
Survey Monument 20: Northeast corner of Eastern Dog Pens Area (Photo No. 4179).

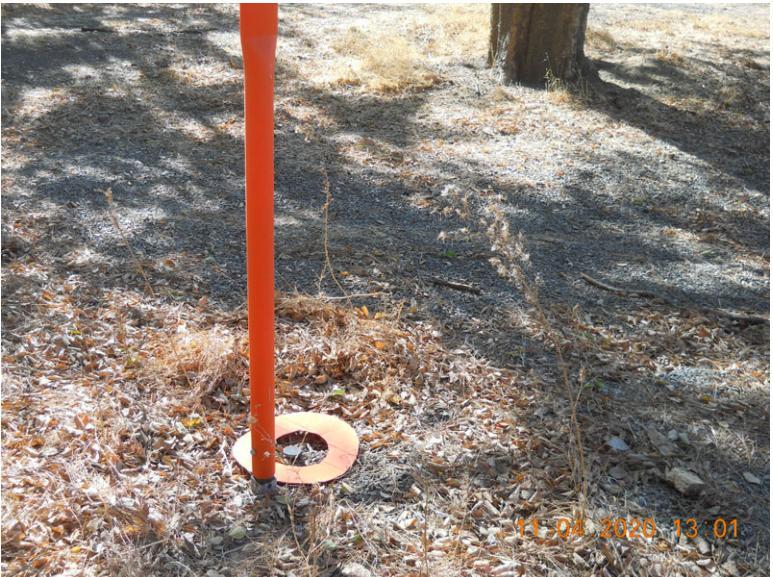
View southwest: Survey Monument 20, within orange ring; delineator left of survey monument; Eastern Dog Pens Area in background (Photo No. 4180).

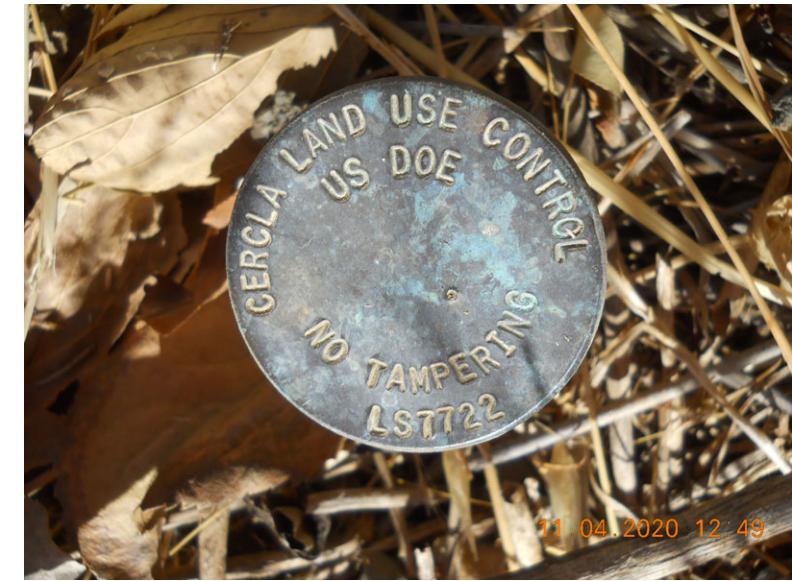
Survey Monument 21: Southwest corner of Eastern Dog Pens Area (Photo No. 4171).

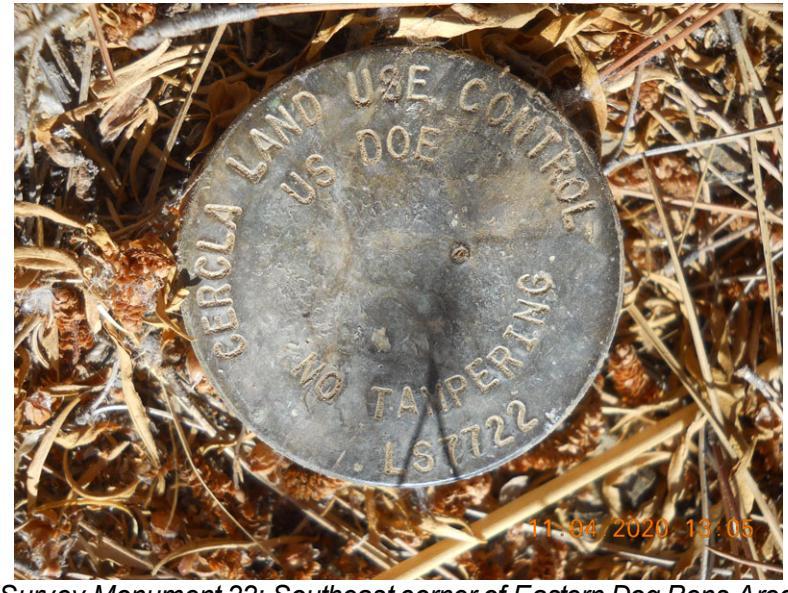
Survey Monument 22: Southeast corner of Eastern Dog Pens Area (Photo No. 4185).

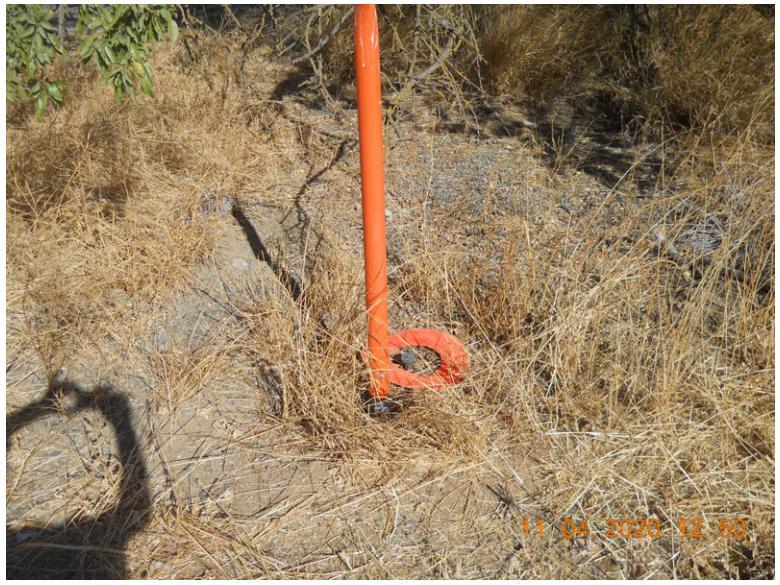
View northeast: Survey Monument 21, within orange ring; delineator left of survey monument; Eastern Dog Pens Area in background (Photo No. 4172).

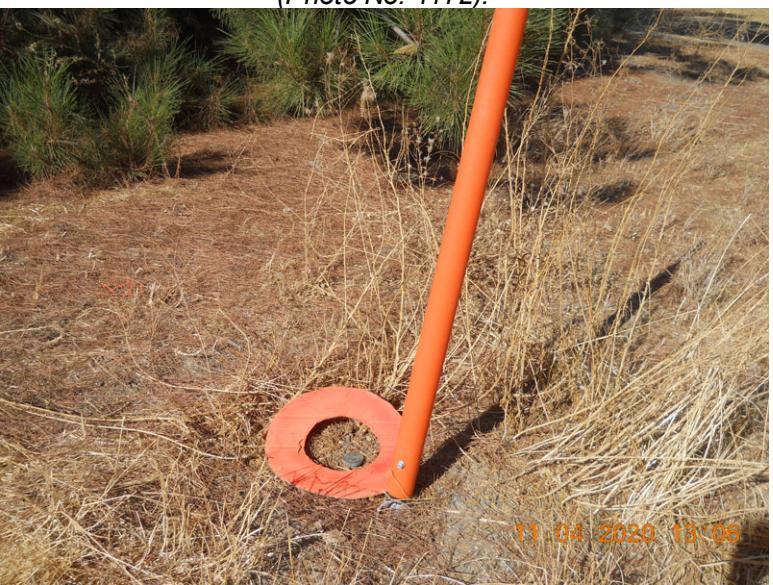
View northwest: Survey Monument 22, within orange ring; delineator right of survey monument; Eastern Dog Pens Area in background (Photo No. 4186).

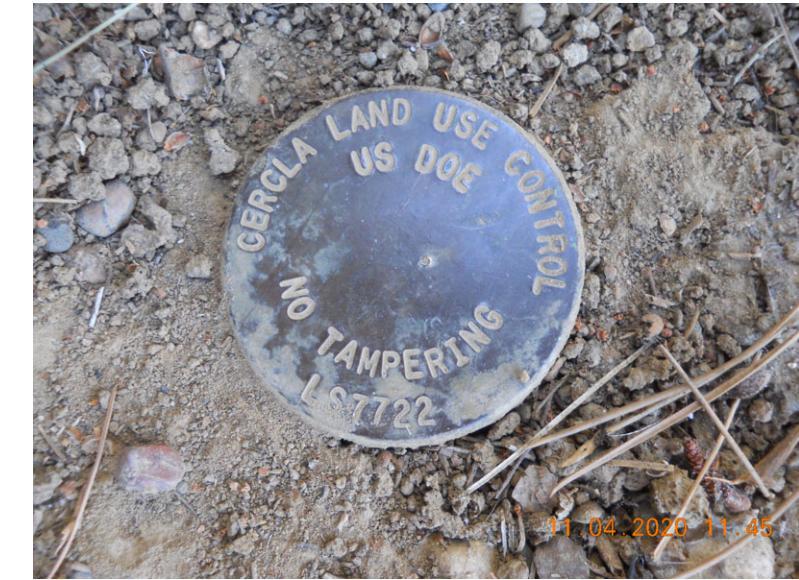
Survey Monument 23: Western perimeter point of Southwest Trenches Area (Photo No. 4160).
