יווי 2020 Annual Land-Use Covenant **Inspection Report** for DOE Areas at the Laboratory for Energy-Related Health **Research/Old Campus Landfill Superfund Site University of California, Davis** January 2021 ENERGY Legacy Management

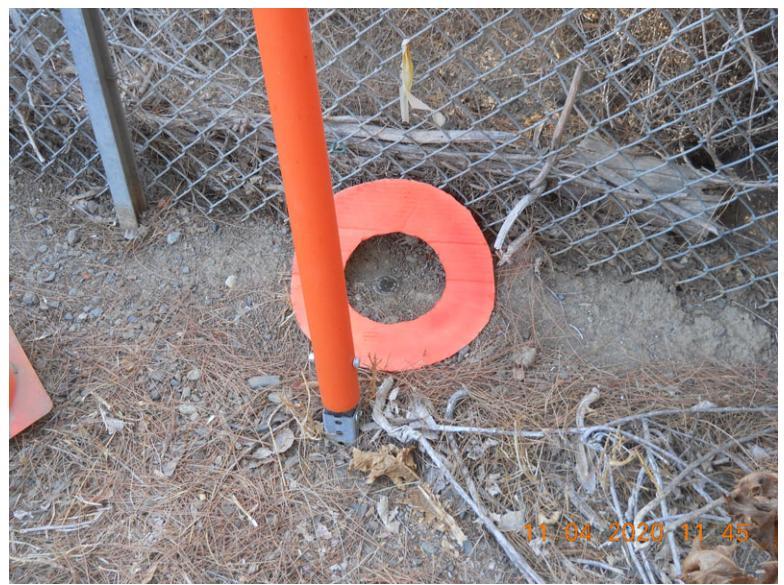
View west: Survey Monument 23, within orange ring; delineator left of survey monument; west perimeter fence behind survey monument (Photo No. 4161).

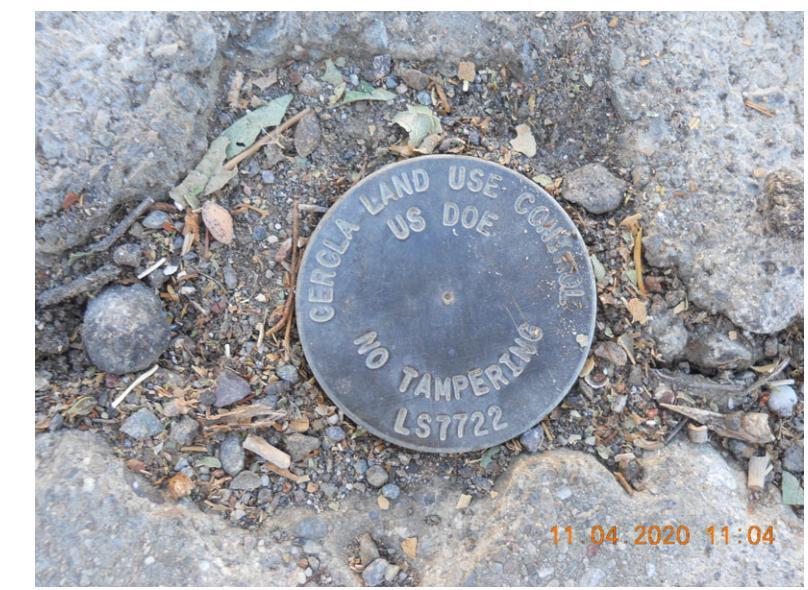
Survey Monument 24: Northeast corner of Southwest Trenches Area, at southern perimeter of Domestic Septic System 3 Area (Photo No. 4140).

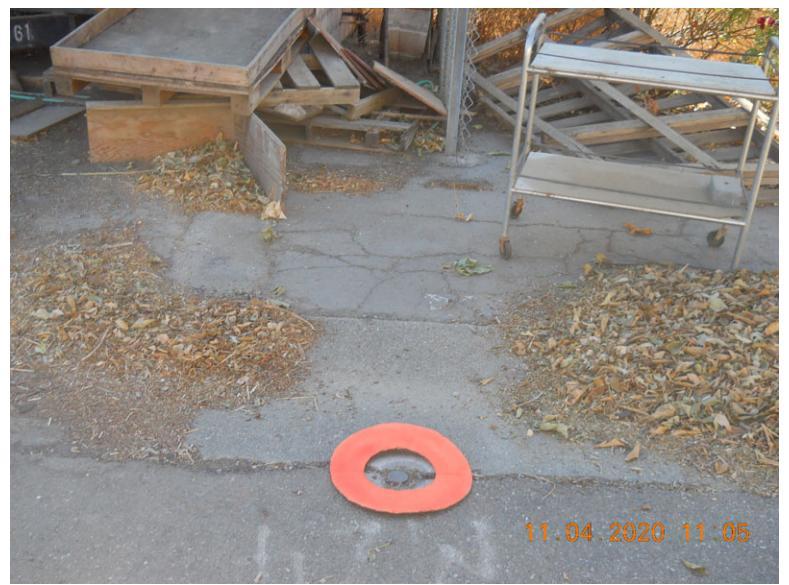
View south: Survey Monument 24, within orange ring on edge of concrete swale (Photo No. 4141).

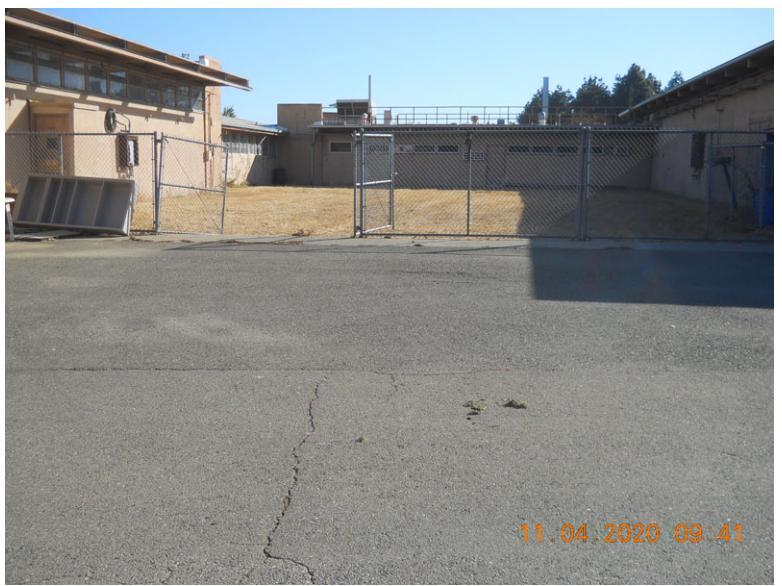
View east of central portion of Radium/Strontium Treatment Systems Area: Building H-218 to right; Building H-219 to left (Photo No. 4100).

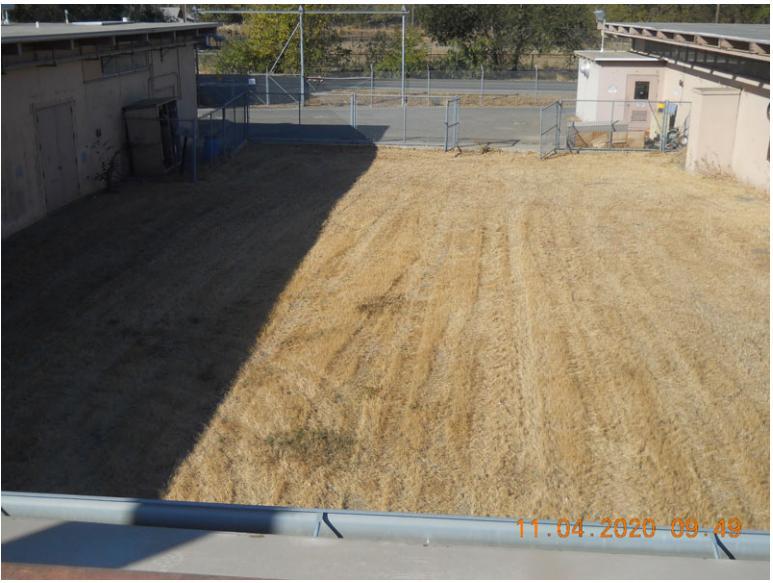
Roof-level view west of central portion of Radium/Strontium Treatment Systems Area: Building H-219 to right; Building H-218 to left (Photo No. 4103).

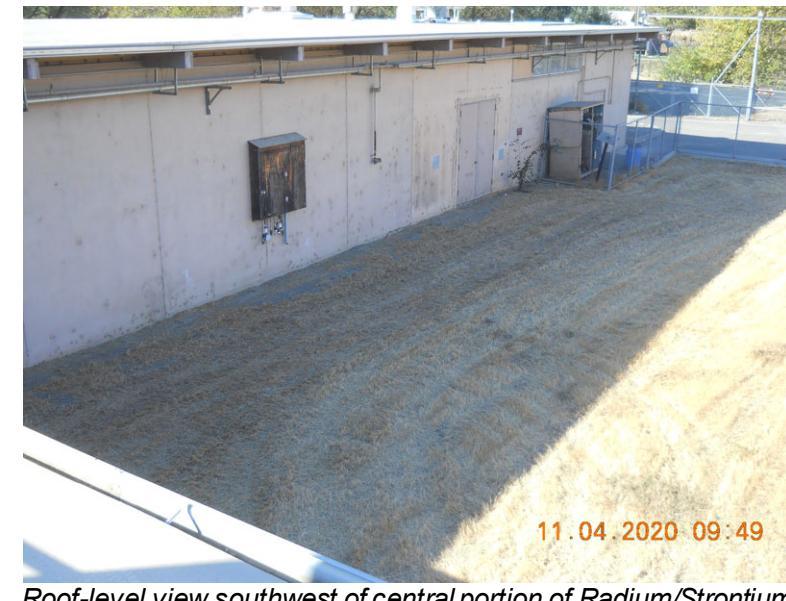
Roof-level view southwest of central portion of Radium/Strontium Treatment Systems Area: Building H-218 in background (Photo No. 4104).

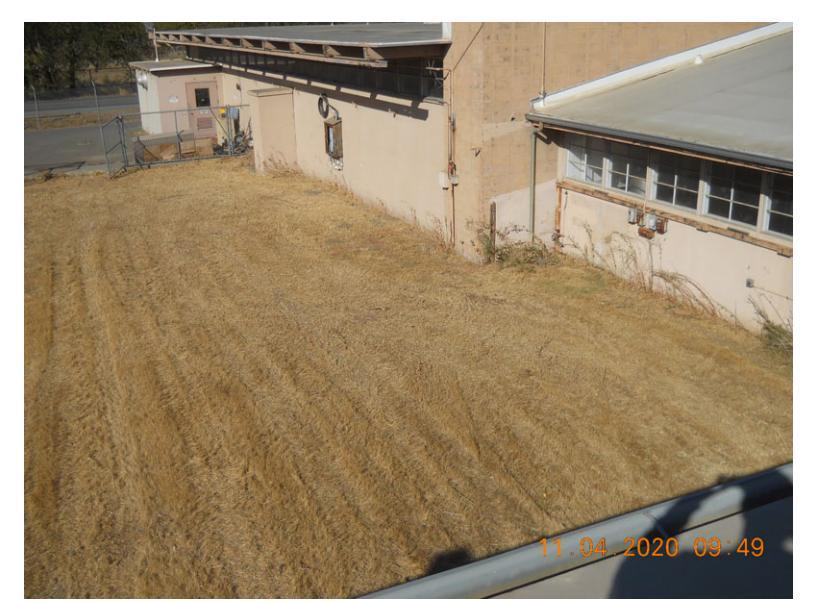
Roof-level view northwest of central portion of Radium/Strontium Treatment Systems Area: Building H-219 in background (Photo No. 4105).

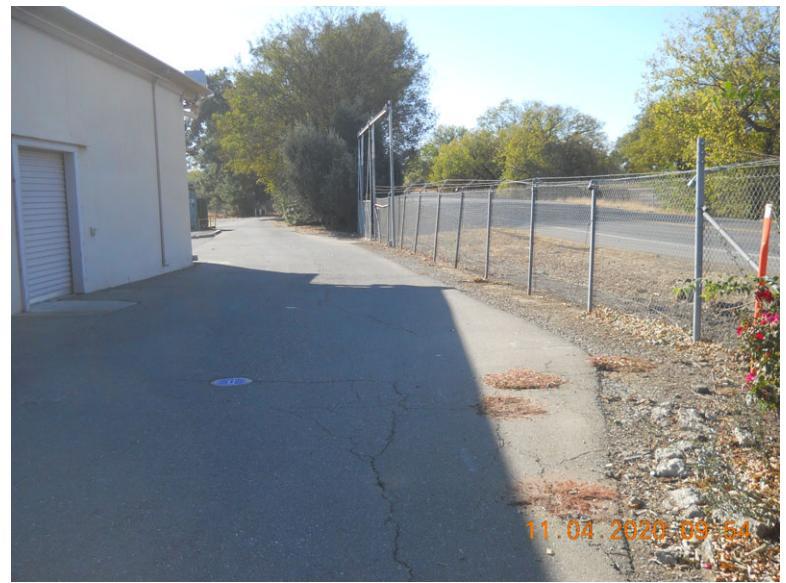
View south over northern portion of Radium/Strontium Treatment Systems Area: Building H-219 to left; west perimeter fence and Old Davis Road to right (photo No. 4106).

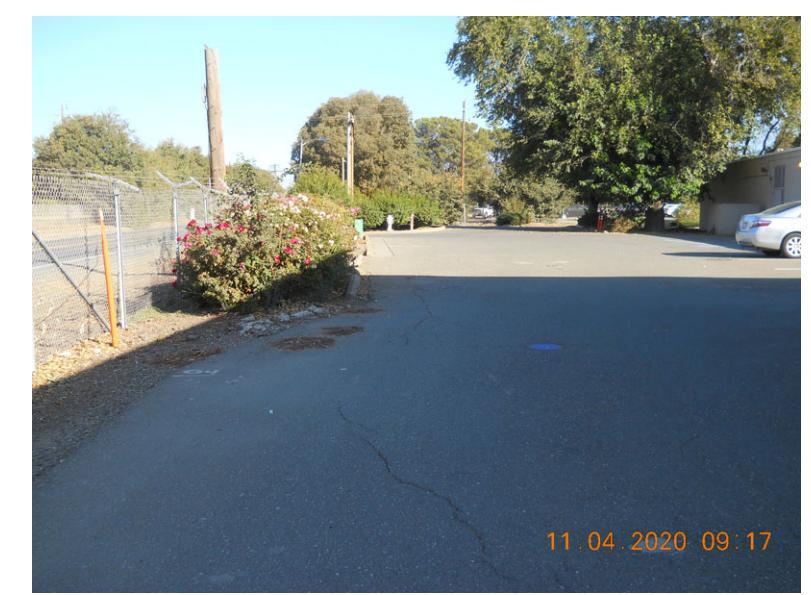
View north of Dry Wells A–E Area: Old Davis Road to left (Photo No. 4086).

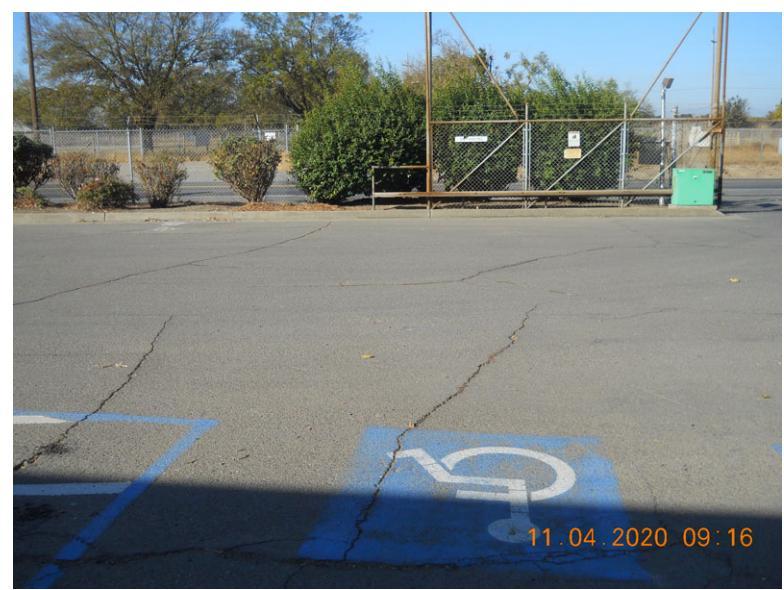
View west of Dry Wells A–E Area and main gate; Old Davis Road in background (Photo No. 4084).

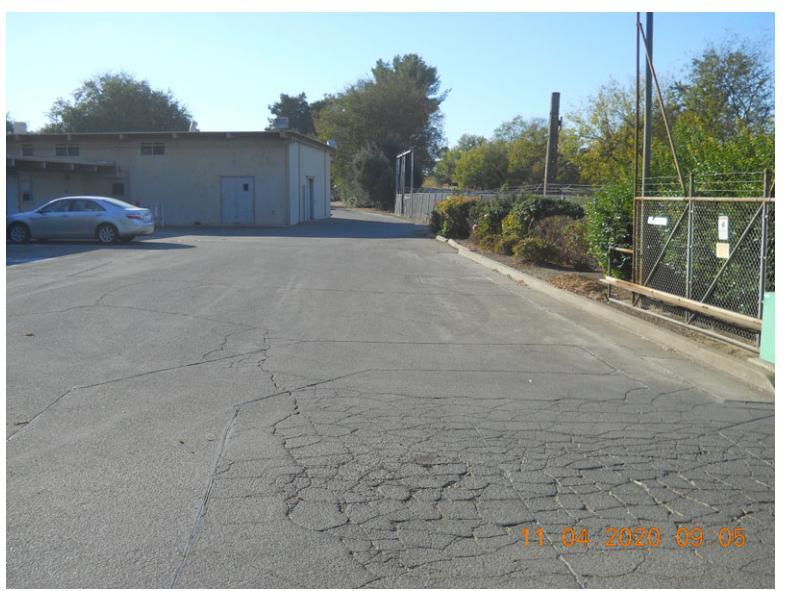
View south of Dry Wells A–E Area: Building H-219 in background/left (Photo No. 4083).

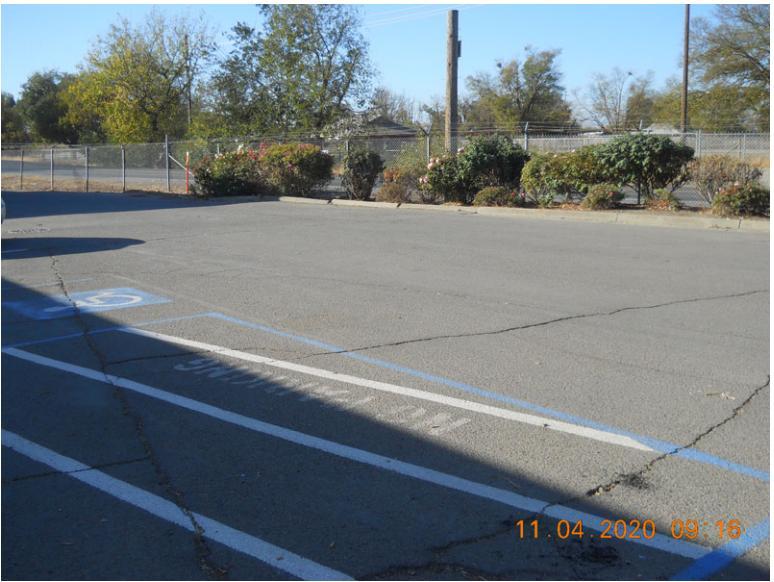
View southwest of Dry Wells A–E Area (Photo No. 4085).

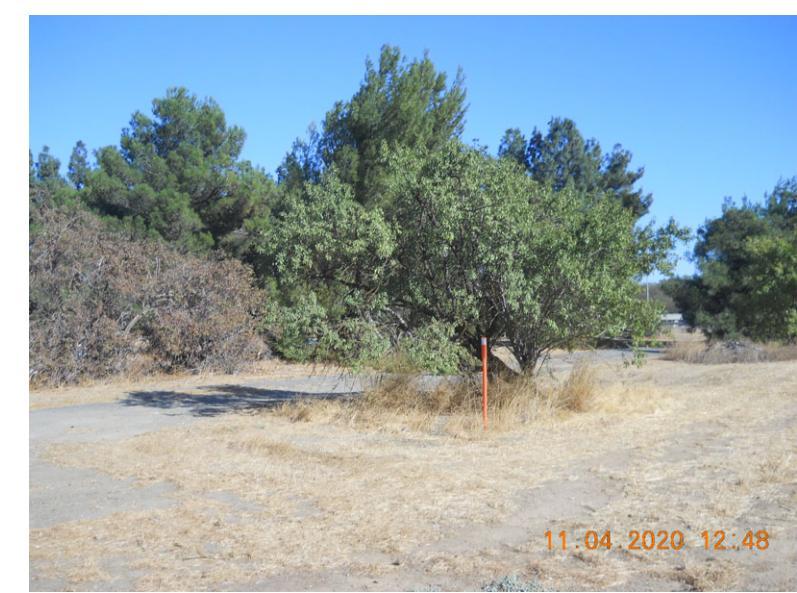
View northeast of Eastern Dog Pens Area from southwest corner with orange delineator showing southwest corner monument location (Photo No. 4170).

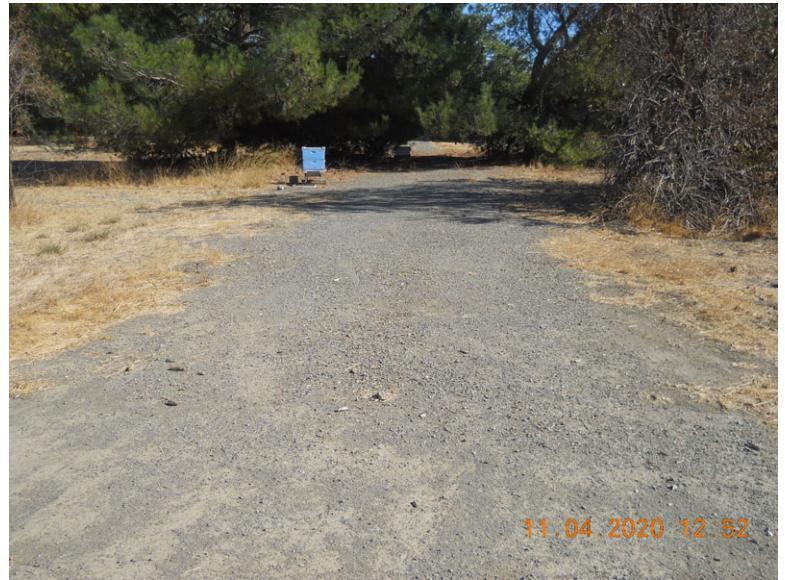
View east of Eastern Dog Pens Area; beehive in background (Photo No. 4173).

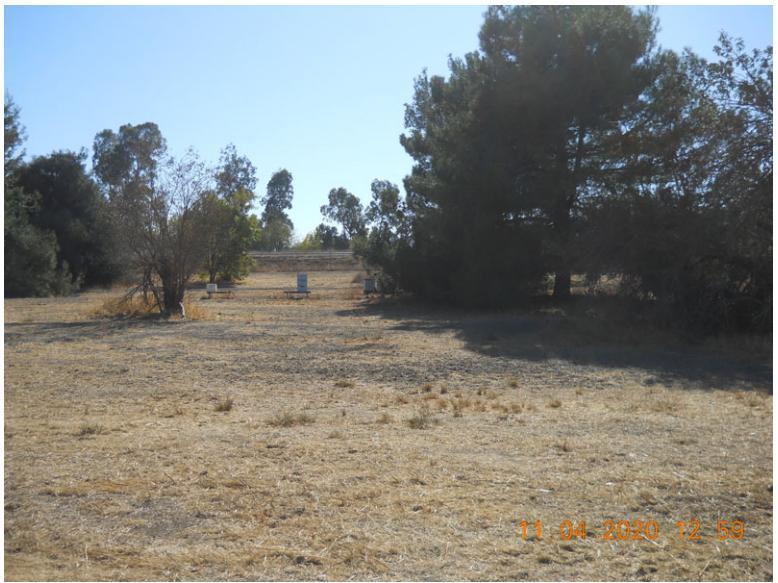
View south of Eastern Dog Pens Area; beehives in background (Photo No. 4177).

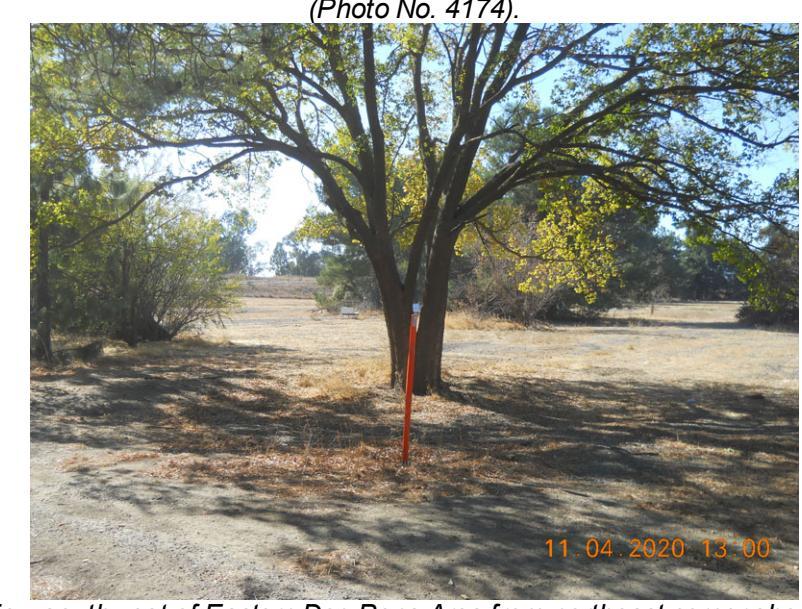
View southwest of Eastern Dog Pens Area from northeast corner showing location of northeast corner monument (Photo No. 4178).

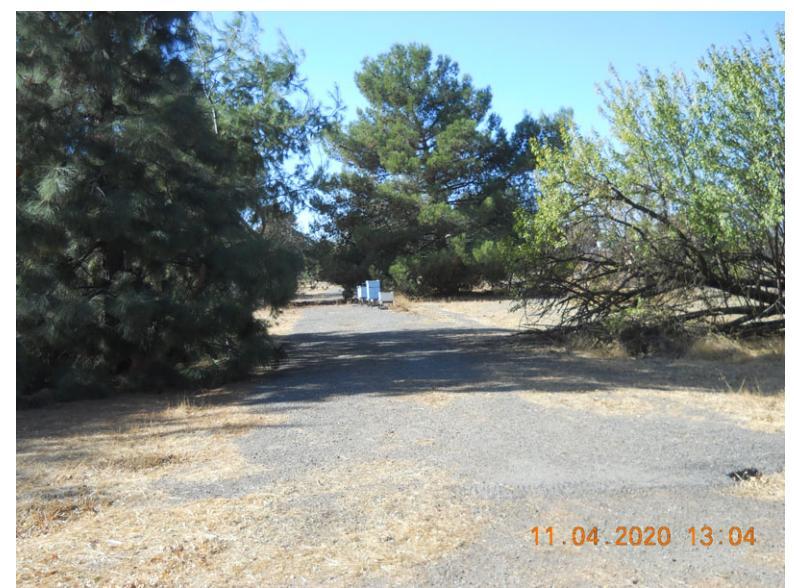
View west of Eastern Dog Pens Area; beehives in background (Photo No. 4183).

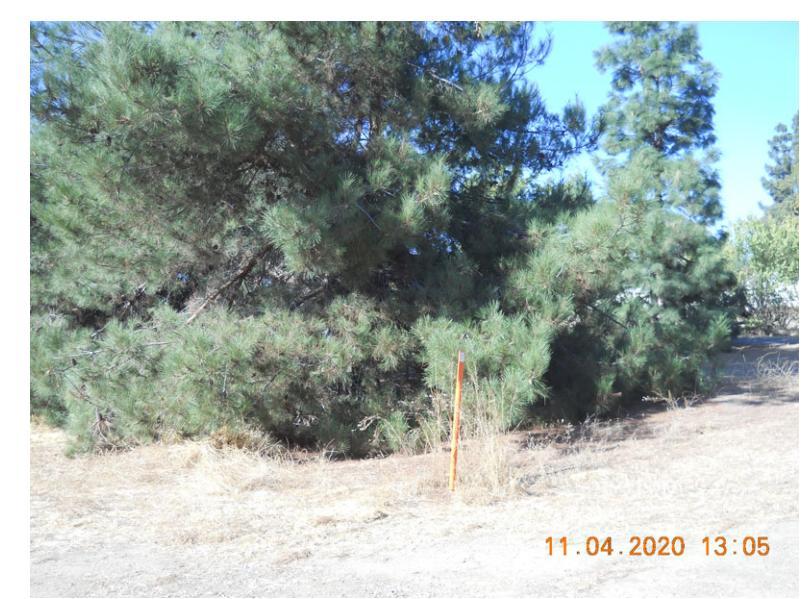
View northwest into Eastern Dog Pens Area from southeast corner showing location of southeast corner monument (Photo No. 4184).

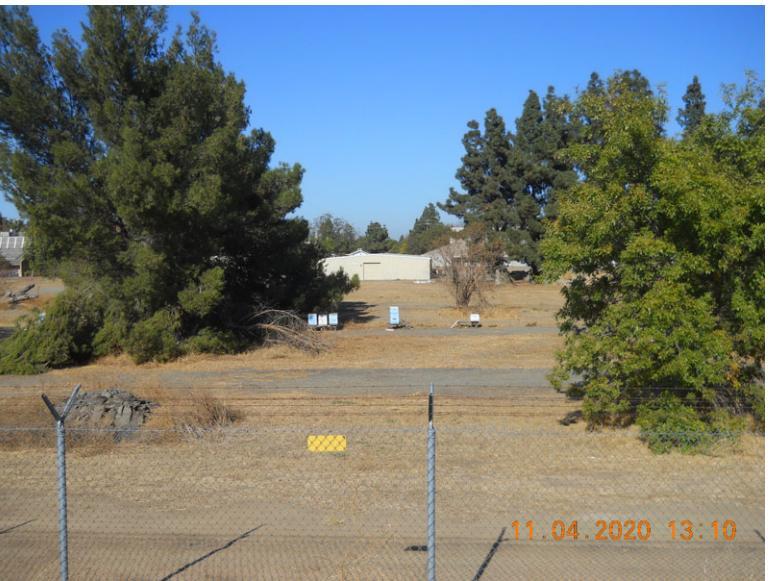
View north over Eastern Dog Pens Area from North Levee of the South Fork of Putah Creek; beehives in middle ground (Photo No. 4187).

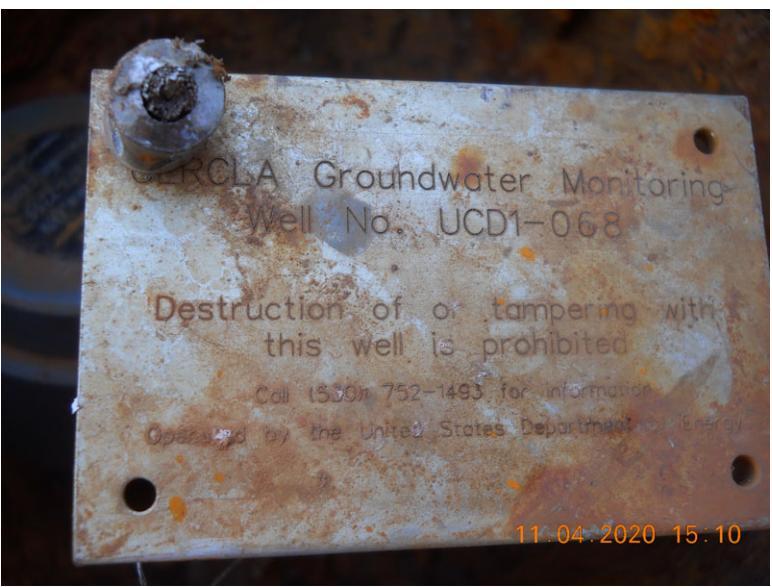
UCD1-068 Wellhead ID plate (Photo No. 4198).

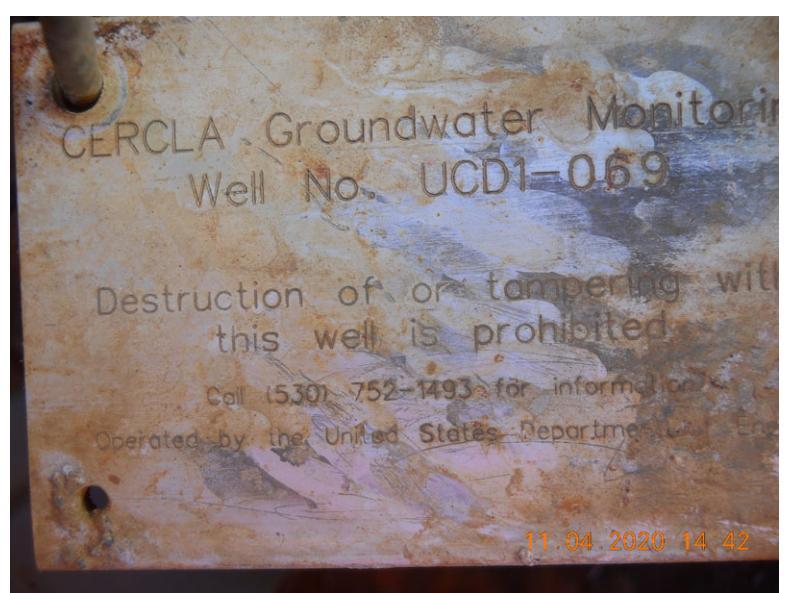
UCD1-069 Wellhead ID plate (Photo No. 4194).

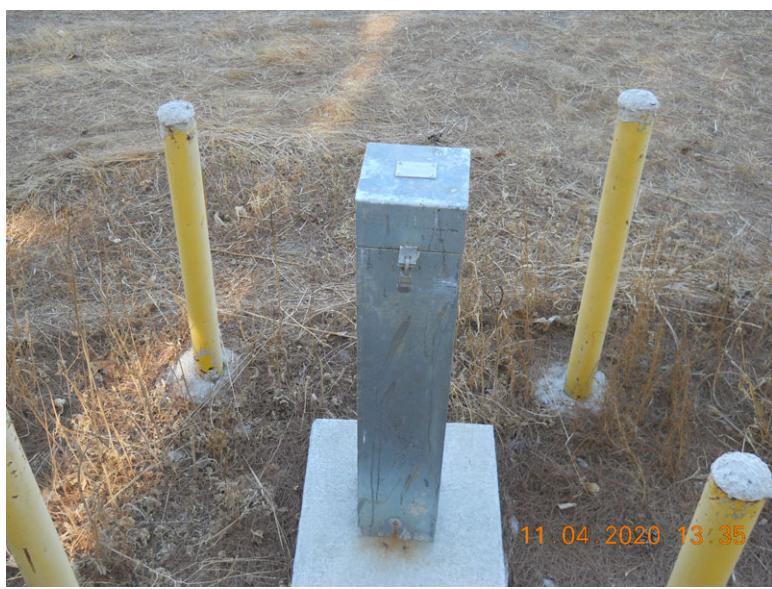
UCD1-069 Interior ID plate (Photo No. 4196).

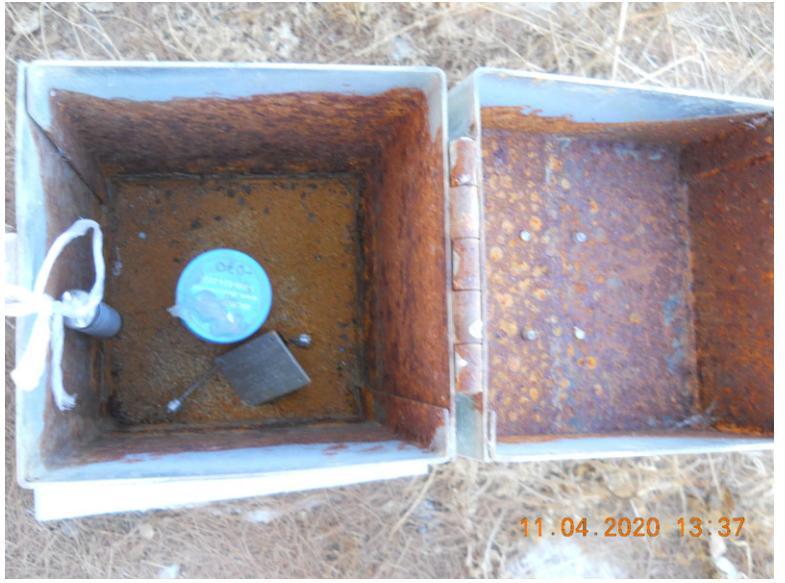
UCD1-070 Wellhead (Photo No. 4188).

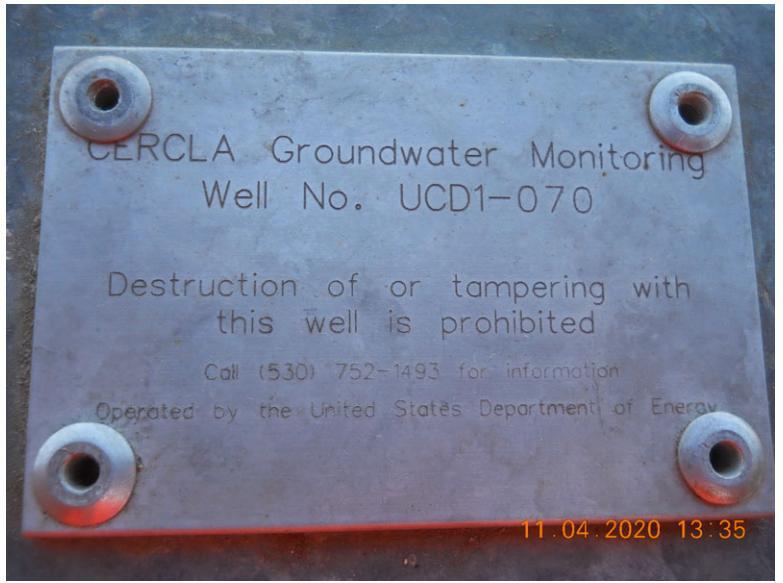
UCD1-070 Interior (Photo No. 4190).

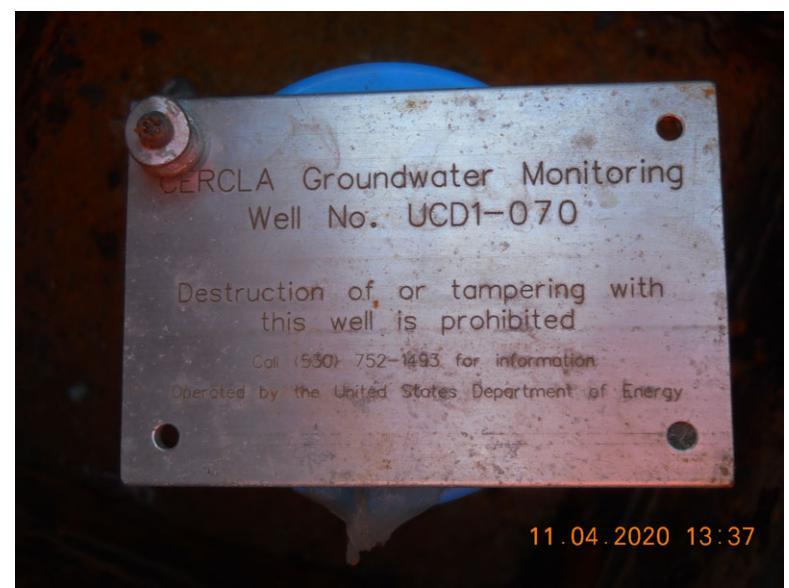
UCD1-070 Wellhead ID plate Photo No. 4189).

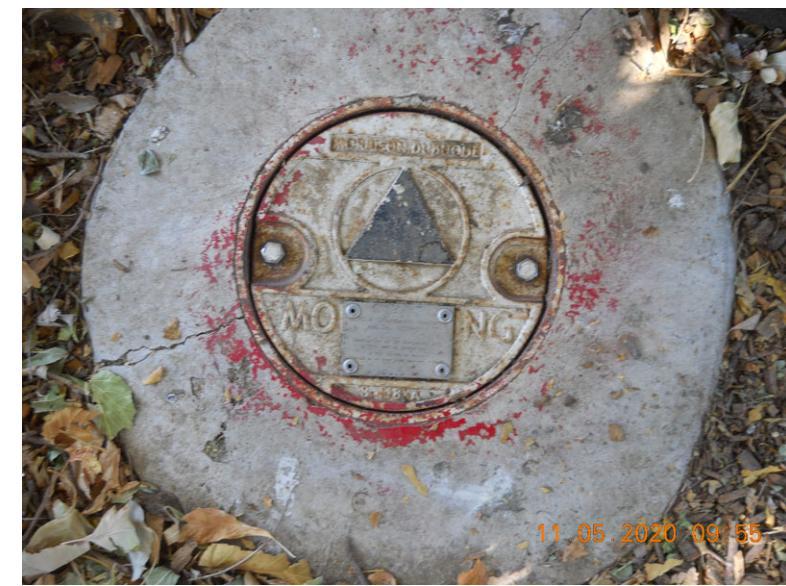
UCD1-070 Interior ID plate (Photo No. 4191).

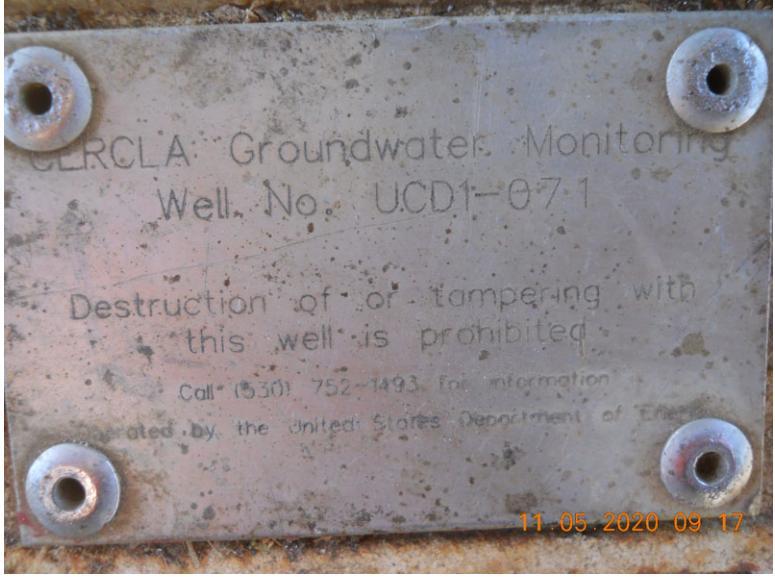
UCD1-071 Interior (Photo No. 4213).

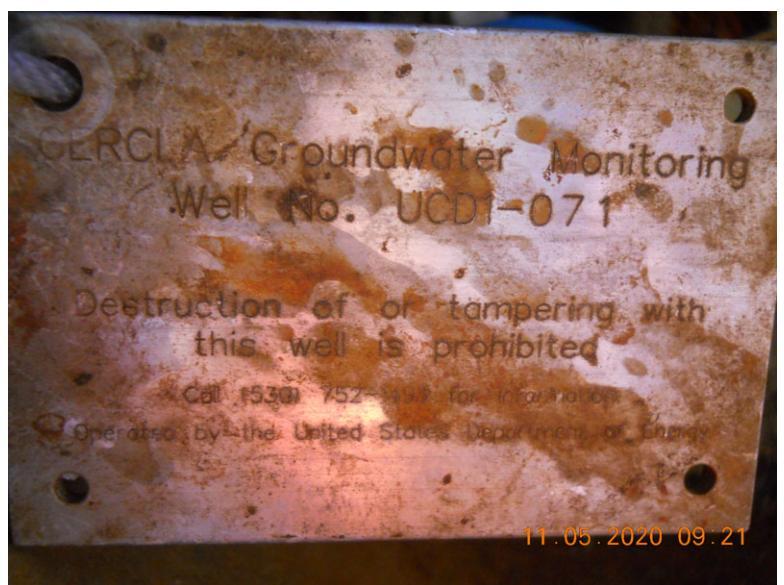
UCD1-071 Wellhead ID plate (Photo No. 4212).

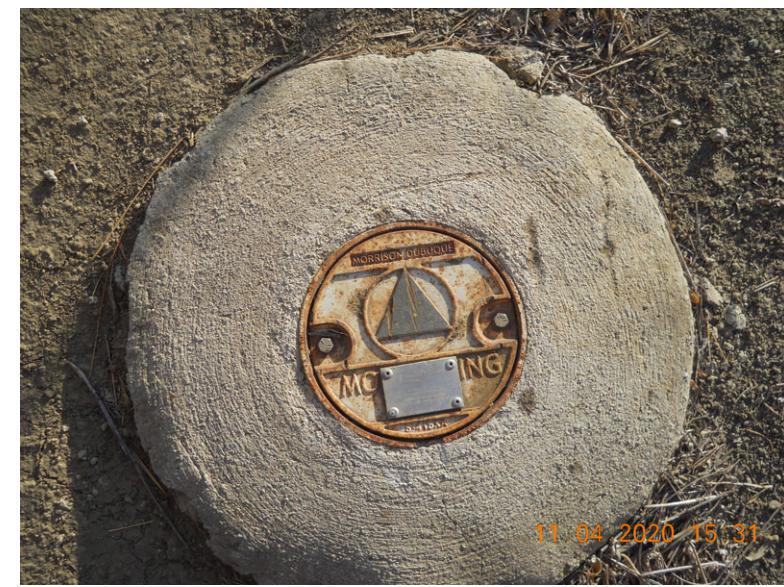
UCD1-071 Interior ID plate (Photo No. 4214).

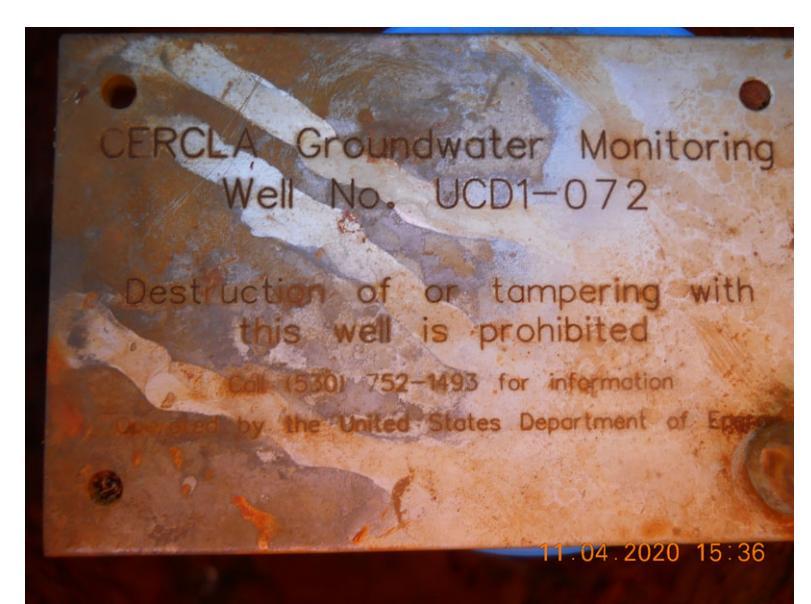
UCD1-072 Wellhead ID plate (Photo No. 4202).

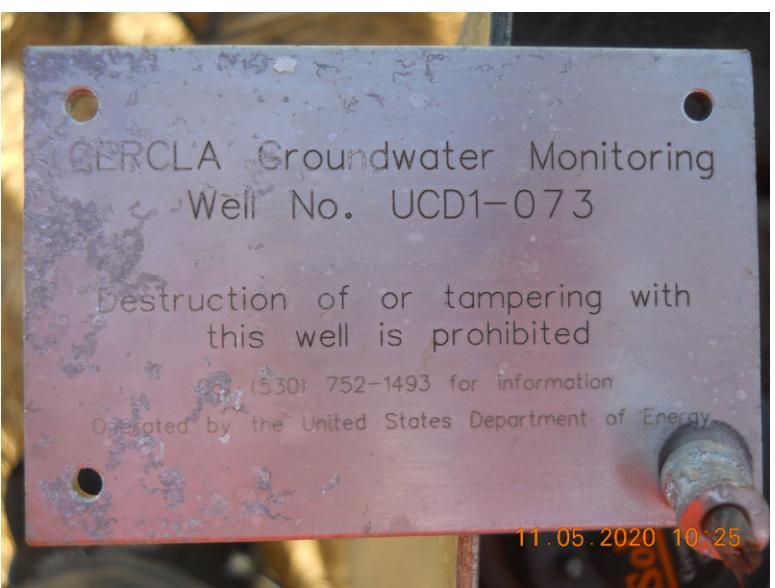
UCD1-073 Wellhead ID plate (Photo No. 4221).
