**2021 Annual Land-Use Covenant
Inspection Report
for DOE Areas at the
Laboratory for Energy-Related
Health Research/Old Campus
Landfill Superfund Site
University of California–Davis**

January 2022

U.S. DEPARTMENT OF
ENERGY

Legacy
Management

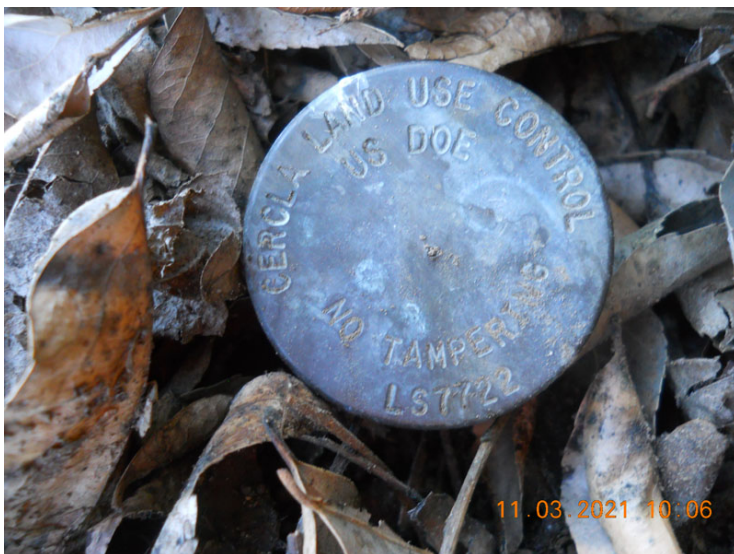
*Survey Monument 1: Northwest Corner of Dry Wells A–E Area
(Photo No. 4409)*

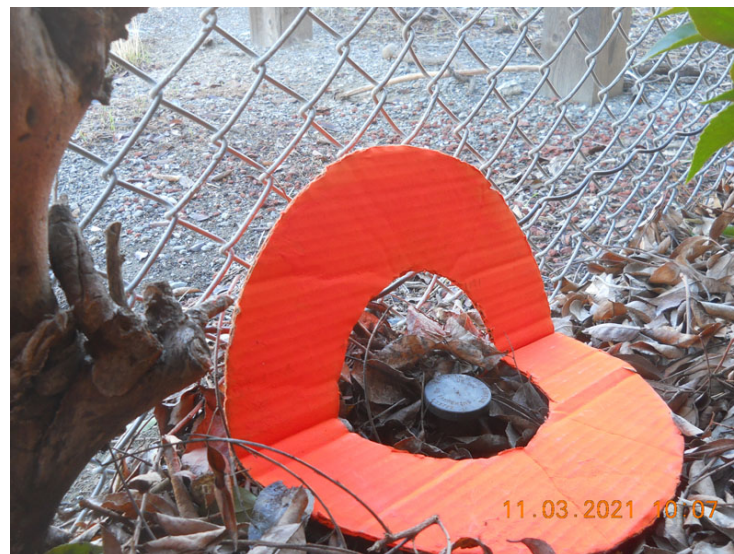
*View Northwest: Survey Monument 1, Within Orange Ring
(outside diameter is 14 inches); West Perimeter Fence
in Background (Photo No. 4410)*

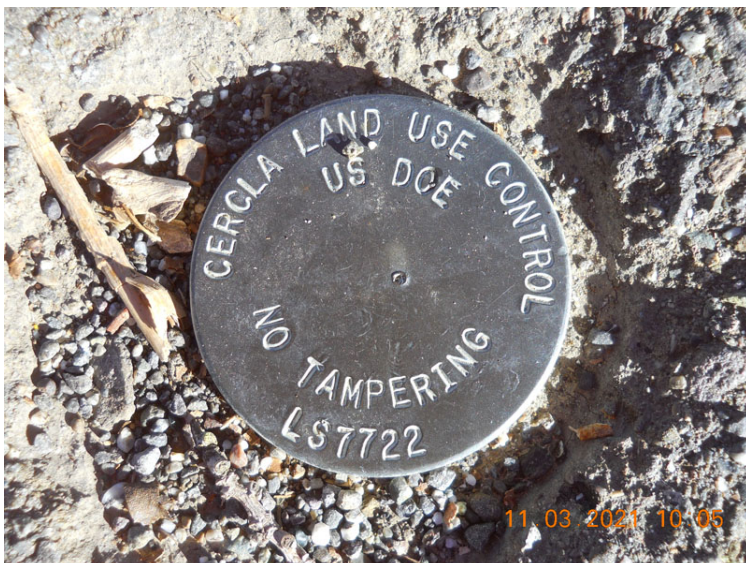
*Survey Monument 2: Northeast Corner of Dry Wells A–E Area
(Photo No. 4407)*

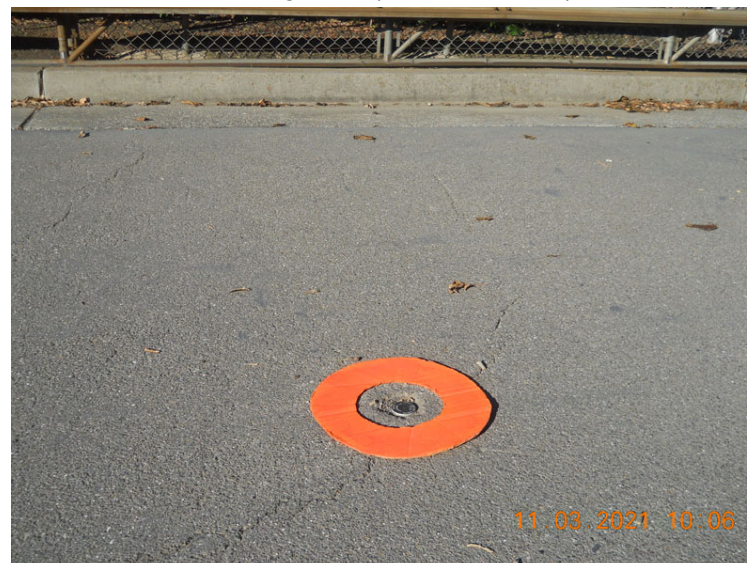
*View West: Survey Monument 2, Within Orange Ring; Foot of
Retracted Entrance Gate in Background (Photo No. 4408)*

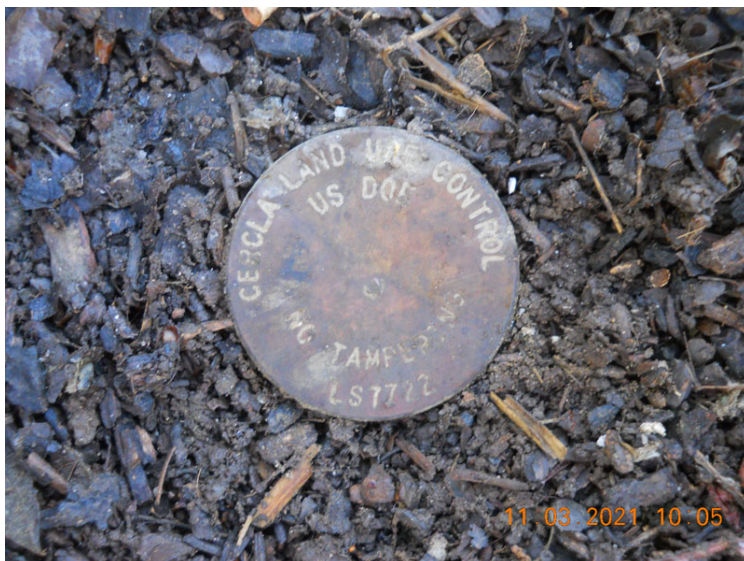
Survey Monument 3: Southwest Corner of Dry Wells A–E Area
(Photo No. 4405)

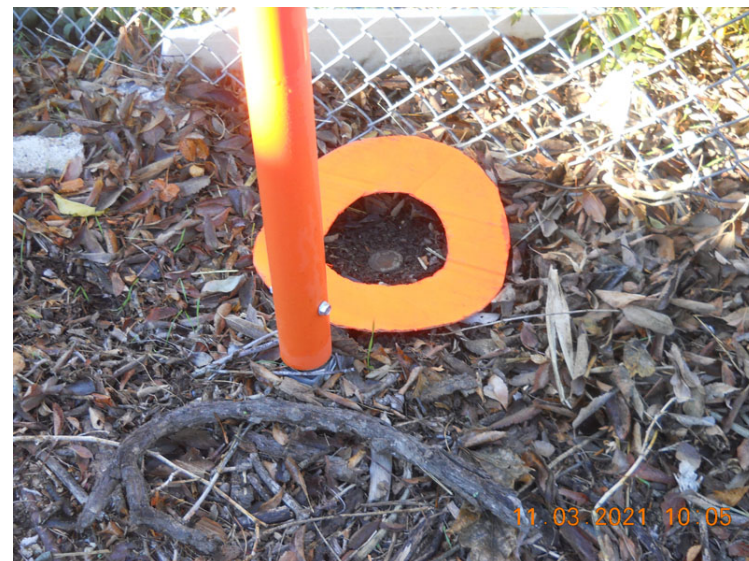
View Southwest: Survey Monument 3, Within Orange Ring; West
Perimeter Fence Behind Survey Monument; Orange Delineator
Left of Survey Monument (Photo No. 4406)

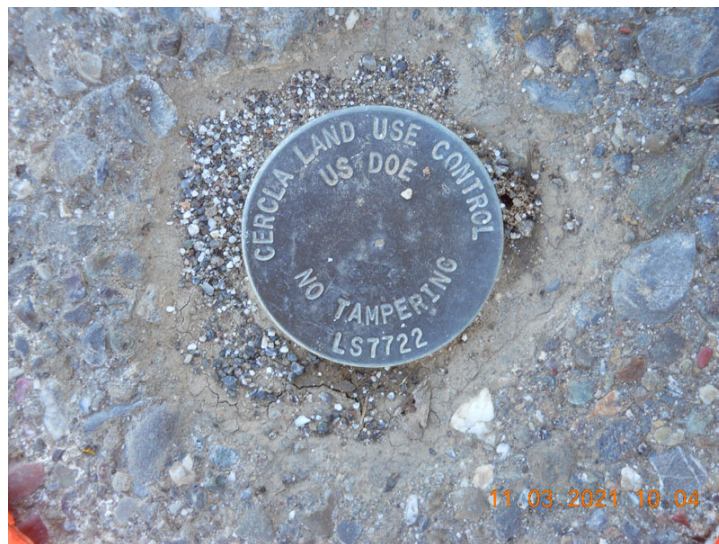
Survey Monument 4: Southeast Corner of Dry Wells A–E Area
(Photo No. 4403)

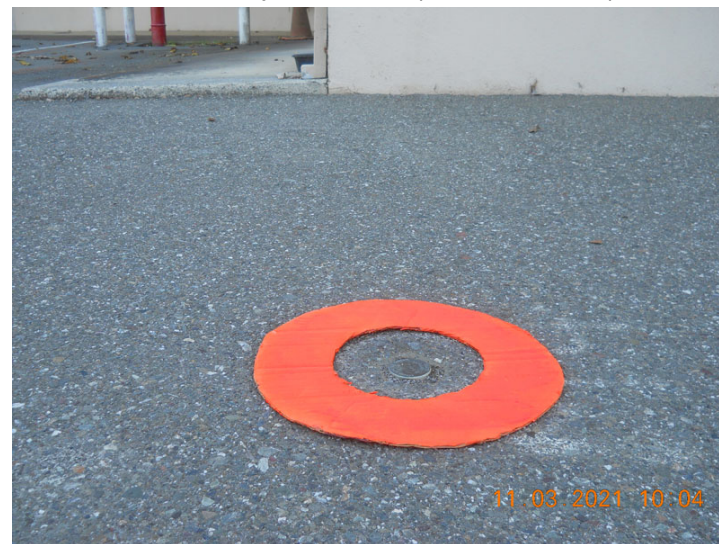
View East: Survey Monument 4, Within Orange Ring;
Building H-219 in Background (Photo No. 4404)

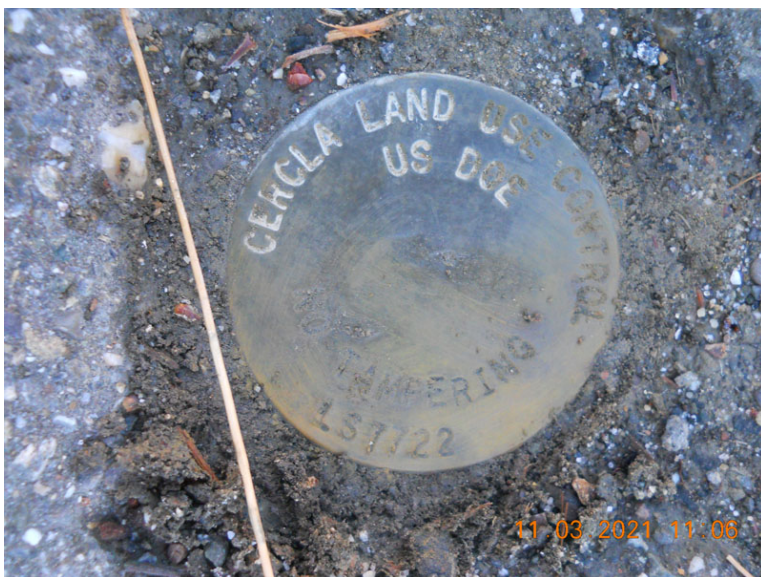
Survey Monument 5: Northwest Corner of Domestic Septic System 4 Area (Photo No. 4427)

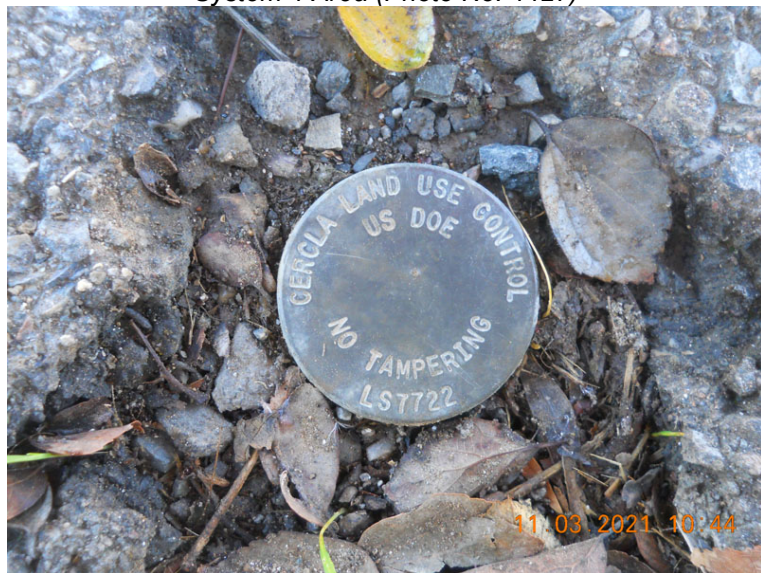
Survey Monument 6: Adjacent to Northwest Corner of Building H-218; Radium/Strontium Treatment Systems Area (Photo No. 4423)

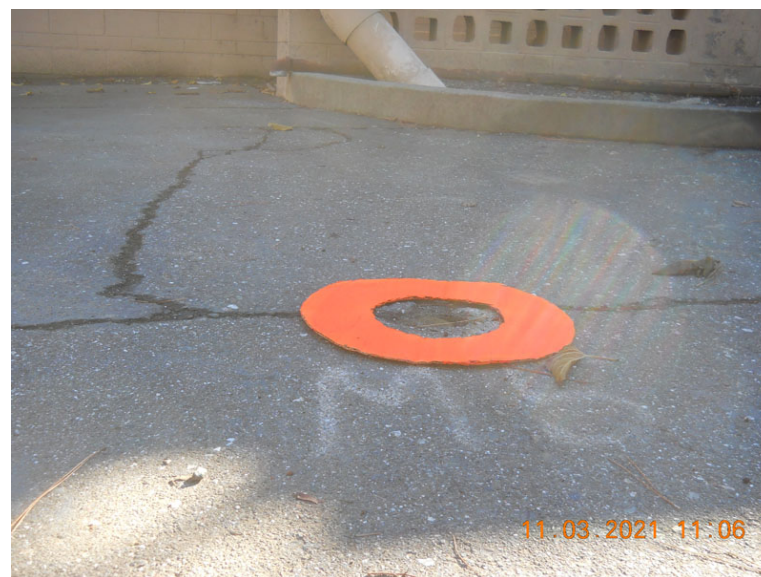
View East: Survey Monument 5, Within Orange Ring; Building H-215 in Background (Photo No. 4428)

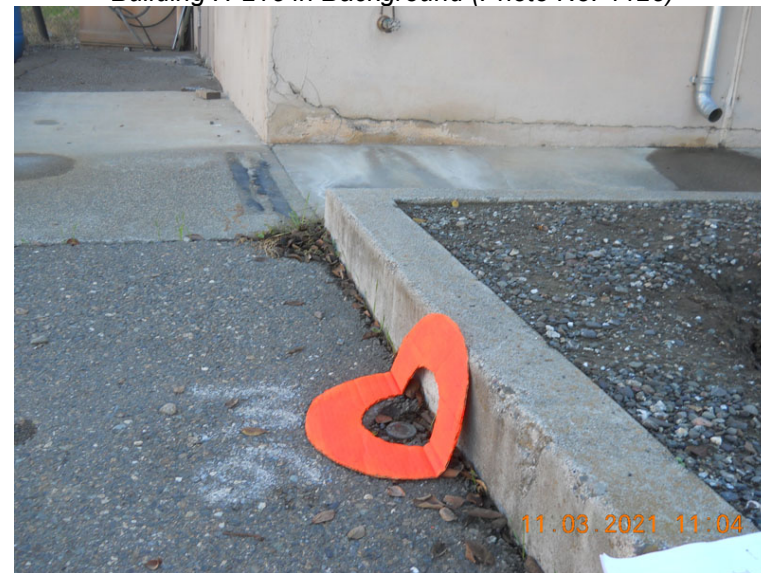
View East: Survey Monument 6, Within Orange Ring; Corner of Building H-218 in Background (Photo No. 4426)

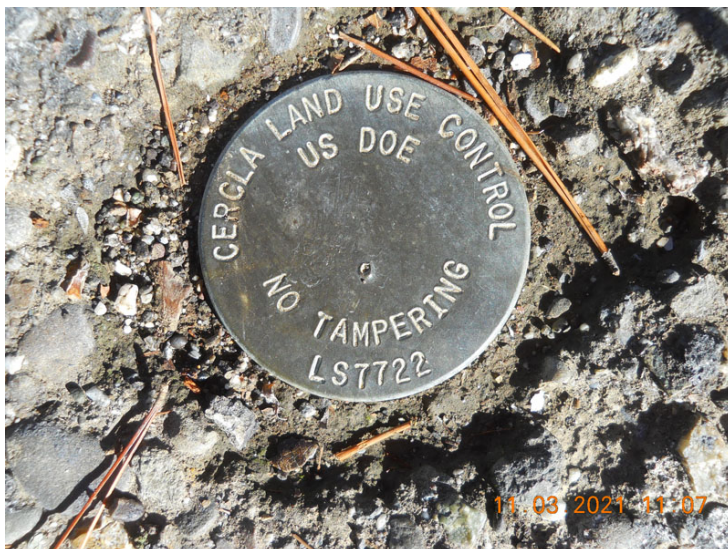
Survey Monument 7: Southwest Corner of Domestic Septic System 4 Area (Photo No. 4429)

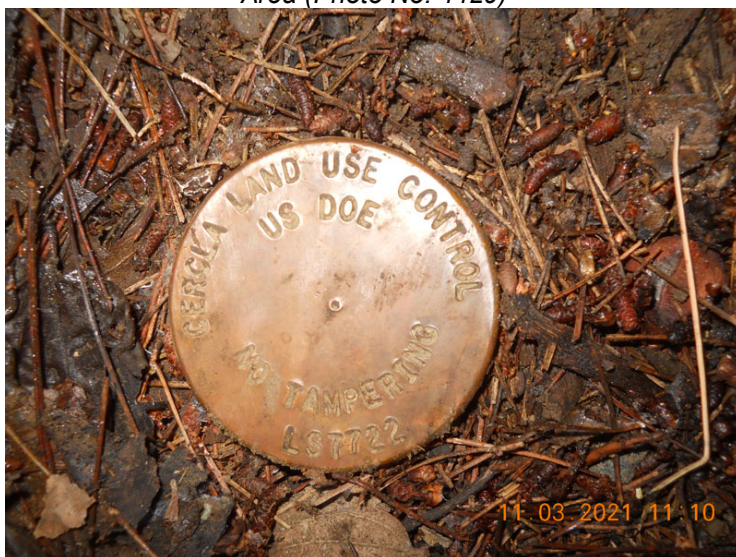
Survey Monument 8: Southwest Corner of Radium-226 Leach Trench; Radium/Strontium Treatment Systems Area (Photo No. 4434)

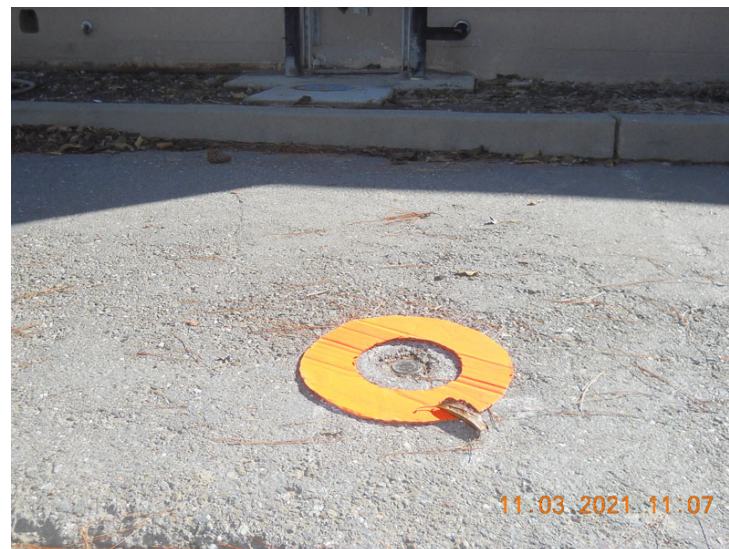
View East: Survey Monument 7, Within Orange Ring; Building H-215 in Background (Photo No. 4430)

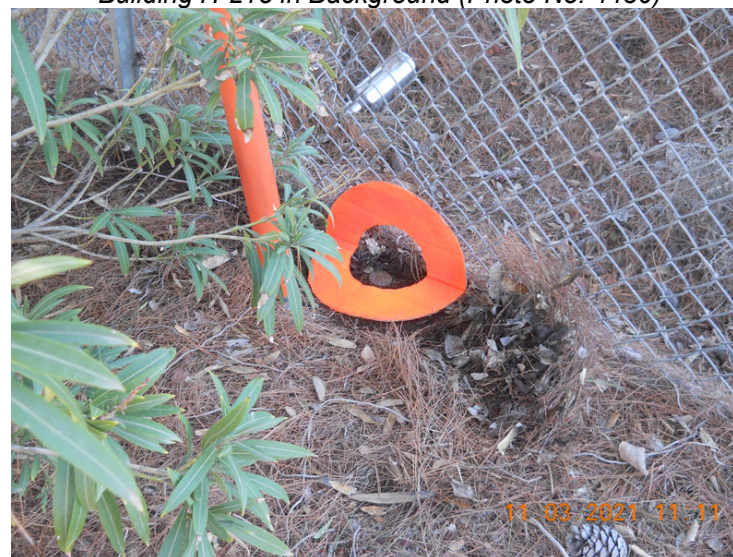
View Southwest: Survey Monument 8, Within Orange Ring; West Perimeter Fence Above Right of Survey Monument; Orange Delineator Left of Survey Monument (Photo No. 4435)

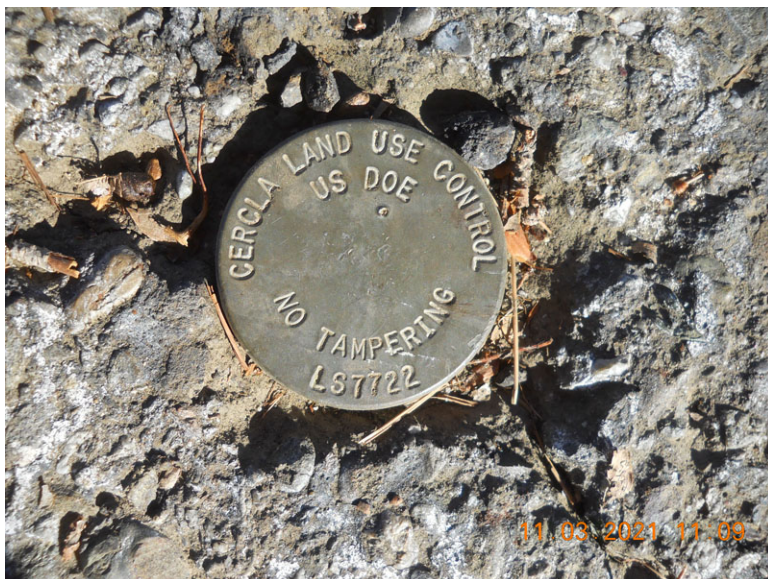
*Survey Monument 9: Southeast Corner of Radium-226 Leach Trench;
Radium/Strontium Treatment Systems Area (Photo No. 4432)*

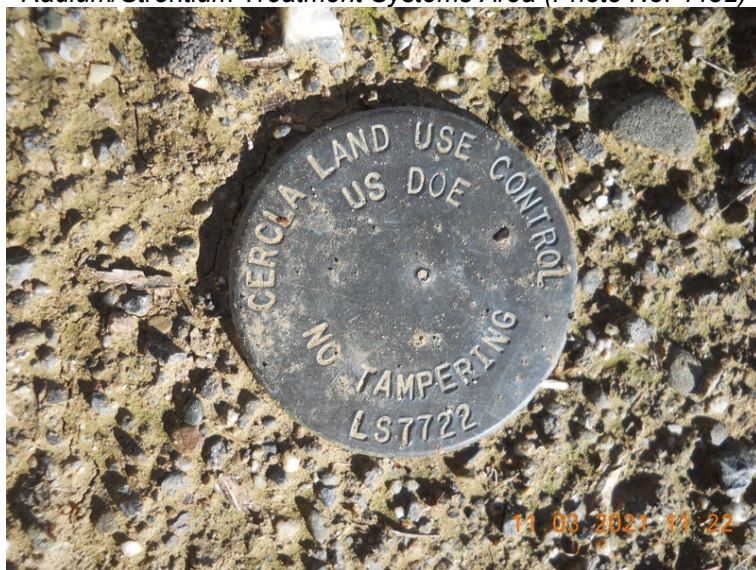
*Survey Monument 10: Northeast Corner of Former Leach Field in
Domestic Septic System 3 Area (Photo No. 4446)*

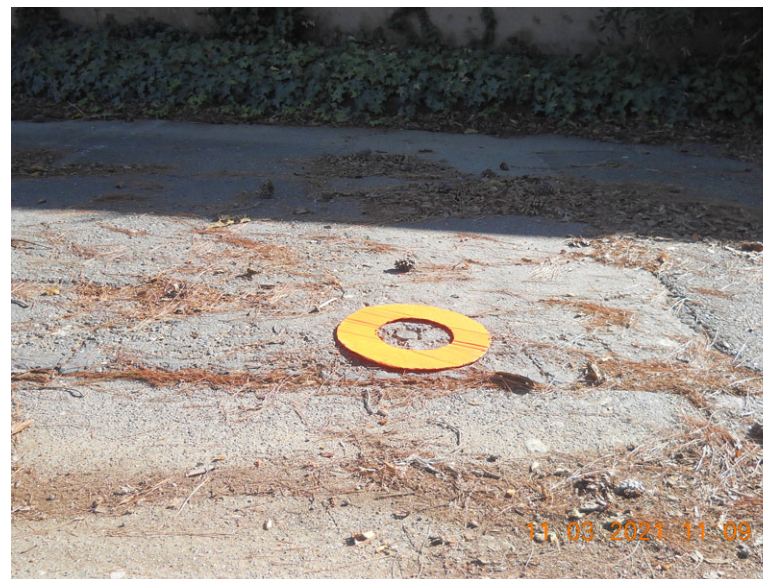
*View East: Survey Monument 9, Within Orange Ring; Planter at
Foot of Building H-215 in Background (Photo No. 4433)*

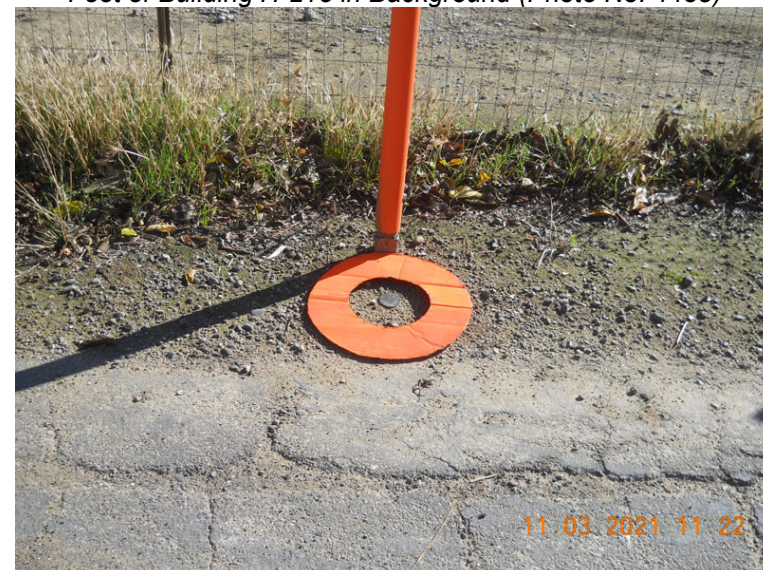
*View East: Survey Monument 10, Within Orange Ring in Foreground;
Delineator Behind Survey Monument (Photo No. 4447)*

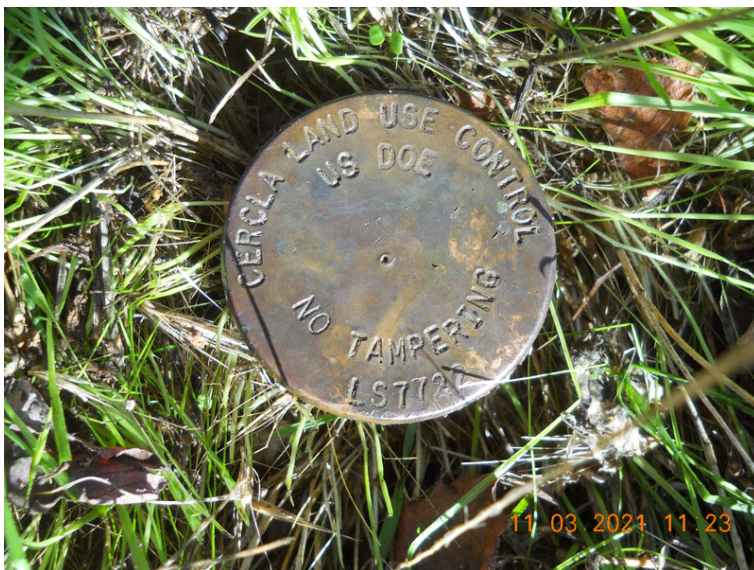
Survey Monument 11: Northeast Corner of Eastern Remediation Support Area (Photo No. 4448)

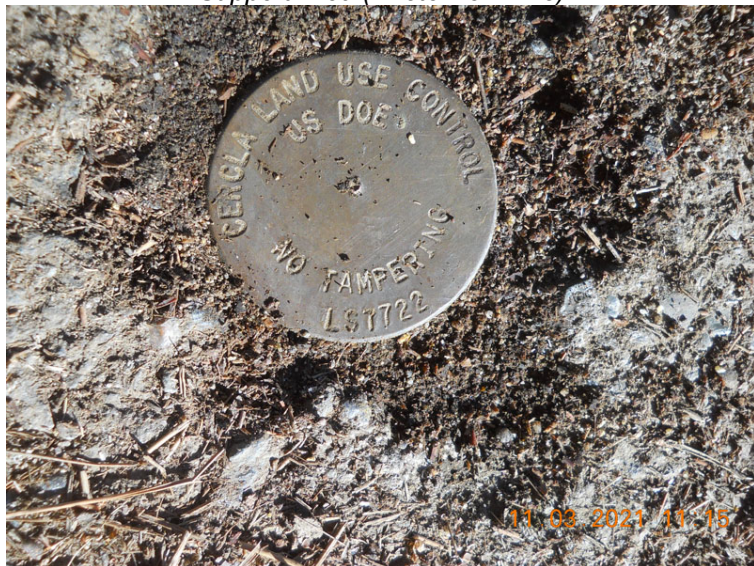
Survey Monument 12: Northwest Corner of Southwest Trenches Area (Photo No. 4436)

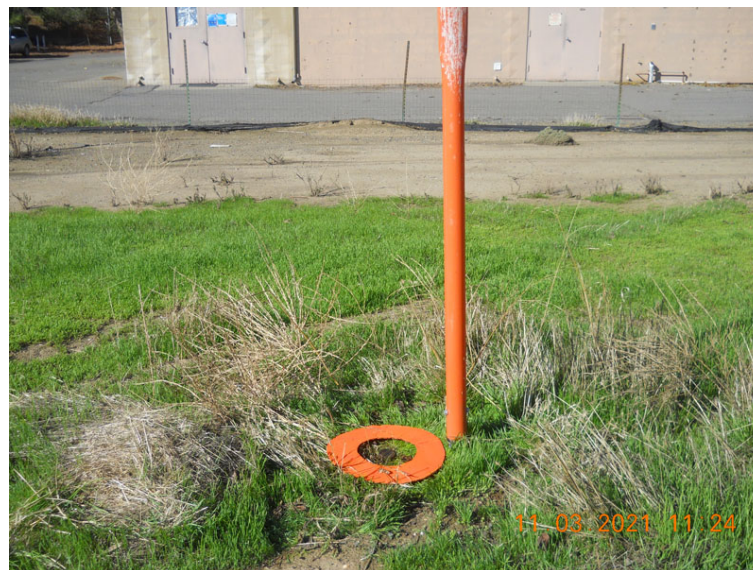
View North: Survey Monument 11, Within Orange Ring; Delineator Right of Survey Monument (Photo No. 4451)

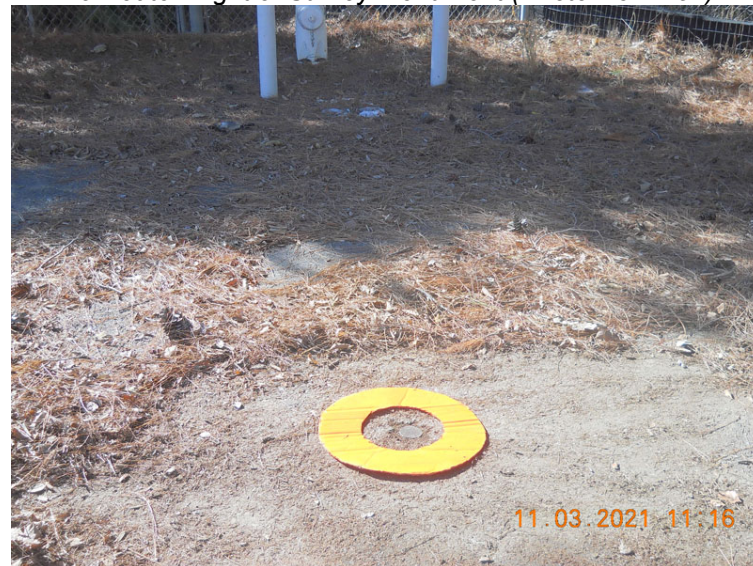
View South: Survey Monument 12, Within Orange Ring in Foreground; Water Hydrant in Background (Photo No. 4437)

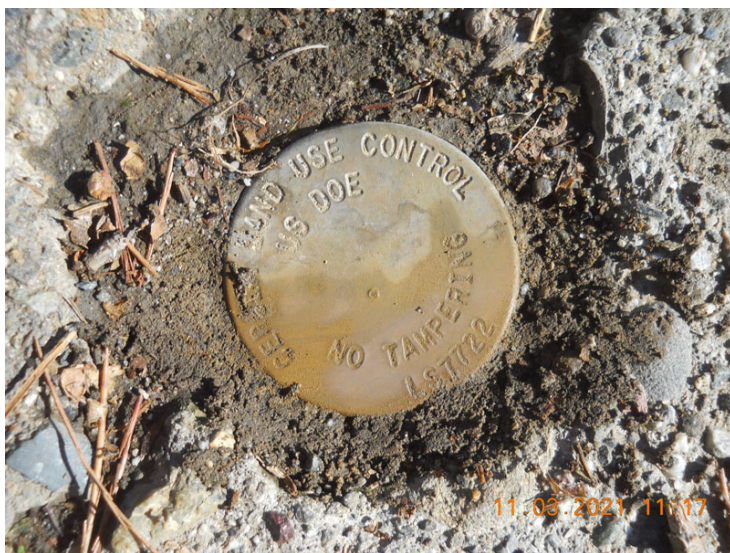
Survey Monument 13: Southwest Corner of Domestic Septic System 3 Area, at Northern Perimeter of Southwest Trenches Area (Photo No. 4438)

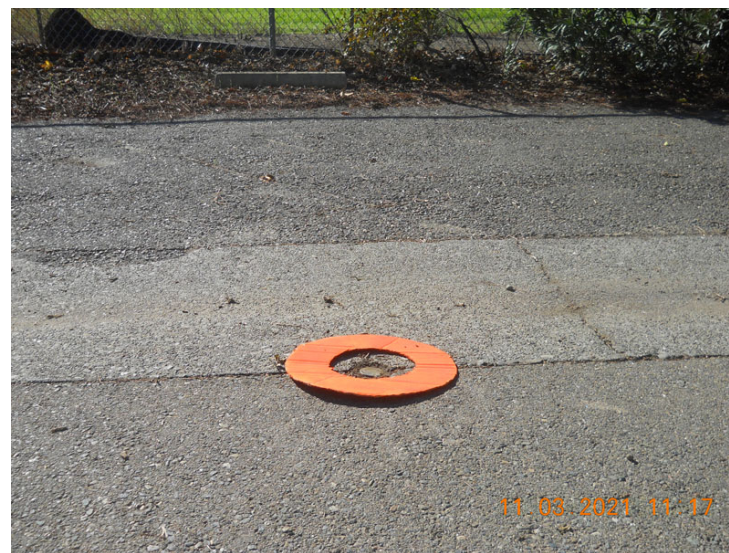
View South: Survey Monument 13, Within Orange Ring at Edge of Concrete Swale (Photo No. 4439)

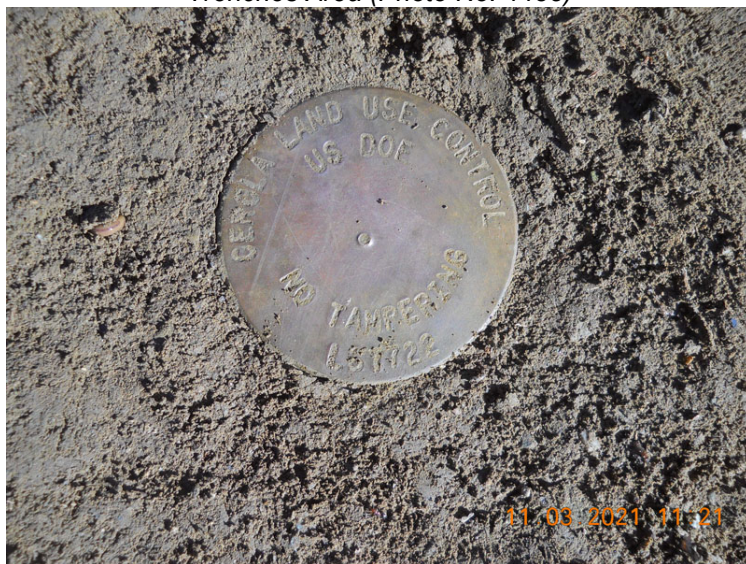
Survey Monument 14: Southeast Corner of Domestic Septic System 3 Area (Photo No. 4444)

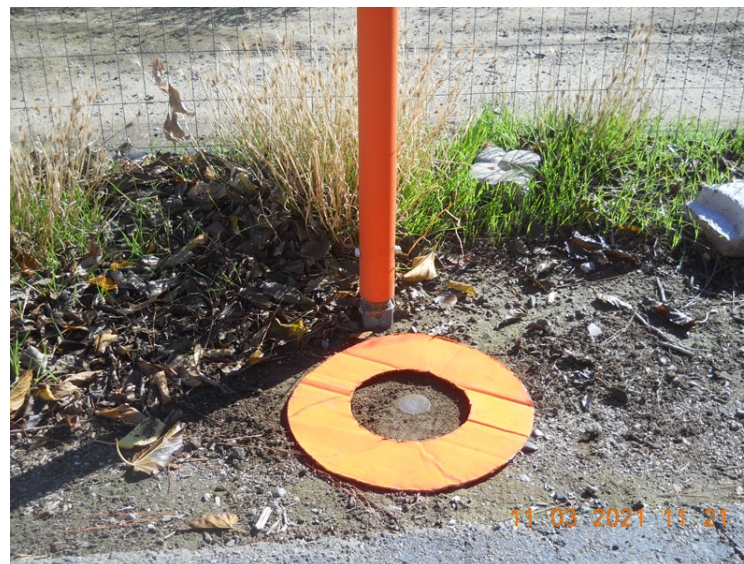
View East: Survey Monument 14, Within Orange Ring; Delineator Behind Survey Monument (Photo No. 4445)

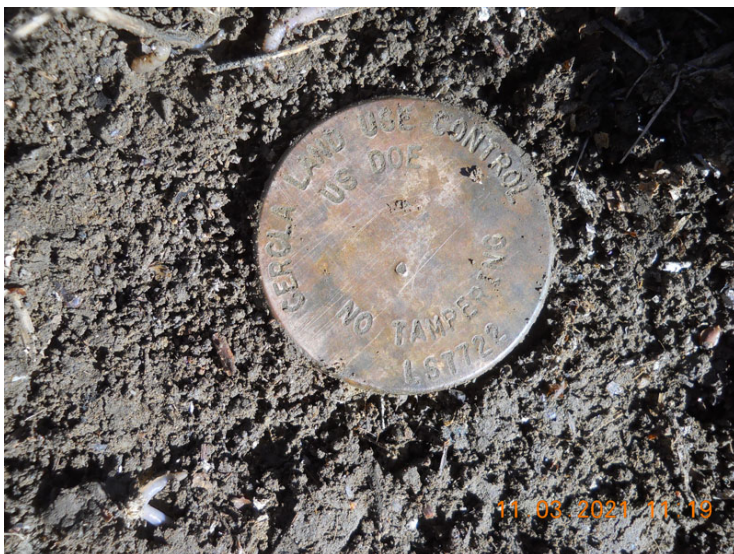
*Survey Monument 15: Eastern Corner of Southwest Trenches Area
(Photo No. 4442)*

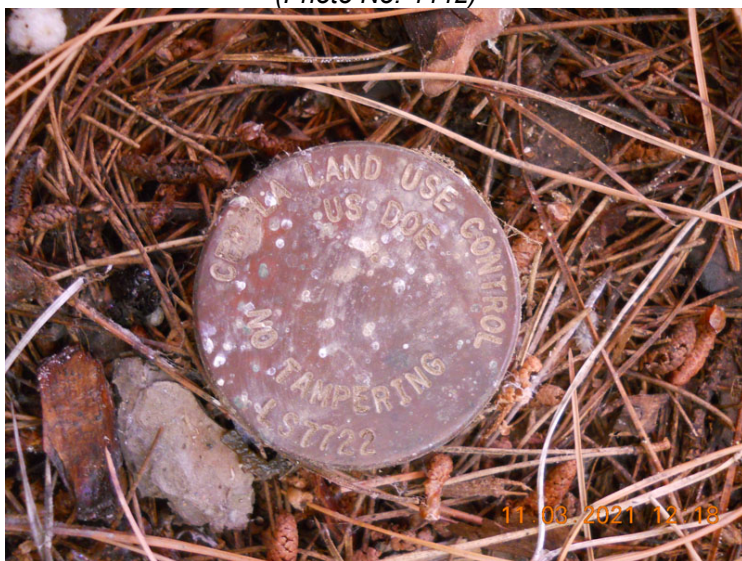
*Survey Monument 16: Southwest Corner of Southwest Trenches Area
(Photo No. 4481)*

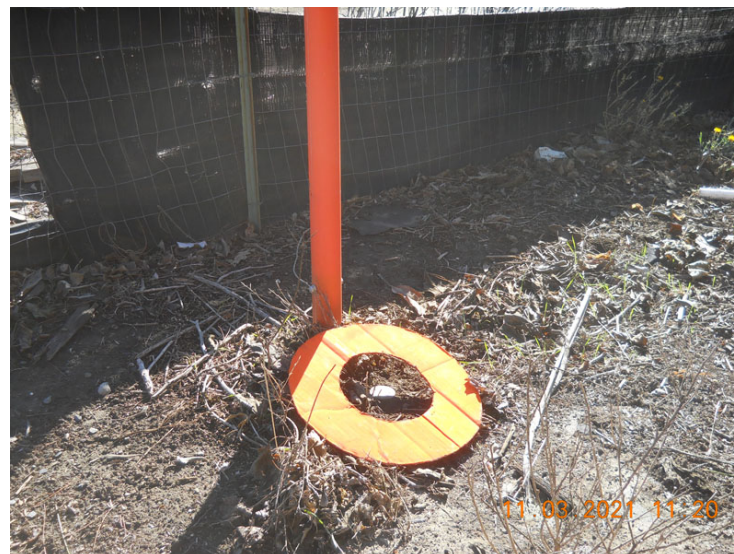
*View East: Survey Monument 15, Within Orange Ring;
Delineator Behind Survey Monument (Photo No. 4443)*

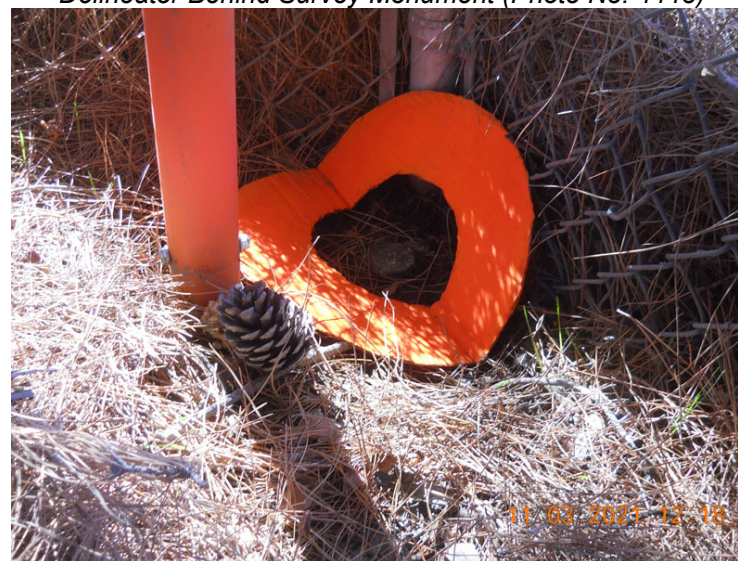
*View Southwest: Survey Monument 16, Within Orange Ring;
Delineator Left of Survey Monument; Southwest Corner Post of
Perimeter Fence Behind Survey Monument (Photo No. 4482)*

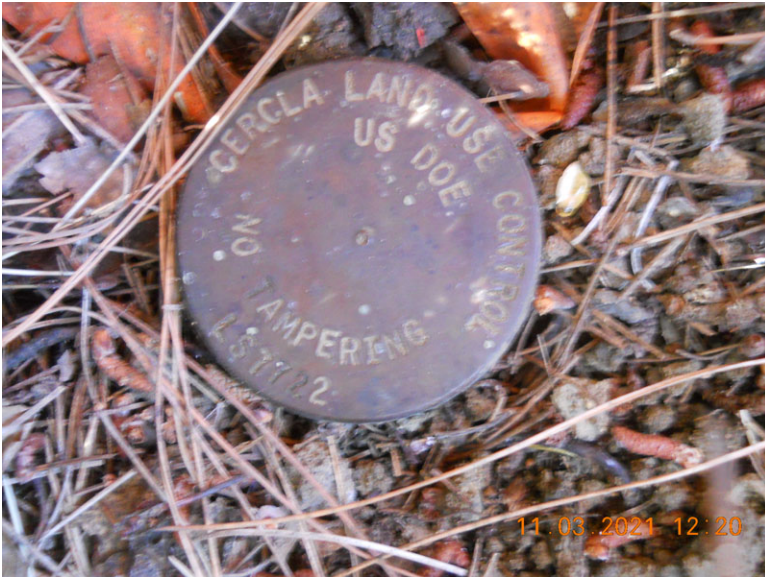
*Survey Monument 17: Southeast Corner of Southwest Trenches Area
(Photo No. 4483)*

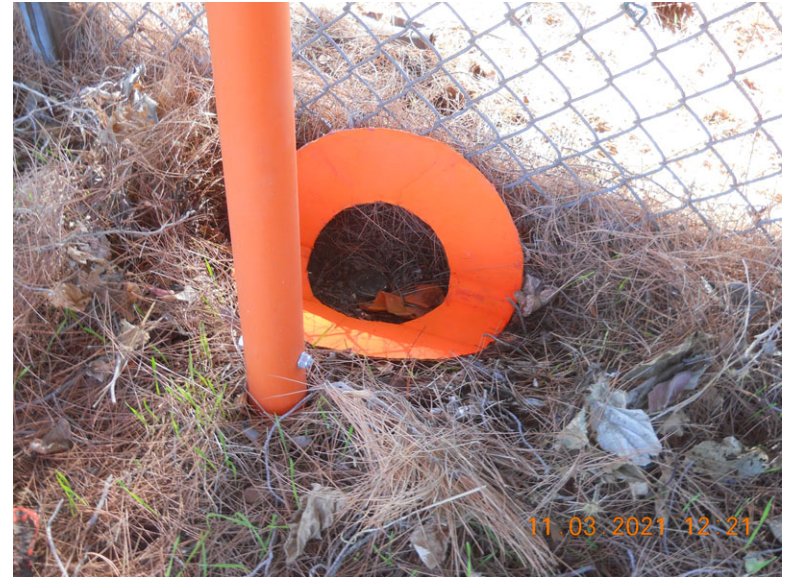
*View Southeast: Survey Monument 17, Within Orange Ring; Delineator
Left of Survey Monument; South Perimeter Fence Behind Survey
Monument; Foot of North Levee in Background (Photo No. 4485)*

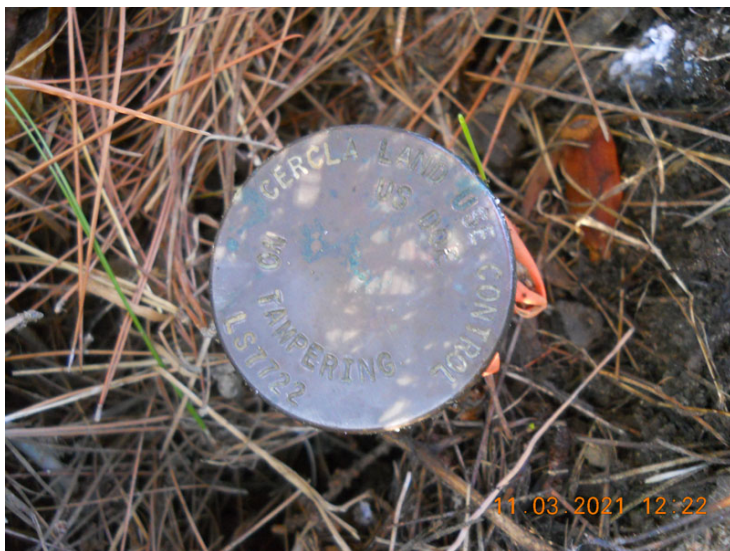
Survey Monument 18: Southeast Corner of Eastern Remediation Support Area (Photo No. 4486)

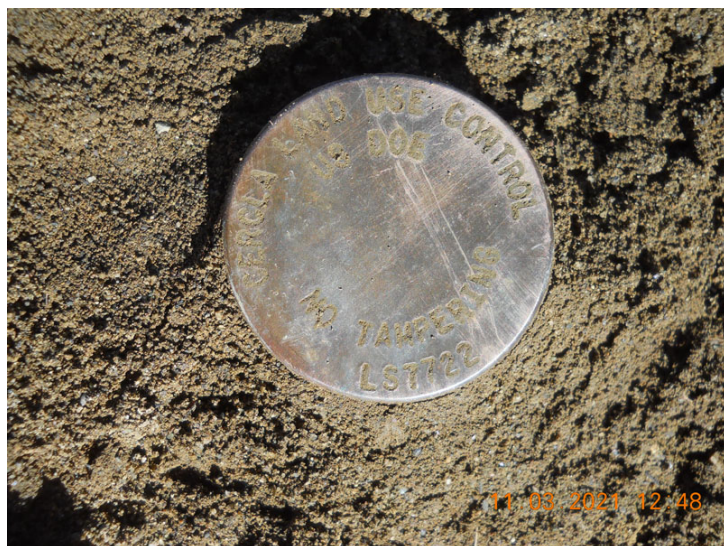
Survey Monument 19: Northwest Corner of Eastern Dog Pens Area (Photo No. 4493)

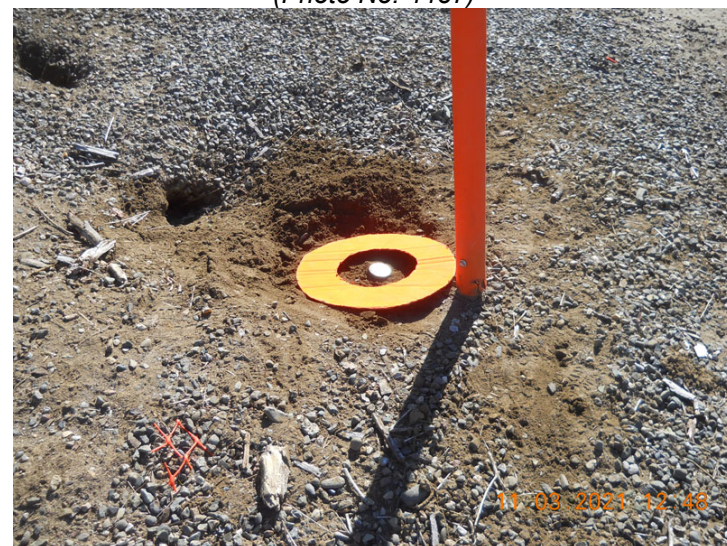
View Southeast: Survey Monument 19, Within Orange Ring; Delineator Right of Survey Monument (Photo No. 4494)

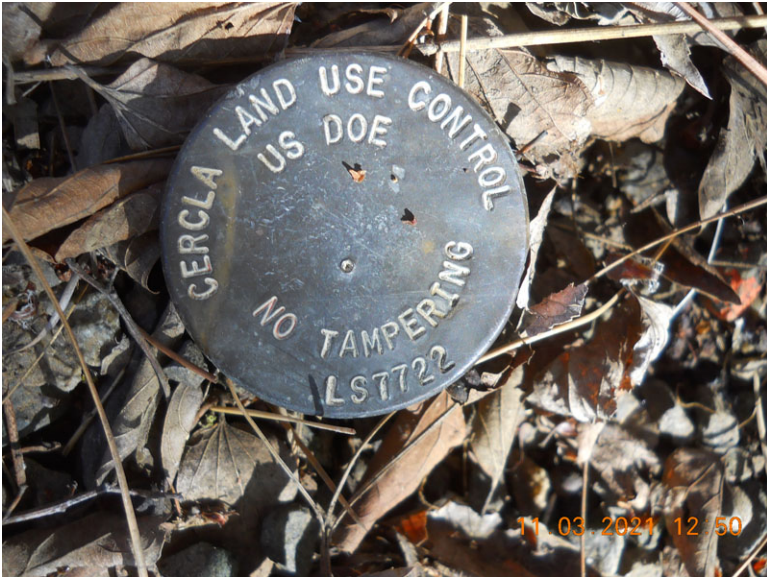
*Survey Monument 20: Northeast Corner of Eastern Dog Pens Area
(Photo No. 4497)*

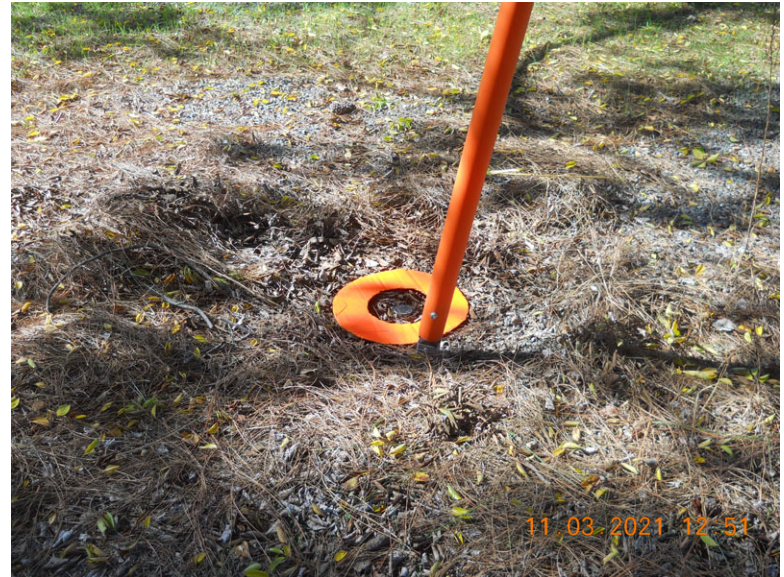
*View Southwest: Survey Monument 20, Within Orange Ring;
Delineator Right of Survey Monument; Eastern Dog Pens Area in
Background (Photo No. 4498)*

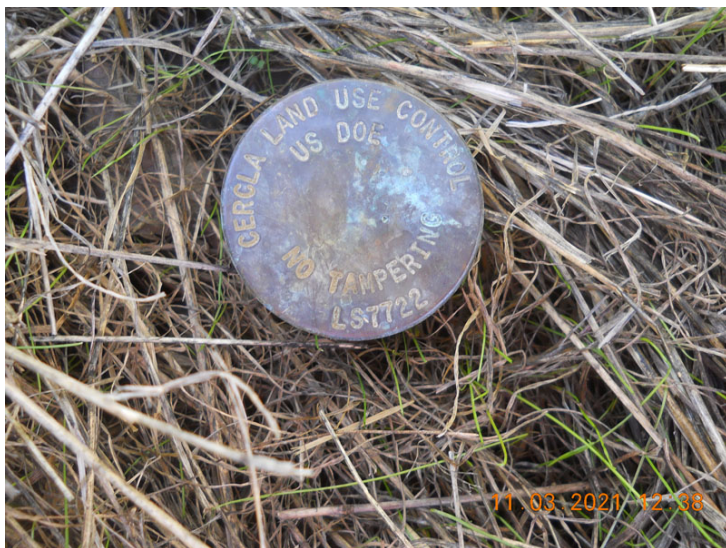
*Survey Monument 21: Southwest Corner of Eastern Dog Pens Area
(Photo No. 4489)*

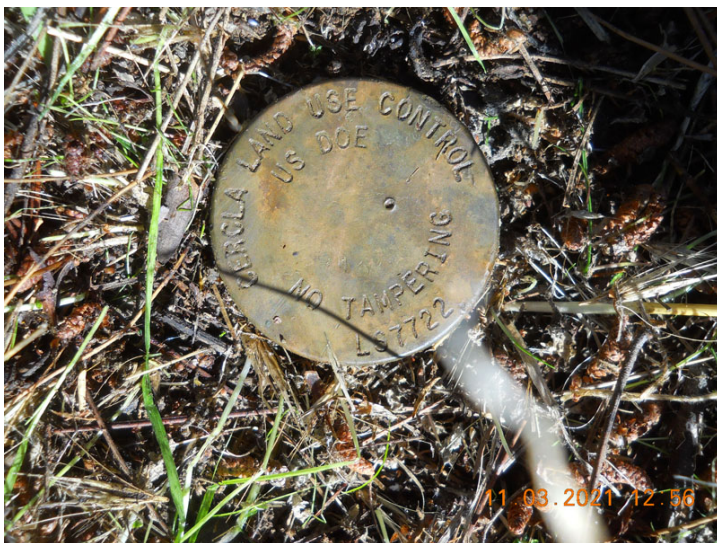
*Survey Monument 22: Southeast Corner of Eastern Dog Pens Area
(Photo No. 4503)*

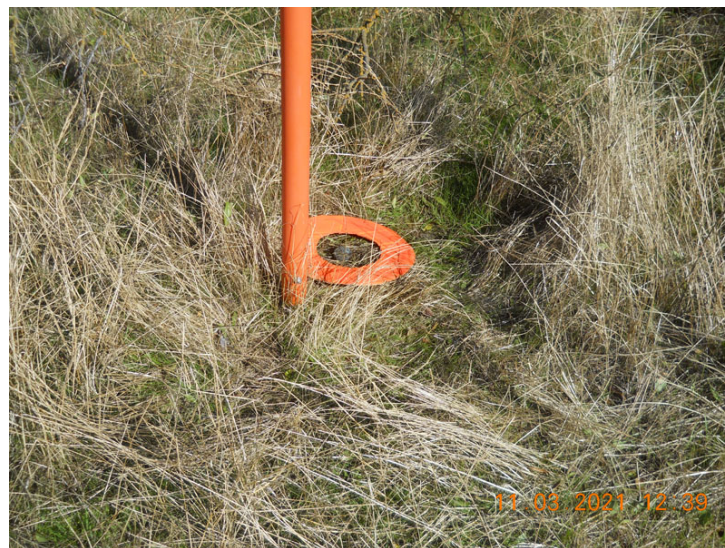
*View Northeast: Survey Monument 21, Within Orange Ring;
Delineator Left of Survey Monument; Eastern Dog Pens Area in
Background (Photo No. 4490)*

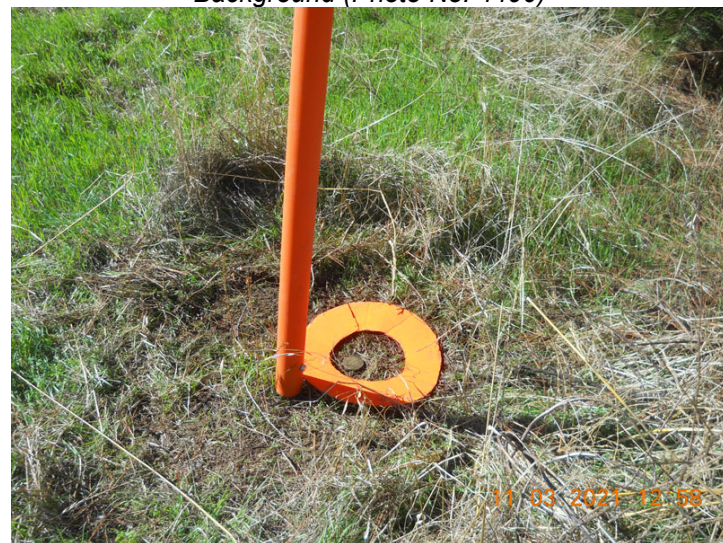
*View West: Survey Monument 22, Within Orange Ring;
Delineator Left of Survey Monument; Eastern Dog Pens Area
in Background Right (Photo No. 4504)*

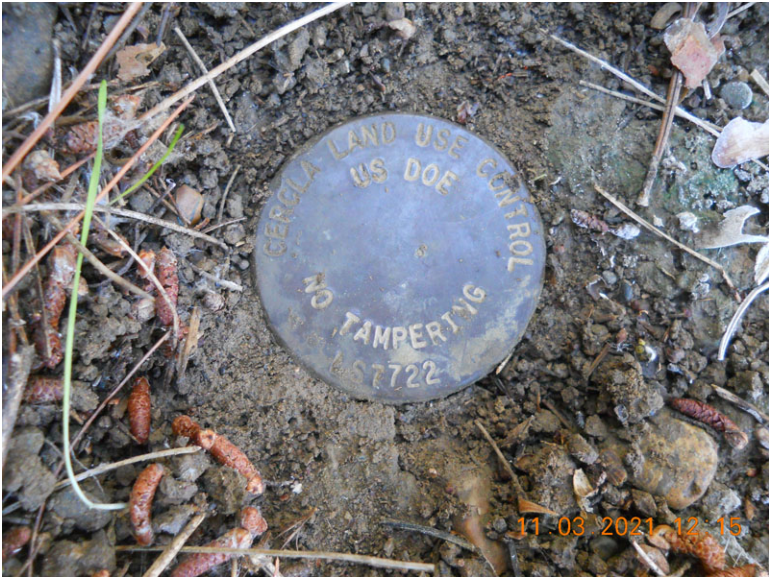
Survey Monument 23: Western Perimeter Point of Southwest Trenches Area (Photo No. 4479)

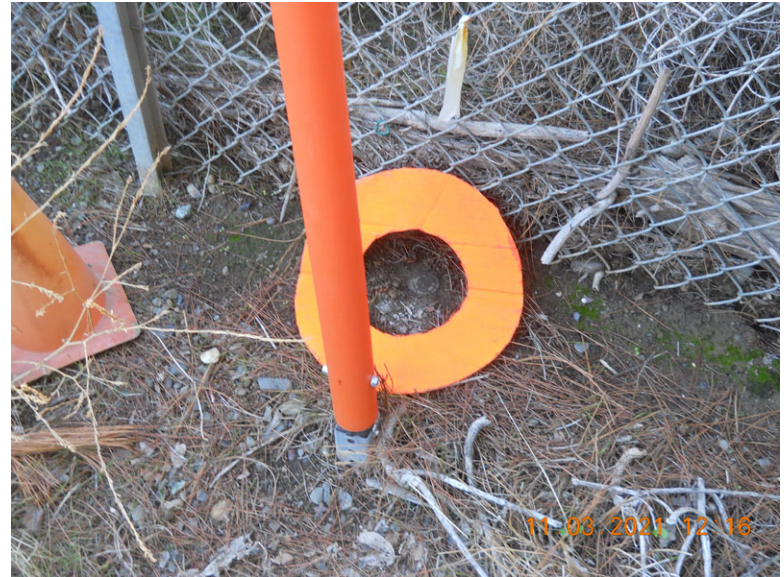
View West: Survey Monument 23, Within Orange Ring; Delineator Left of Survey Monument; West Perimeter Fence Behind Survey Monument (Photo No. 4480)

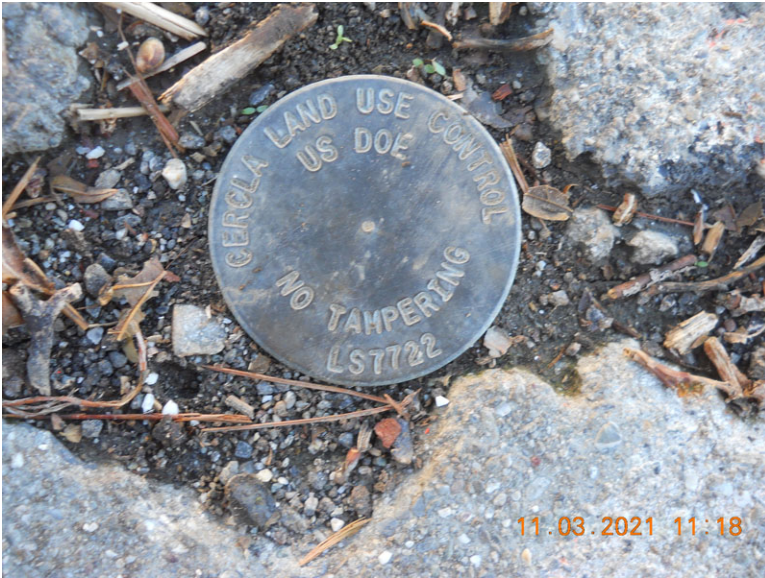
*Survey Monument 24: Northeast Corner of Southwest Trenches Area,
at Southern Perimeter of Domestic Septic System 3 Area
(Photo No. 4440)*

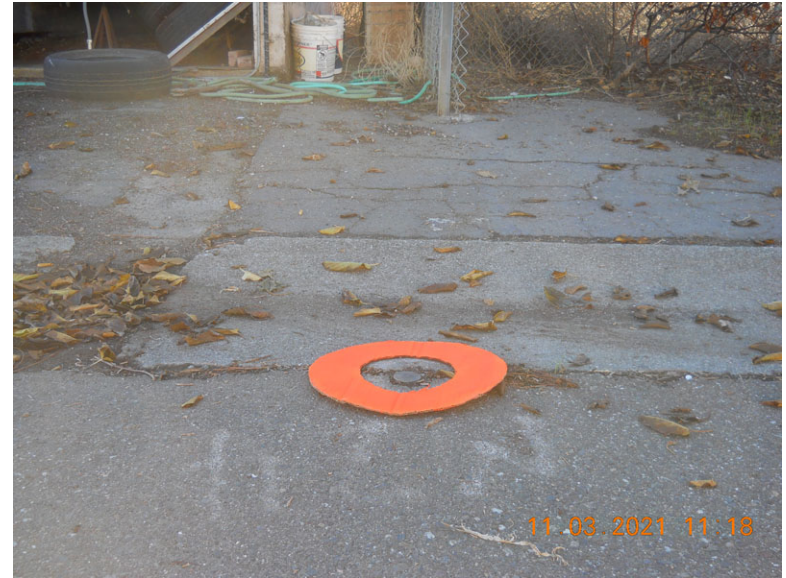
*View South: Survey Monument 24, Within Orange Ring on Edge of
Concrete Swale (Photo No. 4441)*

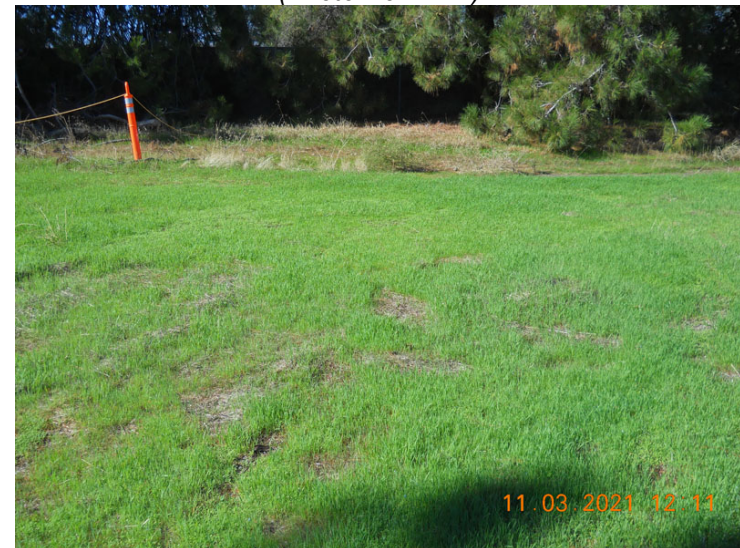
*View West from Center of Southwest Trenches Area;
Tree 16220 Fallen Limbs Behind Stanchion and Rope
in Upper Left of Photo (Photo No. 4473)*

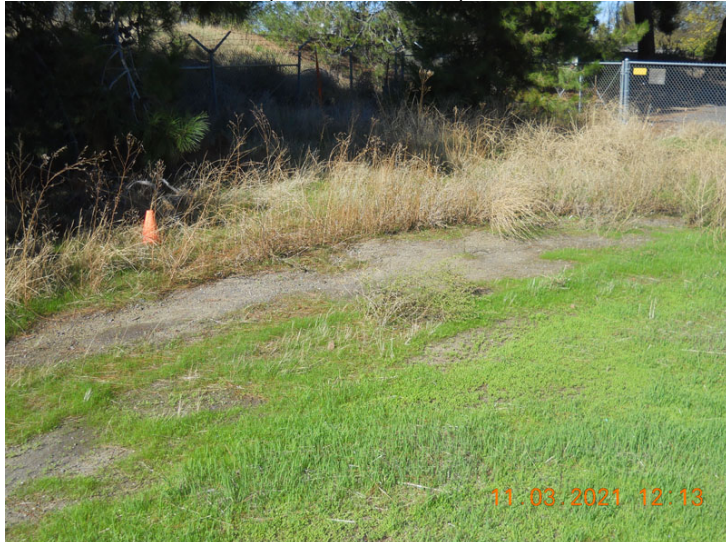
*View North of Northwest Corner of Southwest Trenches Area;
Tree 16219 Fallen Limb Behind Cone in Left of Photo
(Photo No. 4477)*

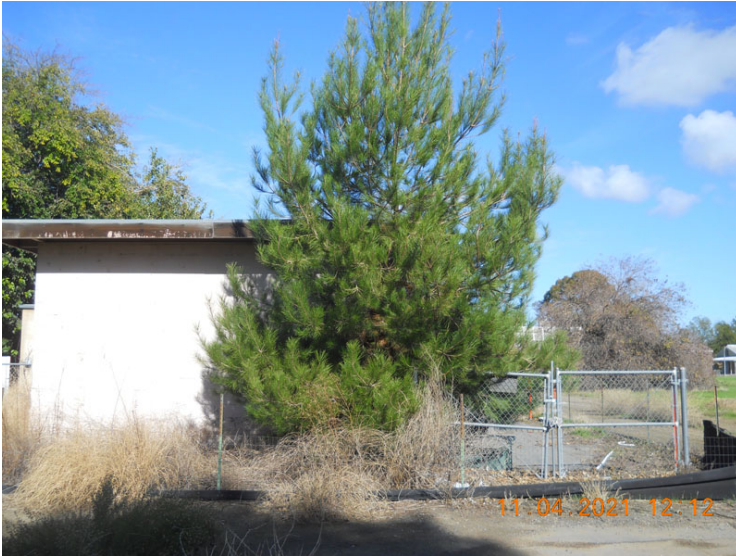
Tree ID	Tag number	Tag Photo ¹	Damaged or missing tag? If Y, explain	Tree/shrub changed since last inspection? If Y, explain	Comments
16230	030	4611	N	N	
16231	031	4612	N	N	
16232	032	4610	N	N	
16233	033	4608	N	Y	Fallen limbs
16234	034	4607	N	N	
16235	035	4605	N	N	
16236	036	4601	N	Y	Fallen limbs
16237	037	4604	N	N	
16238	038	4614	N	N	
16239	039	4613	N	N	
16240	040	4615	N	N	
16241	041	4616	N	N	
16242	042	4617	N	N	
16243	043	4618	N	N	
16244	044	4621	N	N	
16245	045	4620	N	N	
16246	046	4622	N	N	
16247	047	4623	N	N	
16248	048	4629	N	N	
16249	049	4627	N	N	
16250	050	4624	N	N	
16251	051	4628	N	N	
16252	052	4579	N	N	
16253	053	4568	N	N	
16254	054	4567	N	N	
16255	055	4566	N	N	
NA	NA	NA	Y	Y	New pine sapling >6 feet tall, add to inventory, prepare and install tag

View North of Aleppo Pine Sapling in Northeast Corner of Southwest Trenches Area (Photo No. 4591)

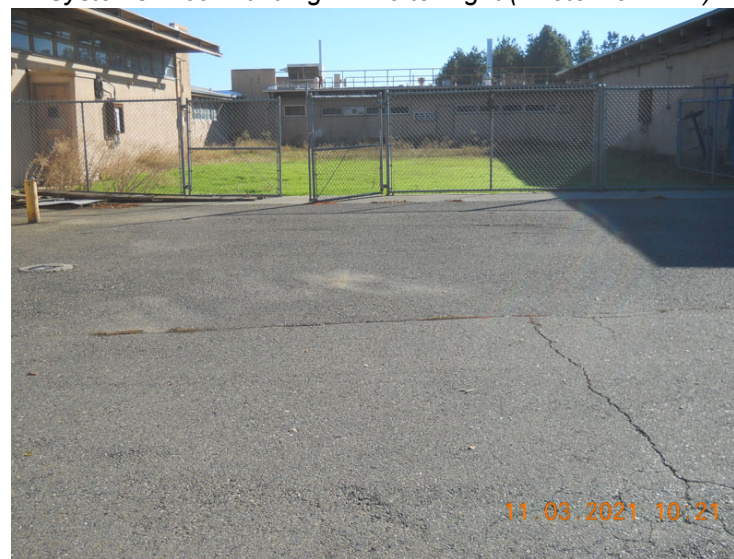
View South of Middle-South Portion of Radium/Strontium Treatment Systems Area: Building H-218 to Left; West Perimeter Gate and Fence to Right (Photo No. 4413)
