**2021 Annual Land-Use Covenant
Inspection Report
for DOE Areas at the
Laboratory for Energy-Related
Health Research/Old Campus
Landfill Superfund Site
University of California–Davis**

January 2022

U.S. DEPARTMENT OF
ENERGY

Legacy
Management

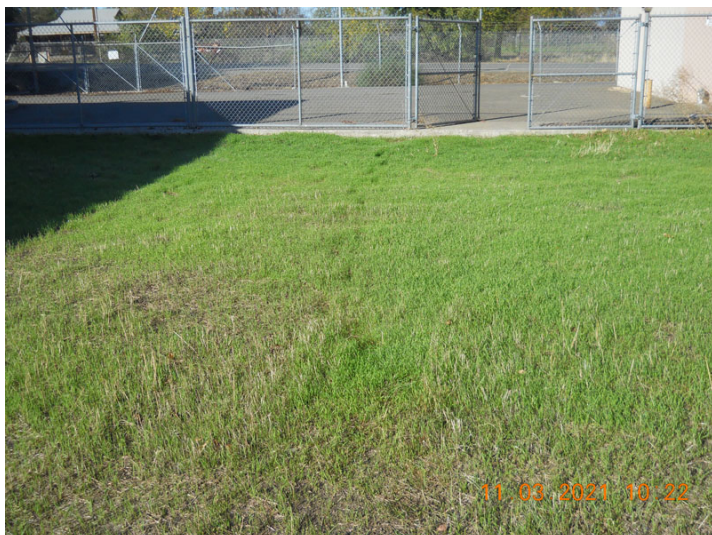
View East of Central Portion of Radium/Strontium Treatment Systems Area: Building H-218 to Right; Building H-219 to Left (Photo No. 4414)

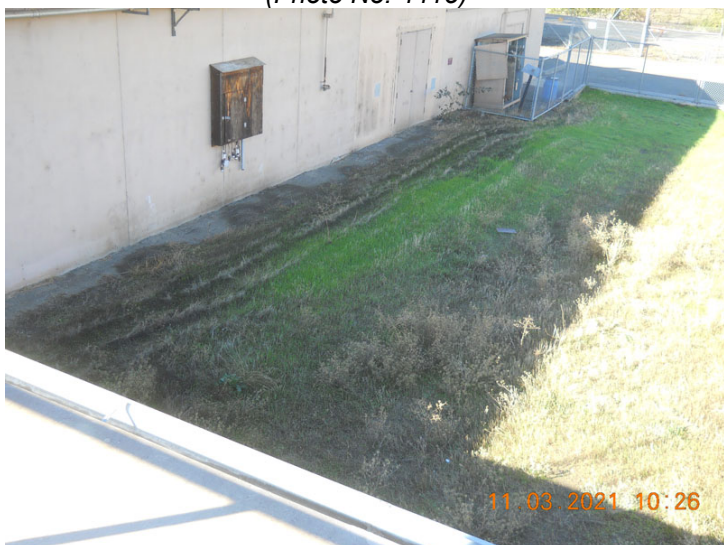
View West of Domestic Septic System 2 Area Within Middle-West Portion of Radium/Strontium Treatment Systems Area (Photo No. 4415)

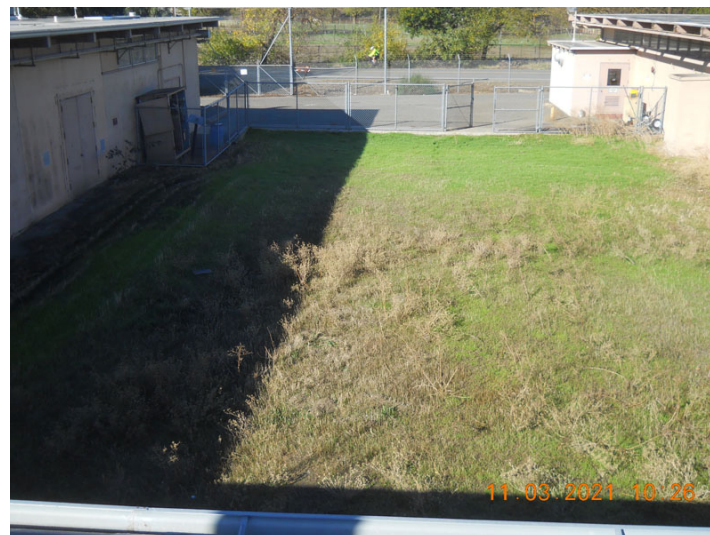
Roof-Level View Southwest of Central Portion of Radium/Strontium Treatment Systems Area: Building H-218 in Background (Photo No. 4417)

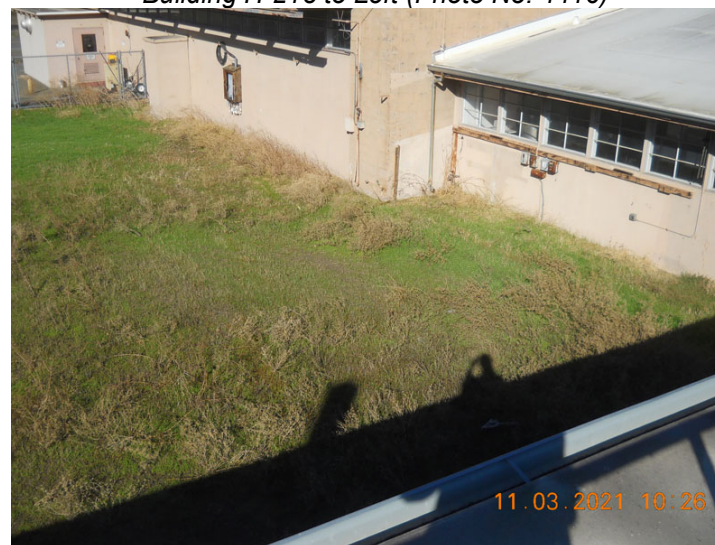
Roof-Level View West of Central Portion of Radium/Strontium Treatment Systems Area: Building H-219 to Right; Building H-218 to Left (Photo No. 4416)

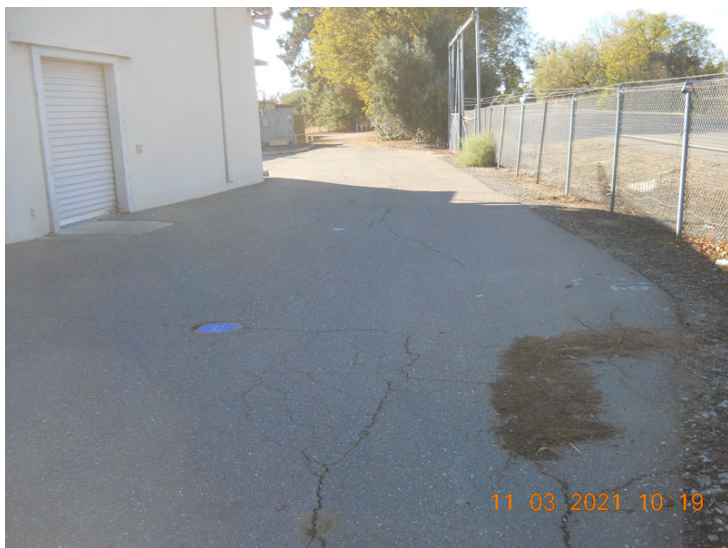
Roof-Level View Northwest of Central Portion of Radium/Strontium Treatment Systems Area: Building H-219 in Background (Photo No. 4418)

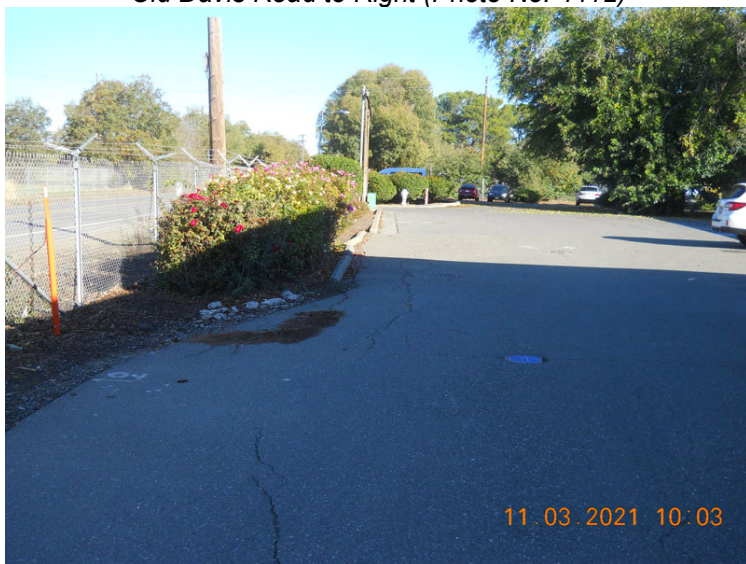
View South over Northern Portion of Radium/Strontium Treatment Systems Area: Building H-219 to Left; West Perimeter Fence and Old Davis Road to Right (Photo No. 4412)

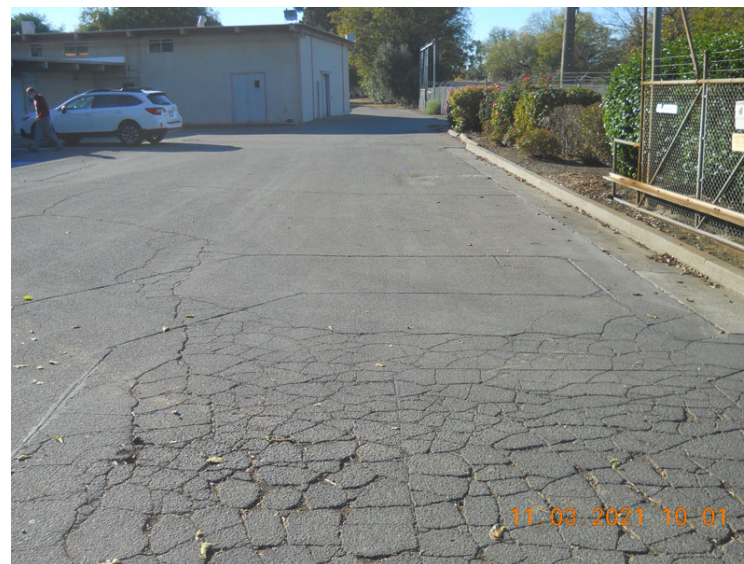
View North of Dry Wells A-E Area: Old Davis Road to Left (Photo No. 4402)

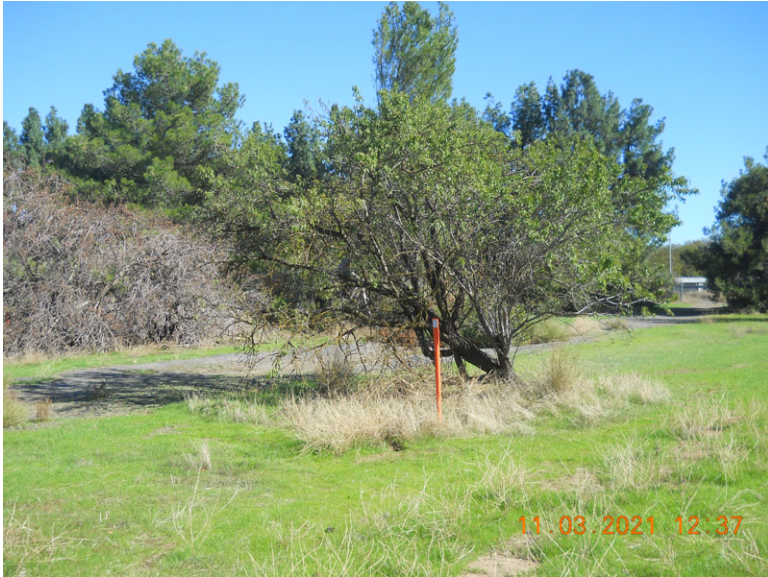
View Southwest of Dry Wells A–E Area (Photo No. 4401)

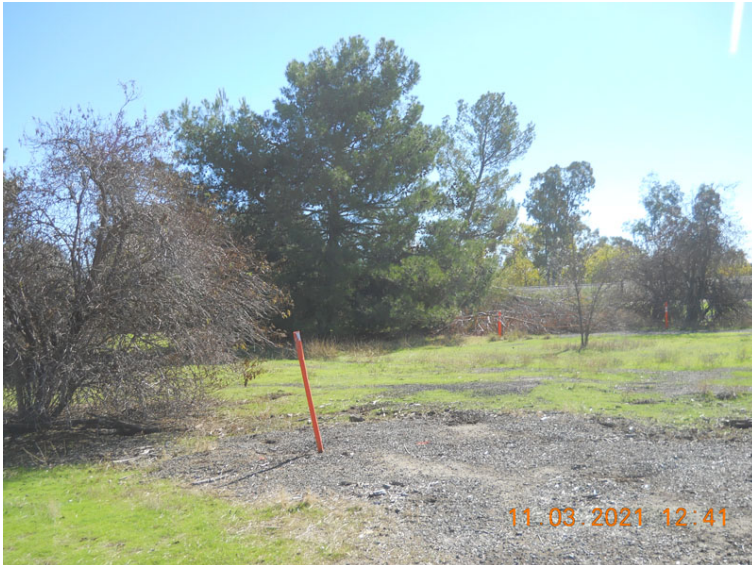
View East of Eastern Dog Pens Area; Tree 16236 Fallen Limb in Center, Behind Stanchions and Rope (Photo No. 4491)

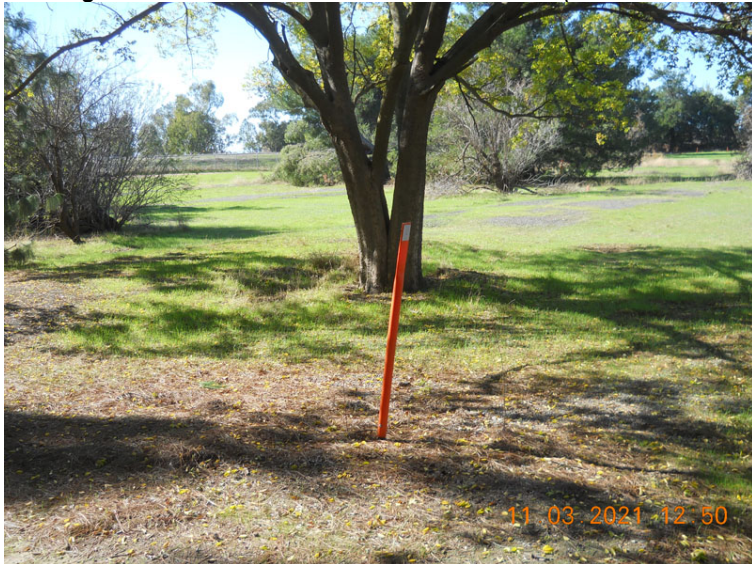
View Southeast of Eastern Dog Pens Area from Northwest Corner Showing Northwest Corner Monument Location (Photo No. 4492)

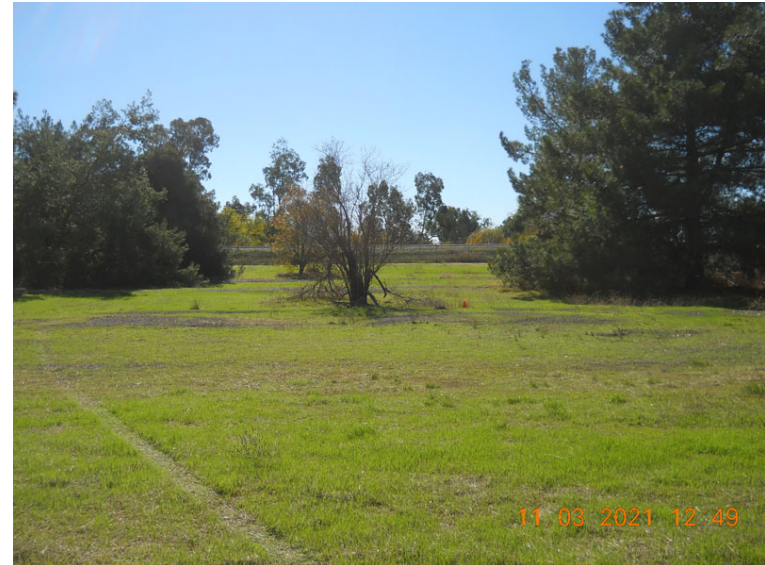
View Southwest of Eastern Dog Pens Area from Northeast Corner Showing Location of Northeast Corner Monument (Photo No. 4496)

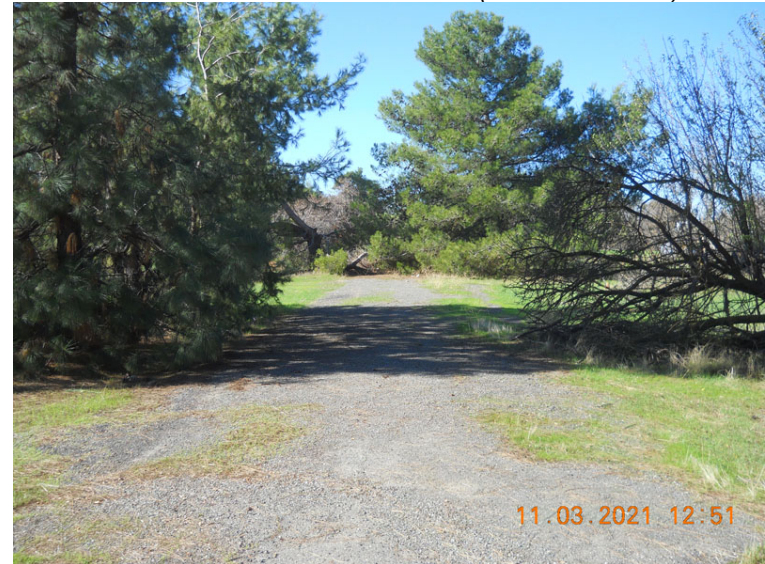
View South of Eastern Dog Pens Area; Shrub 16233 with Small Fallen Limbs in Center of Photo (Photo No. 4495)

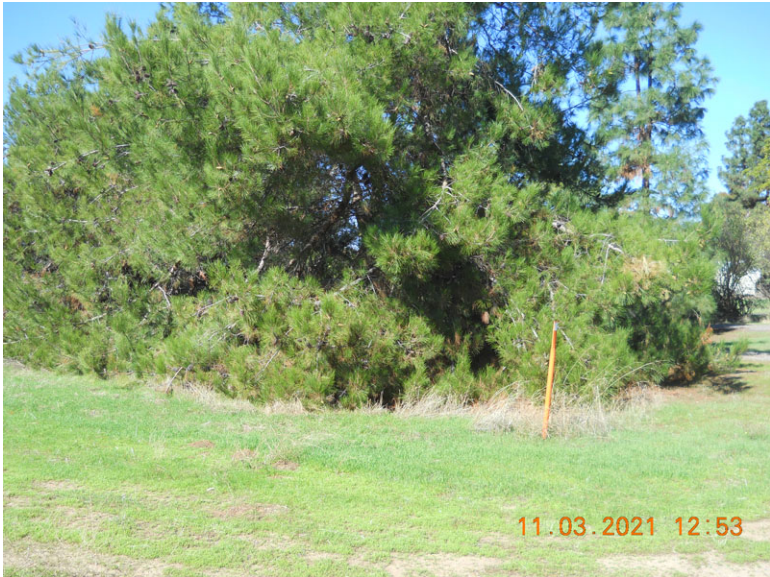
View West of Eastern Dog Pens Area (Photo No. 4499)

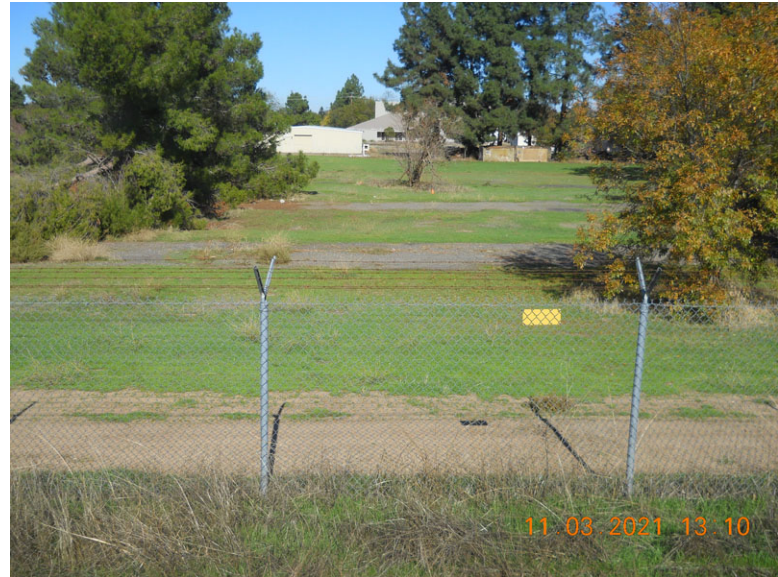
View Northwest into Eastern Dog Pens Area from Southeast Corner Showing Location of Southeast Corner Monument (Photo No. 4502)
